2nd Japan-Peru Workshop on Enhancement of Earthquake and
Tsunami Disaster Mitigation Technology,
Chiba University, March 9-11, 2011

Effects of the 27 February 2010 Earthquake in (Industrial Facilities) in Chile

Ernesto F. Cruz, Ph.D. and Dania Valdivia, M.Sc.

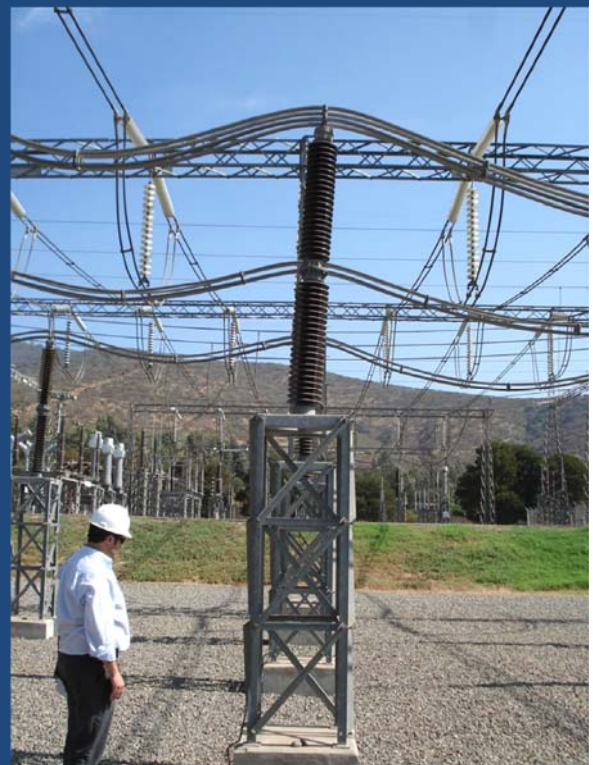
Sub-estación Eléctrica, cercana a
Quillota, Aislador inclinado,

Electrical Substation, near Quillota,
inclined Isolator

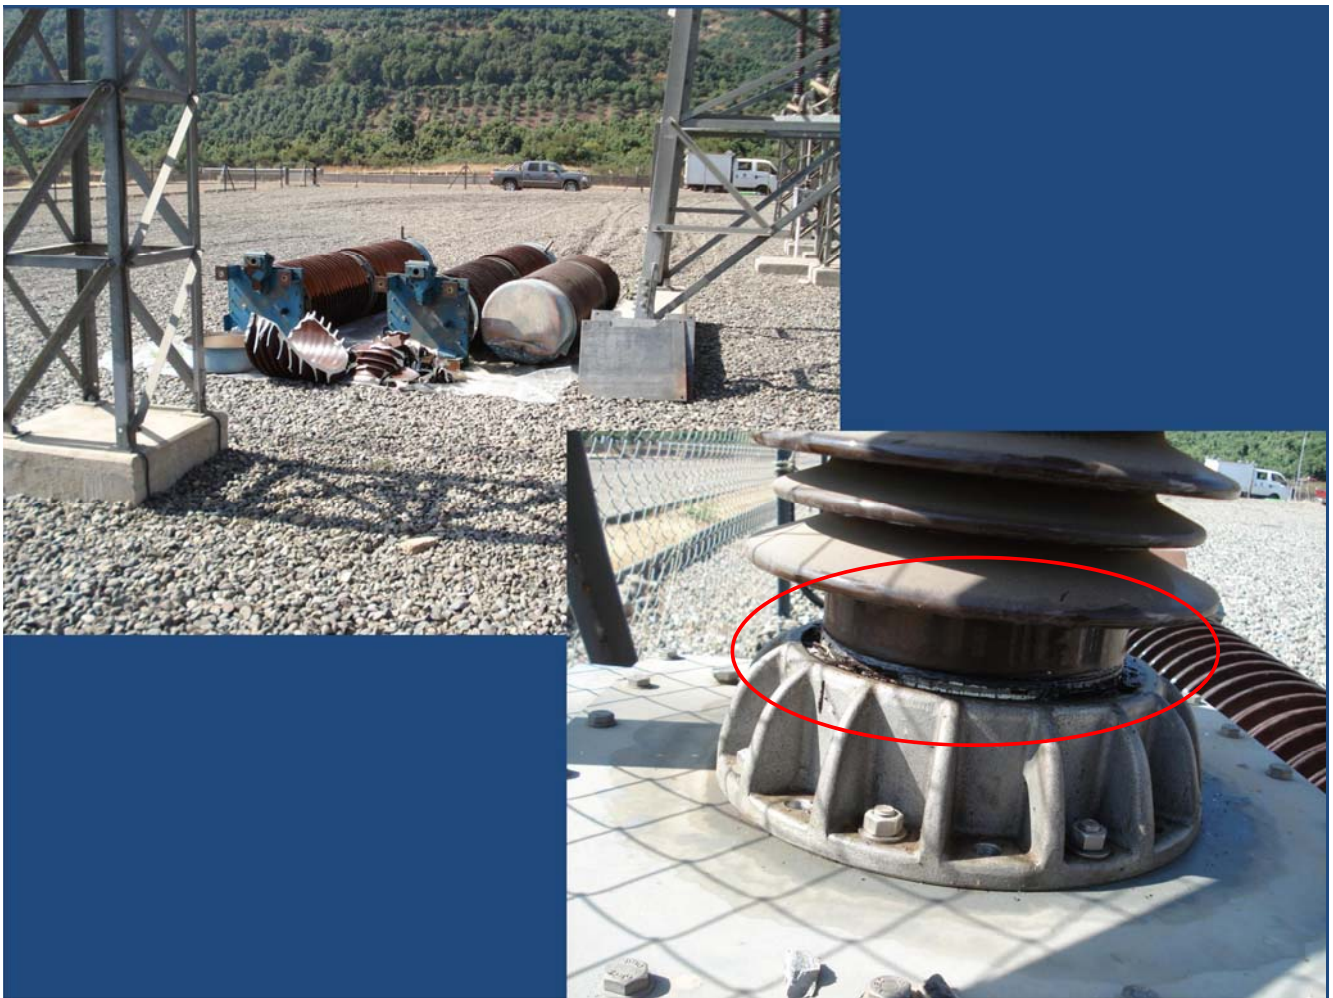
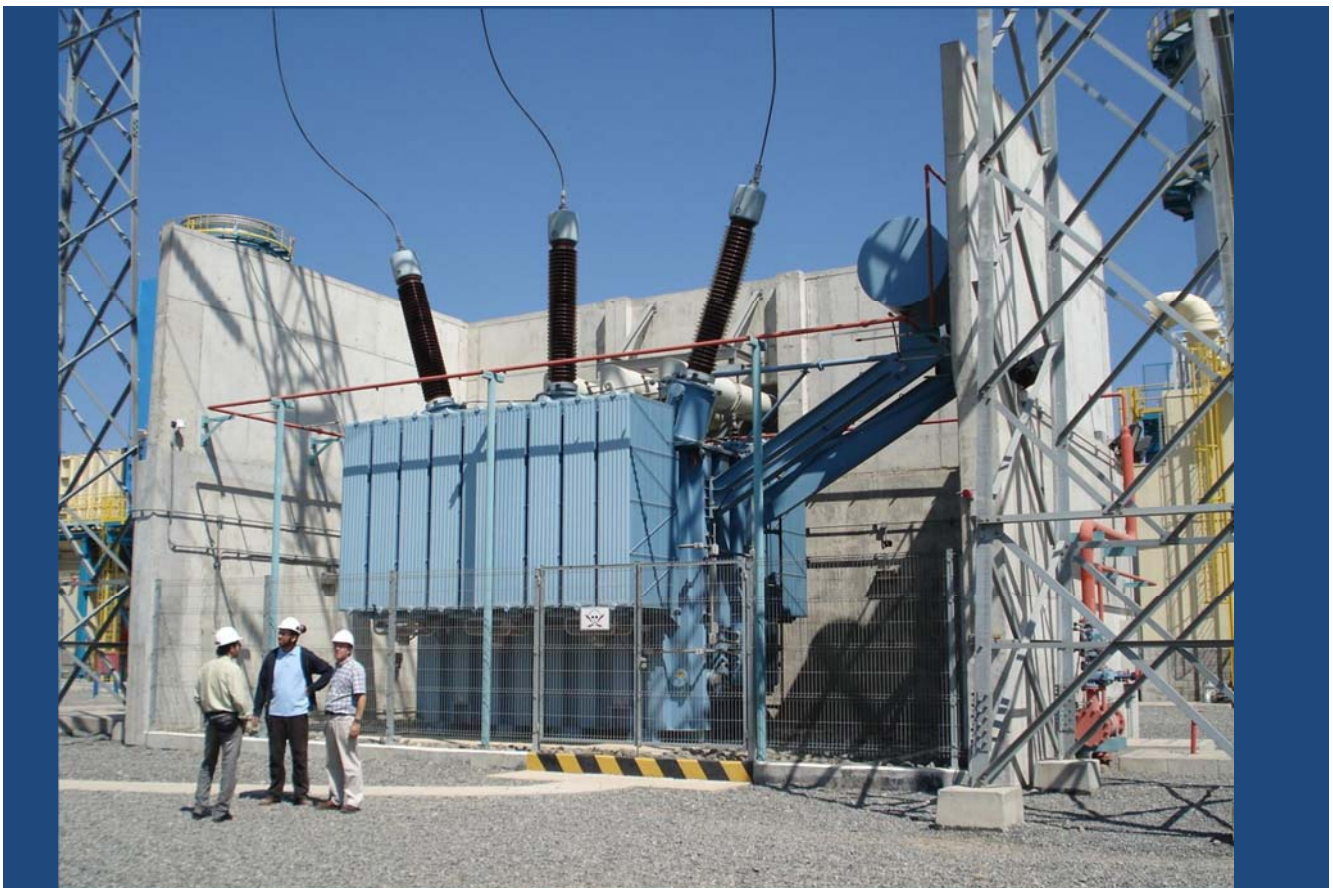
Transformador Principal, Central Termo-eléctrica, cercano a Codegua.
Main Transformer, Diesel Fired Power Station , near Codegua

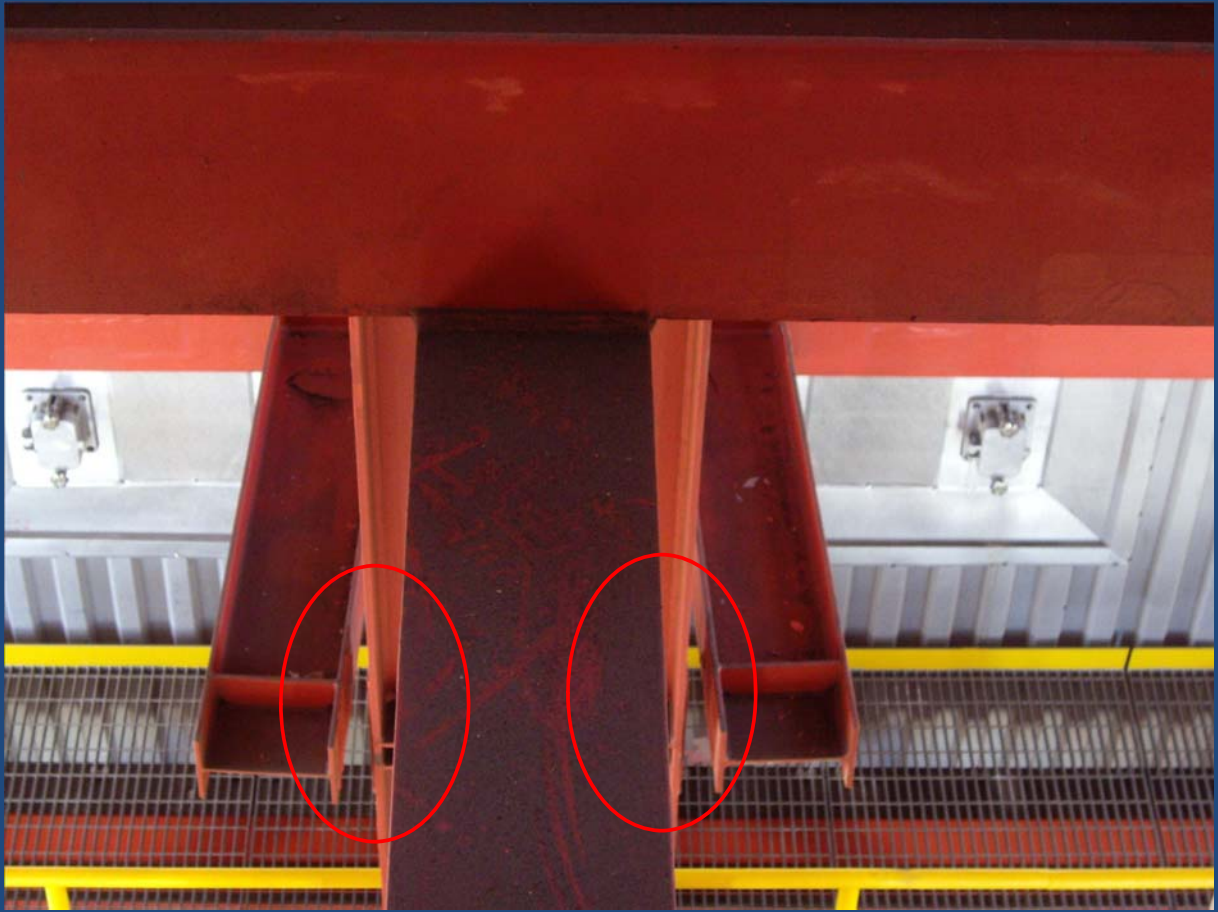
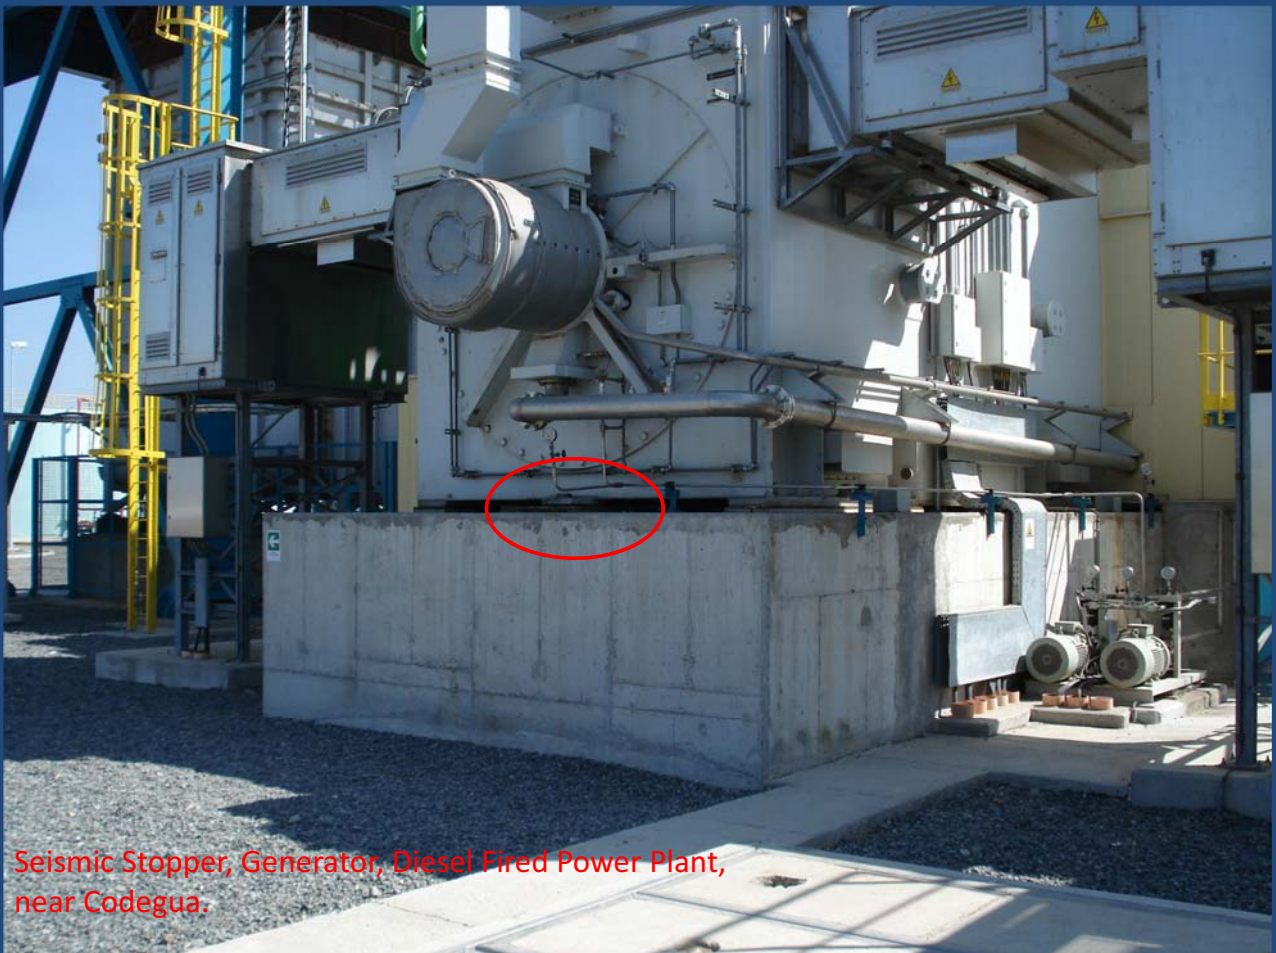
Seismic Stopper, Generator, Diesel Fired Power Plant,
near Codegua.

Seismic Stopper,
Steam Turbine,
Combined Cycle
Power Plant, near
Quillota.

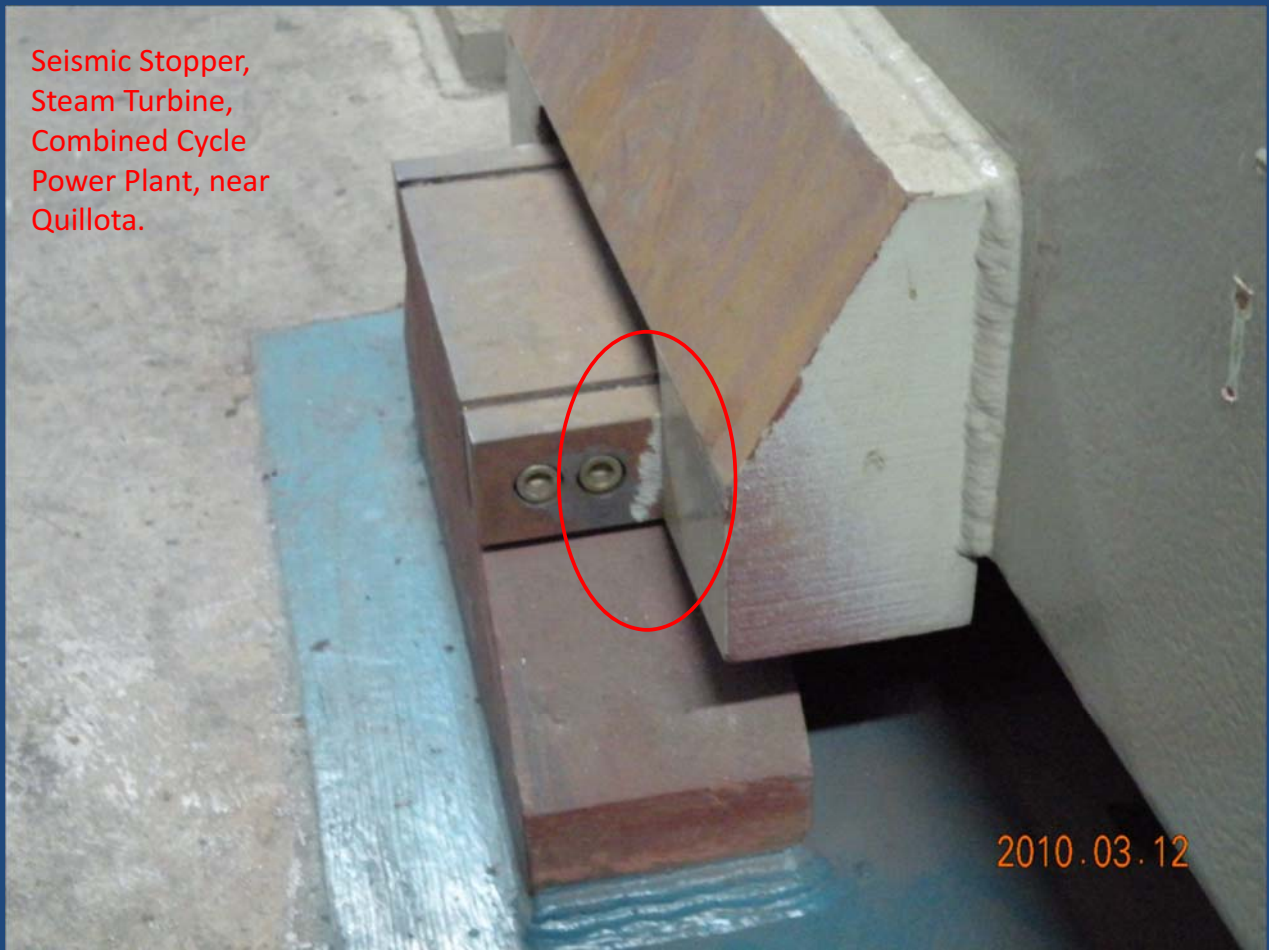
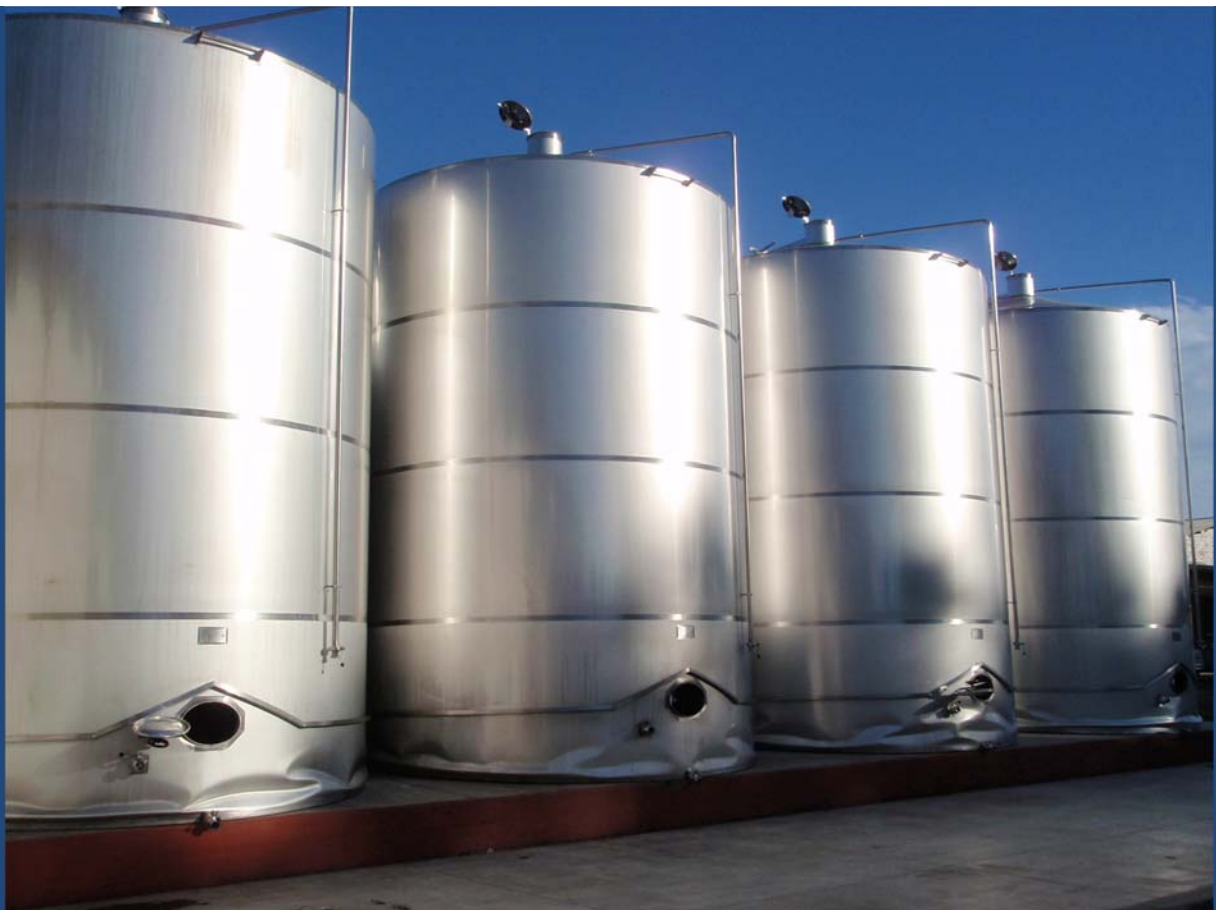
Falla Base Estanques de Acero Inoxidable para Almacenamiento de Vino. Cercano a Curicó.
Failure at Base of Stainless Steel Storage Tanks, Winery near Curicó

Damage to contents , Storage Racks, Winery near Curico

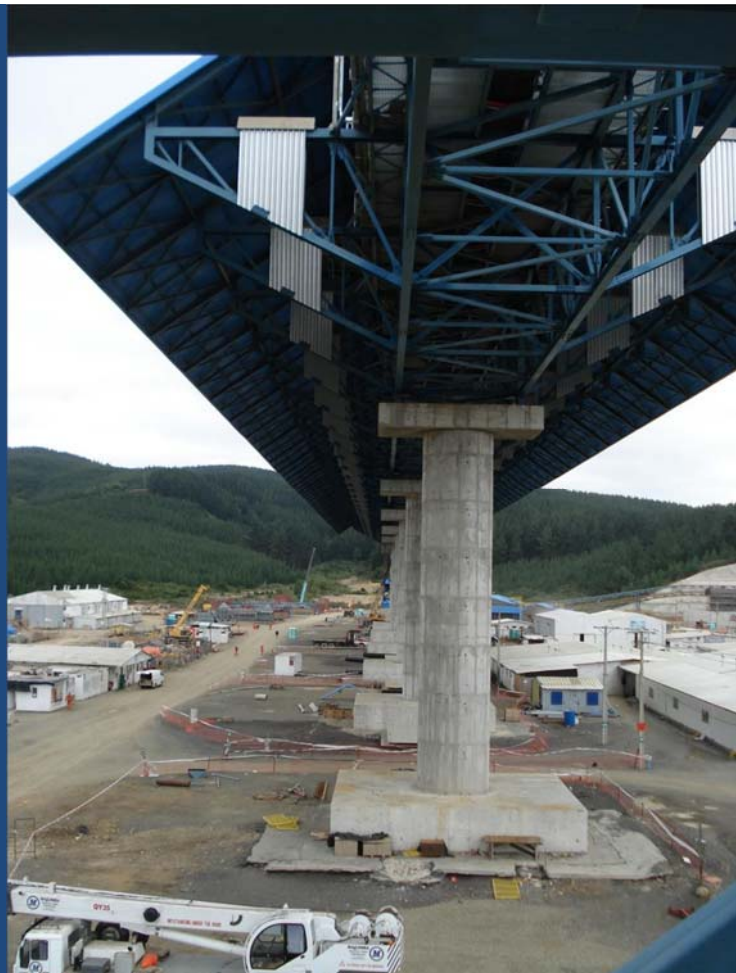
Cepas Apilador de Carbón,
Central Termo-eléctrica, Zona
Coronel (en construcción)

Support Structure for Coal
Tripper, Coal Fired Power
Station, near Coronel
(under Construction)

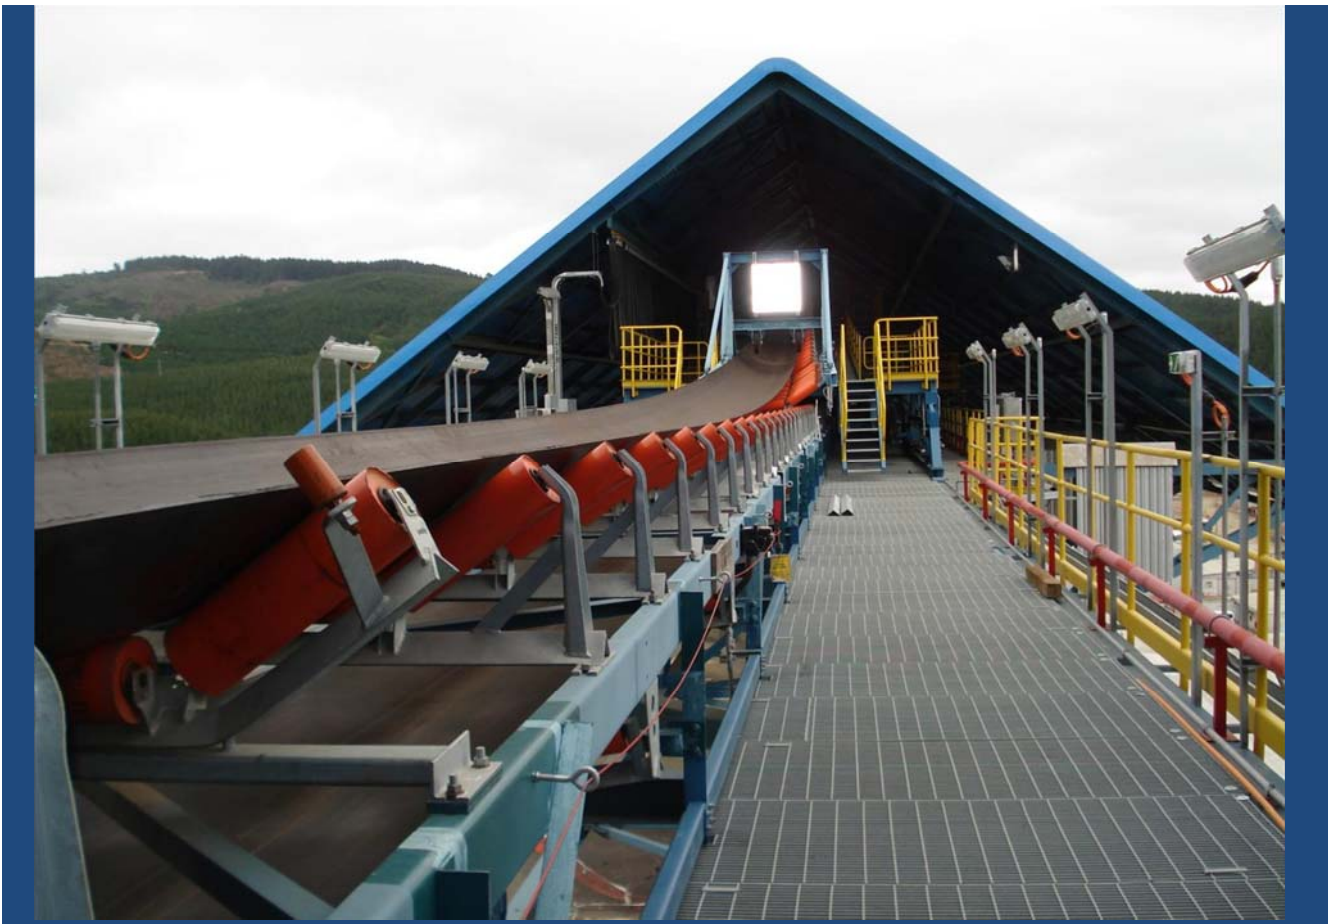
Correa Apilador de Carbón, Central Termo-eléctrica, Zona Coronel
Conveyor for Coal Tripper, Coal Fired Power Station, near Coronel (under Construction)

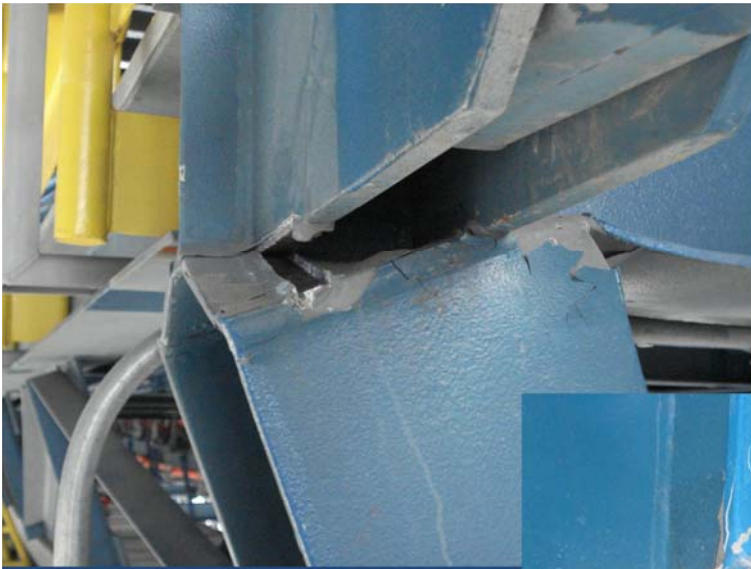
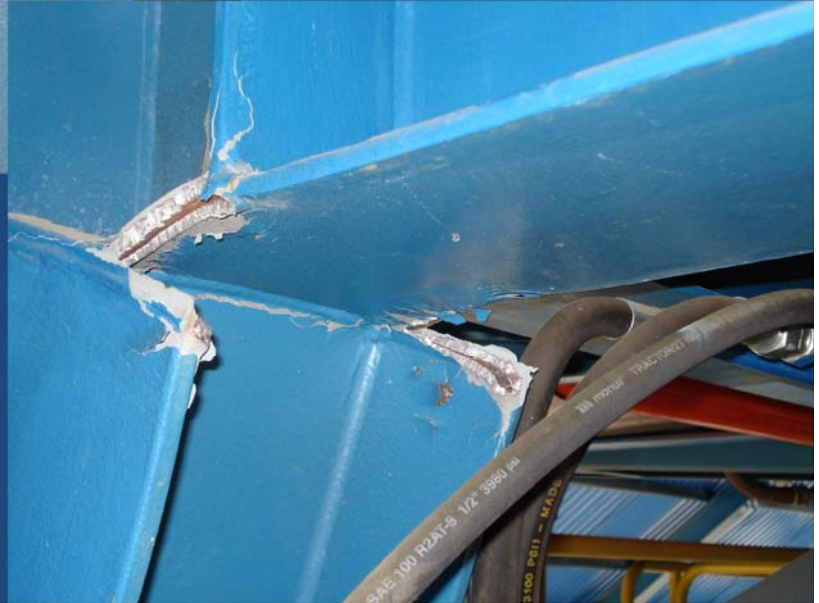
Coal Tripper Car, Coal Fired Power Station near Coronel. Failure at Moment Connections Details

Carro Apilador de Carbón, Central Termo-eléctrica, Zona Coronel; Falla conexión de momento. Detalles

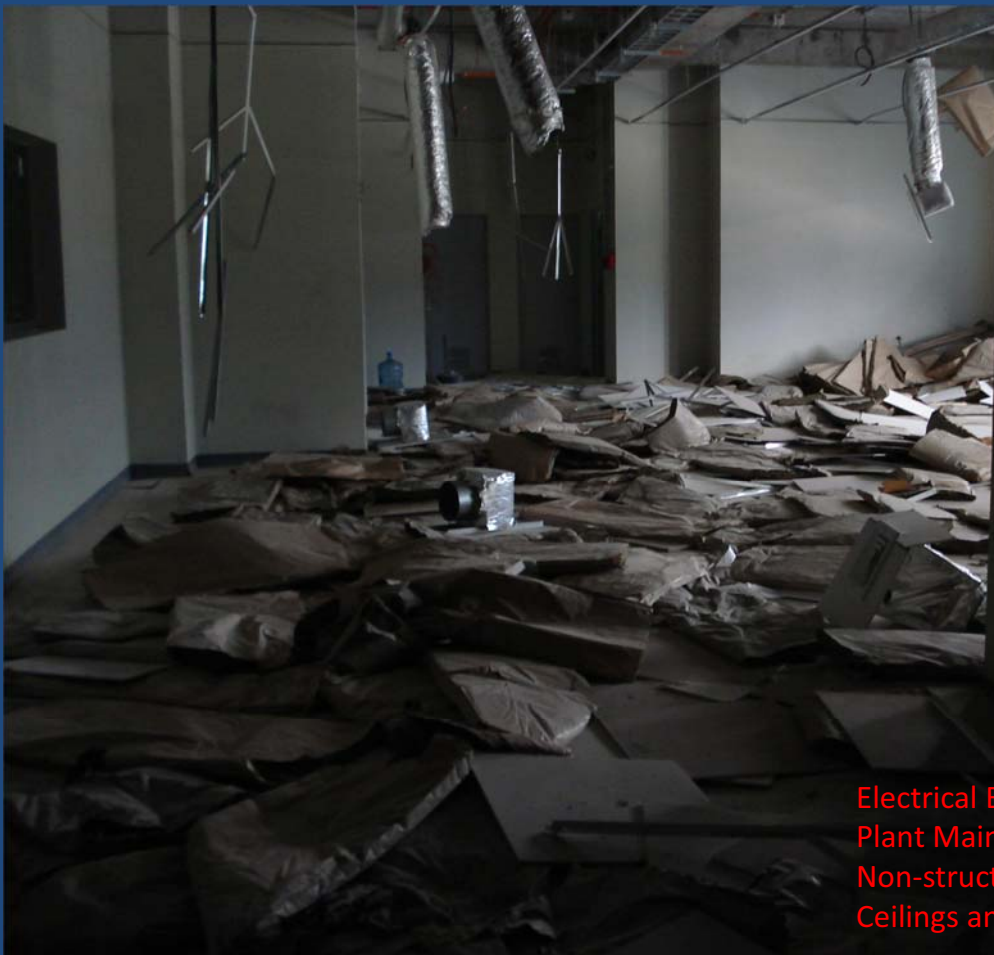
Electrical Building – Power Plant Main Control Room
Non-structural elements
Ceilings and Air conditioning

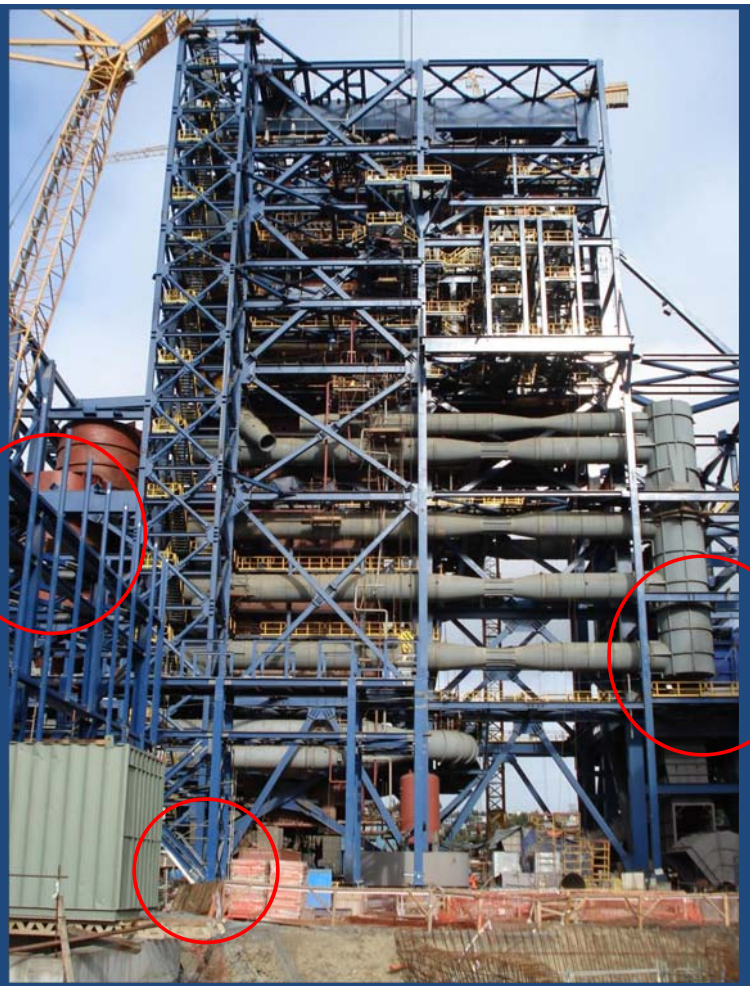
Silos de carbón, Estructura de Soporte Caldera Carbón Pulverizado, Central Termo-eléctrica, Zona Coronel

Daños debido a montaje parcial de la estructura y los equipos.

Steel Support Structure
Coal Fired Power Plant
Steam Generator Boiler

Minor damage due to incomplete erection of structure and equipment

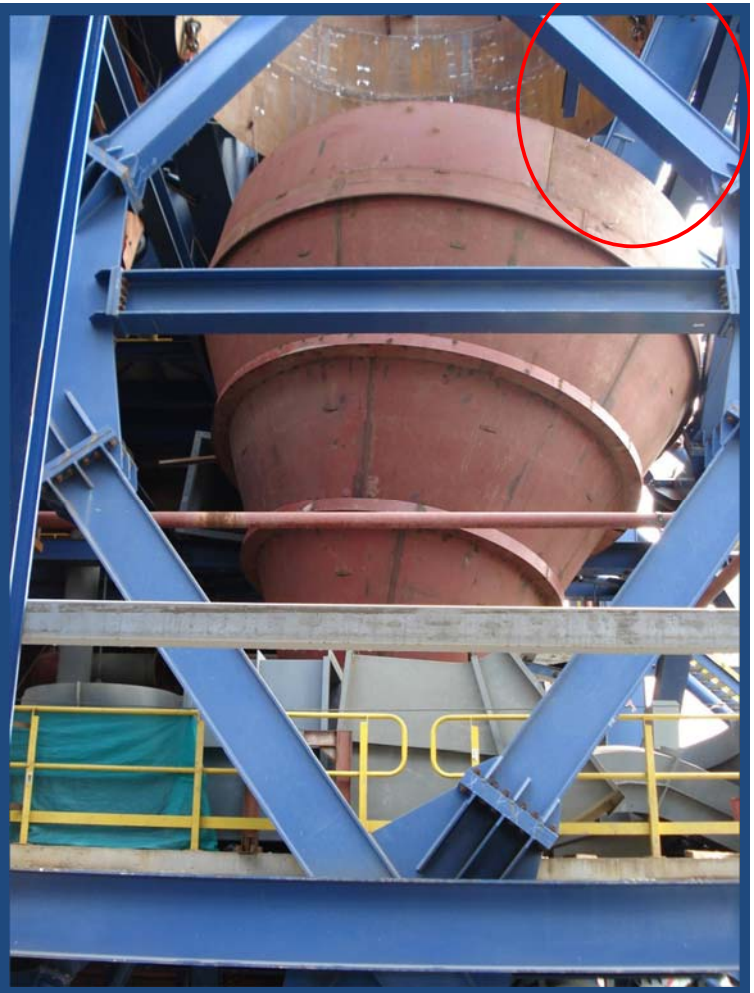
Steel Support Structure
Coal Fired Power Plant
Steam Generator Boiler
In Coronel
(under Construction)
Heavy Equipment,
(GGH, approx. 300 ton)
Damage to anchor
bolts, NO seismic
stoppers installed

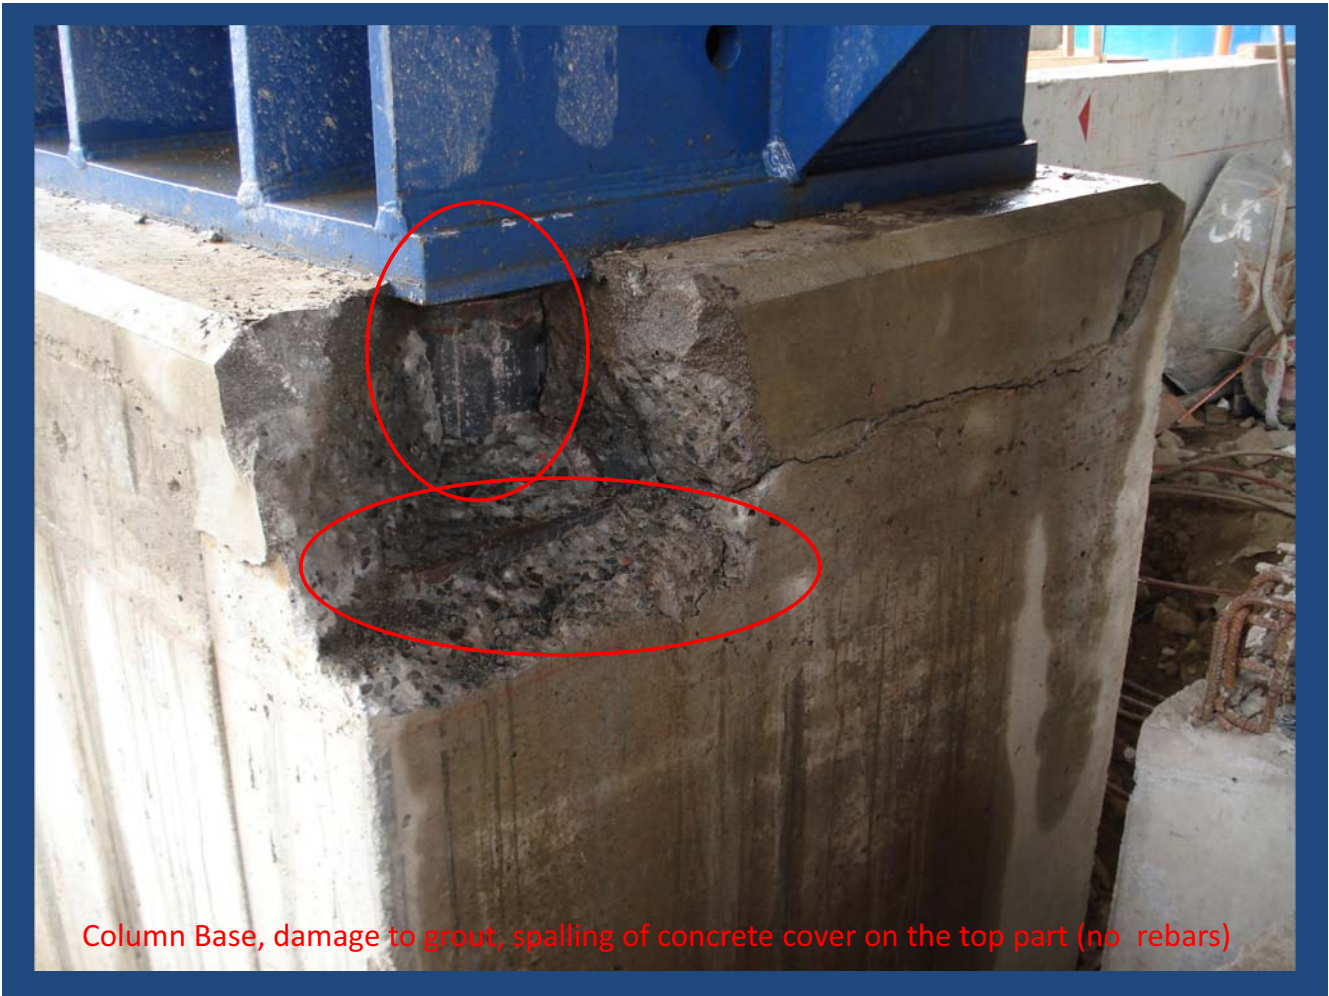
Column Base, damage to grout, spalling of concrete cover on the top part (no rebars)

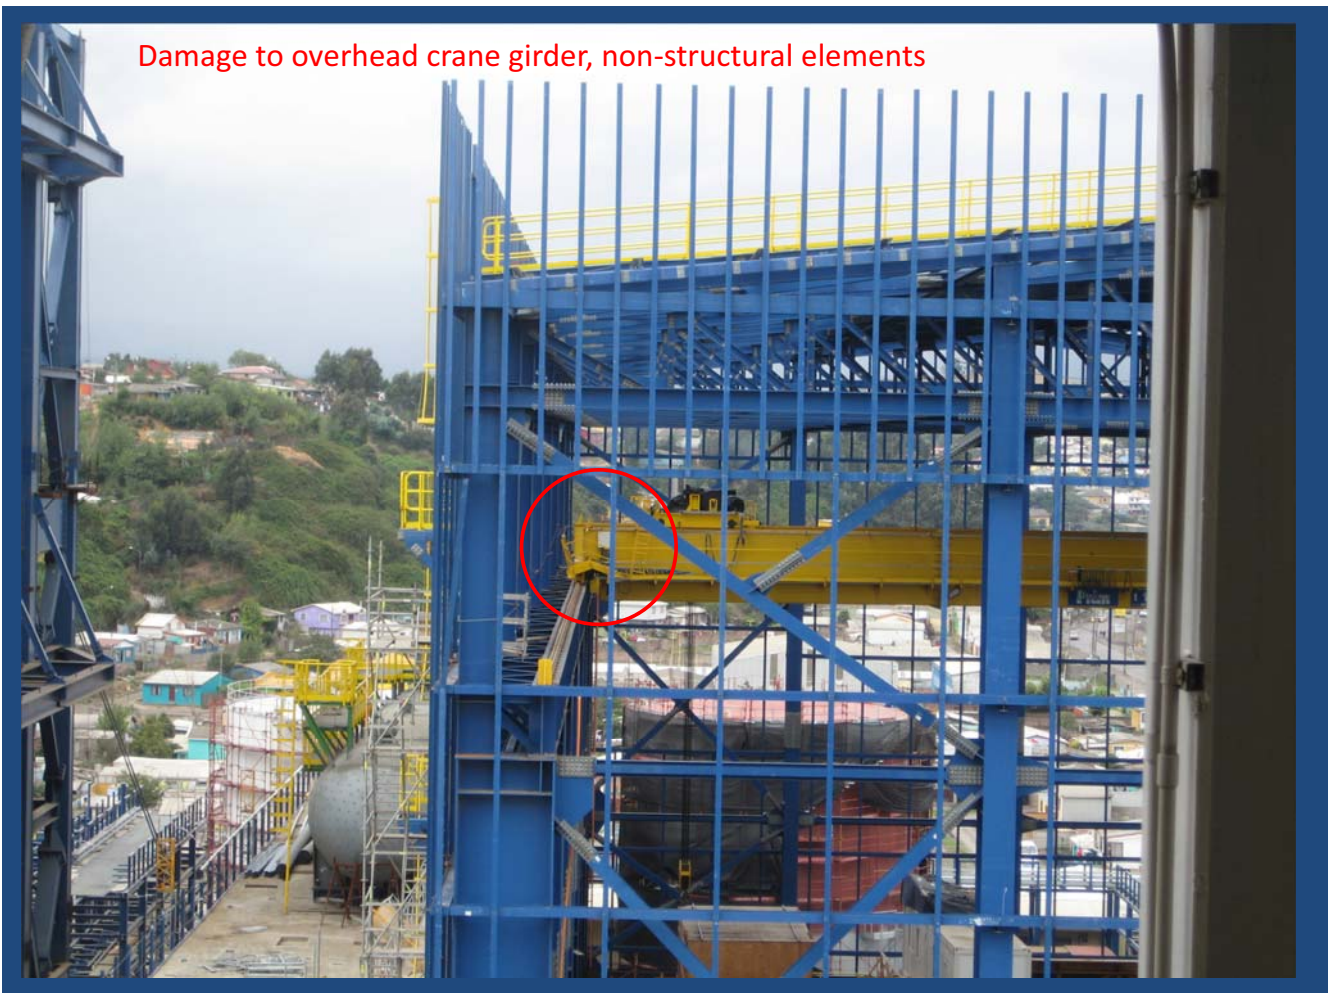
Damage to overhead crane girder, non-structural elements

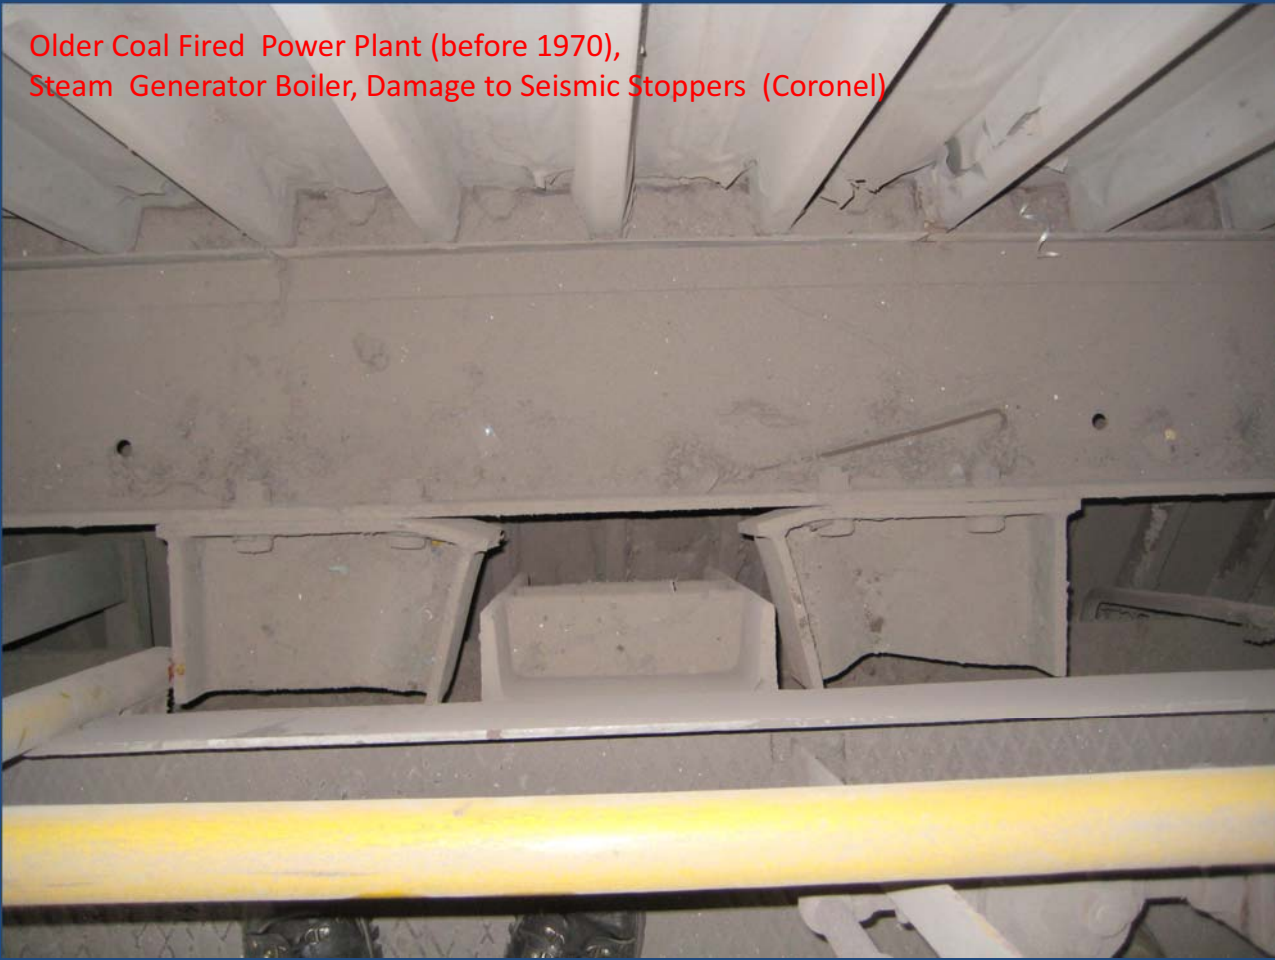
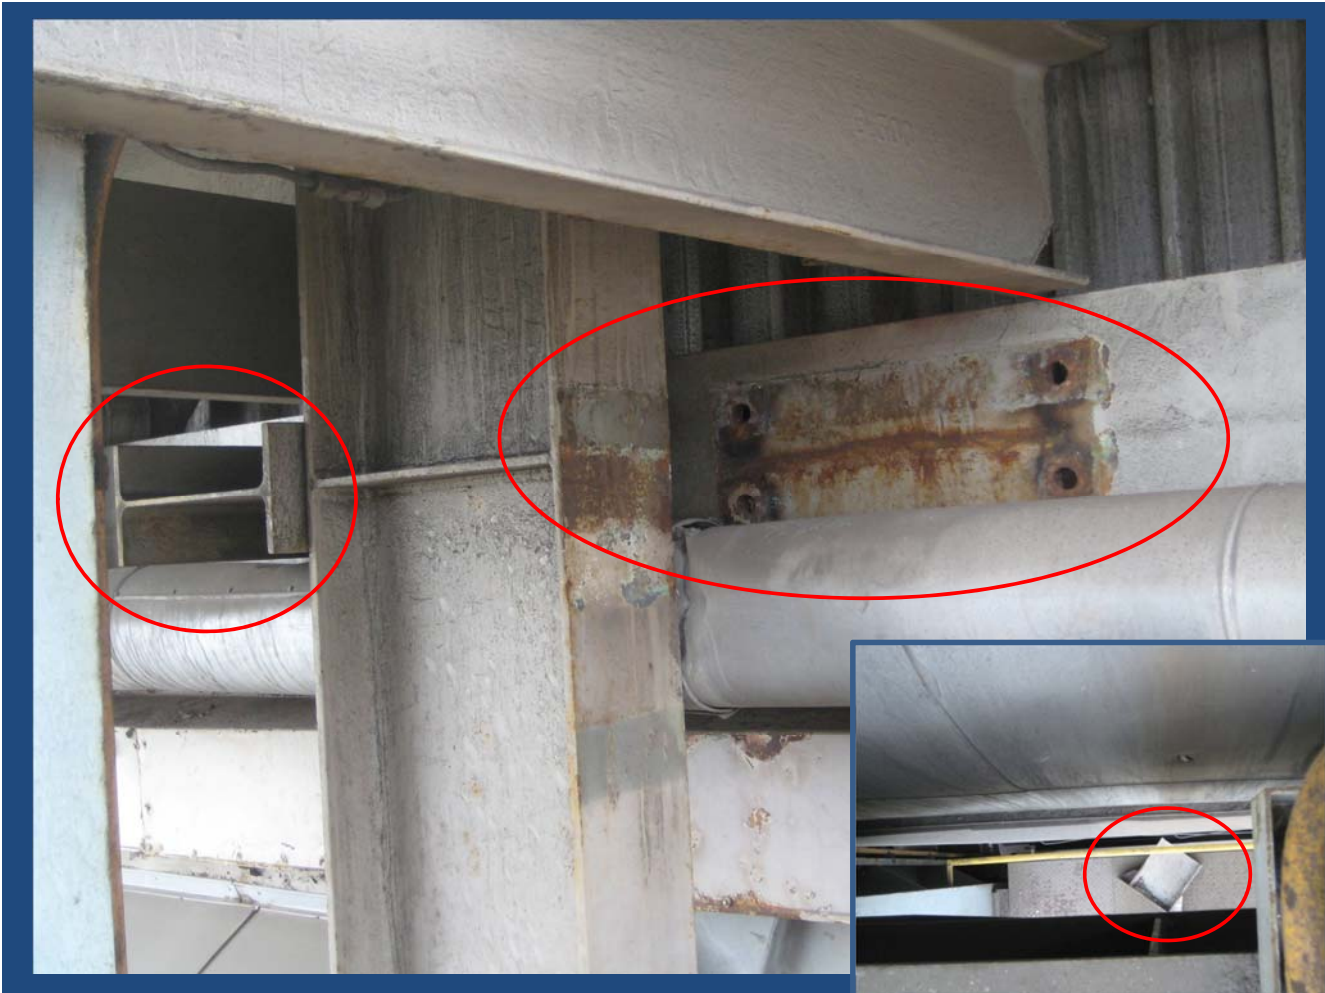
Older Coal Fired Power Plant (before 1970),
Steam Generator Boiler, Damage to Seismic Stoppers (Coronel)

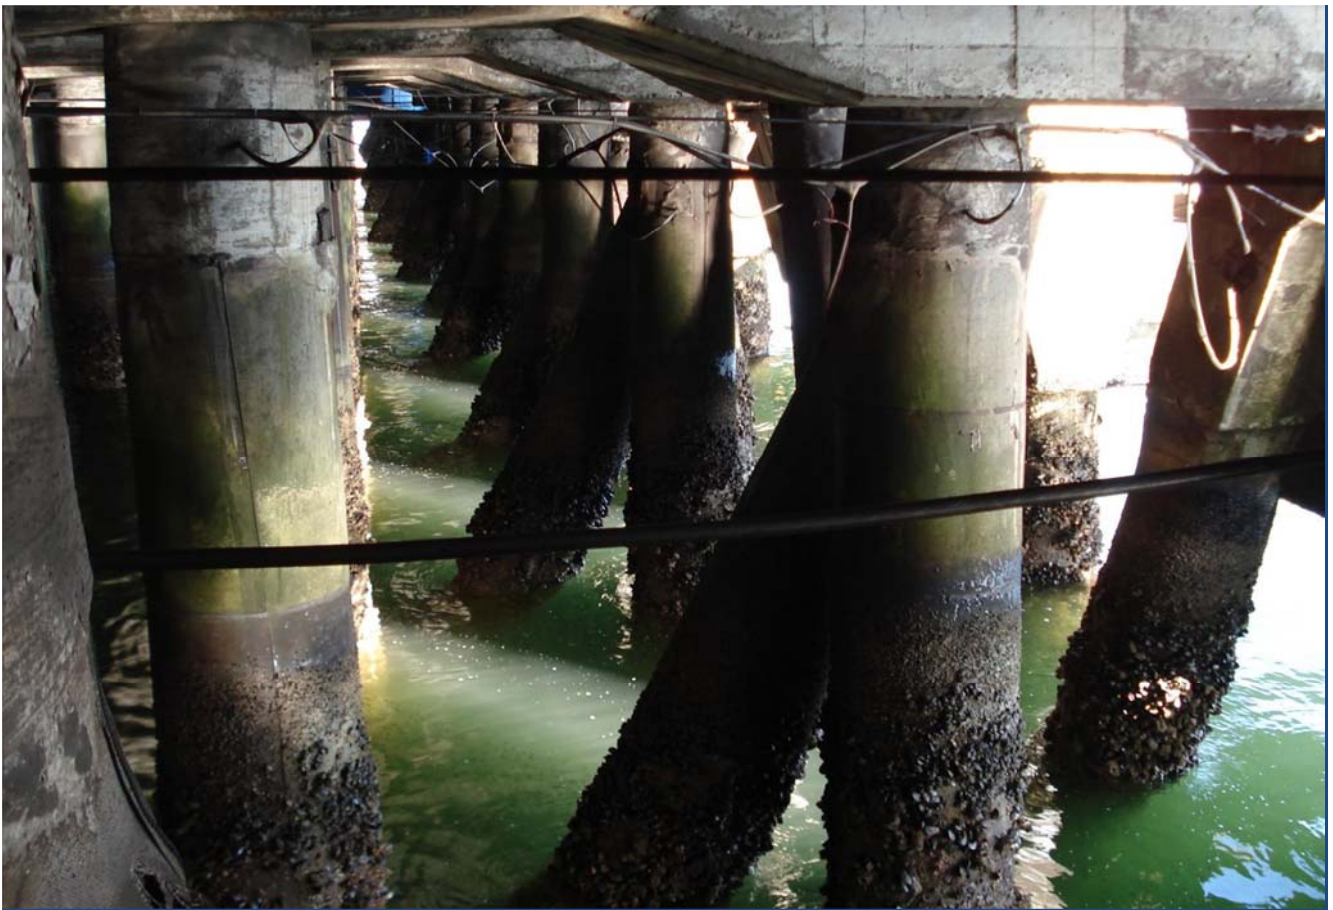
Huachipato, Vista General bajo el Muelle Pilotes Diagonales cortados.,
Wharf near Concepcion, Diagonal piles were sheared off at the top

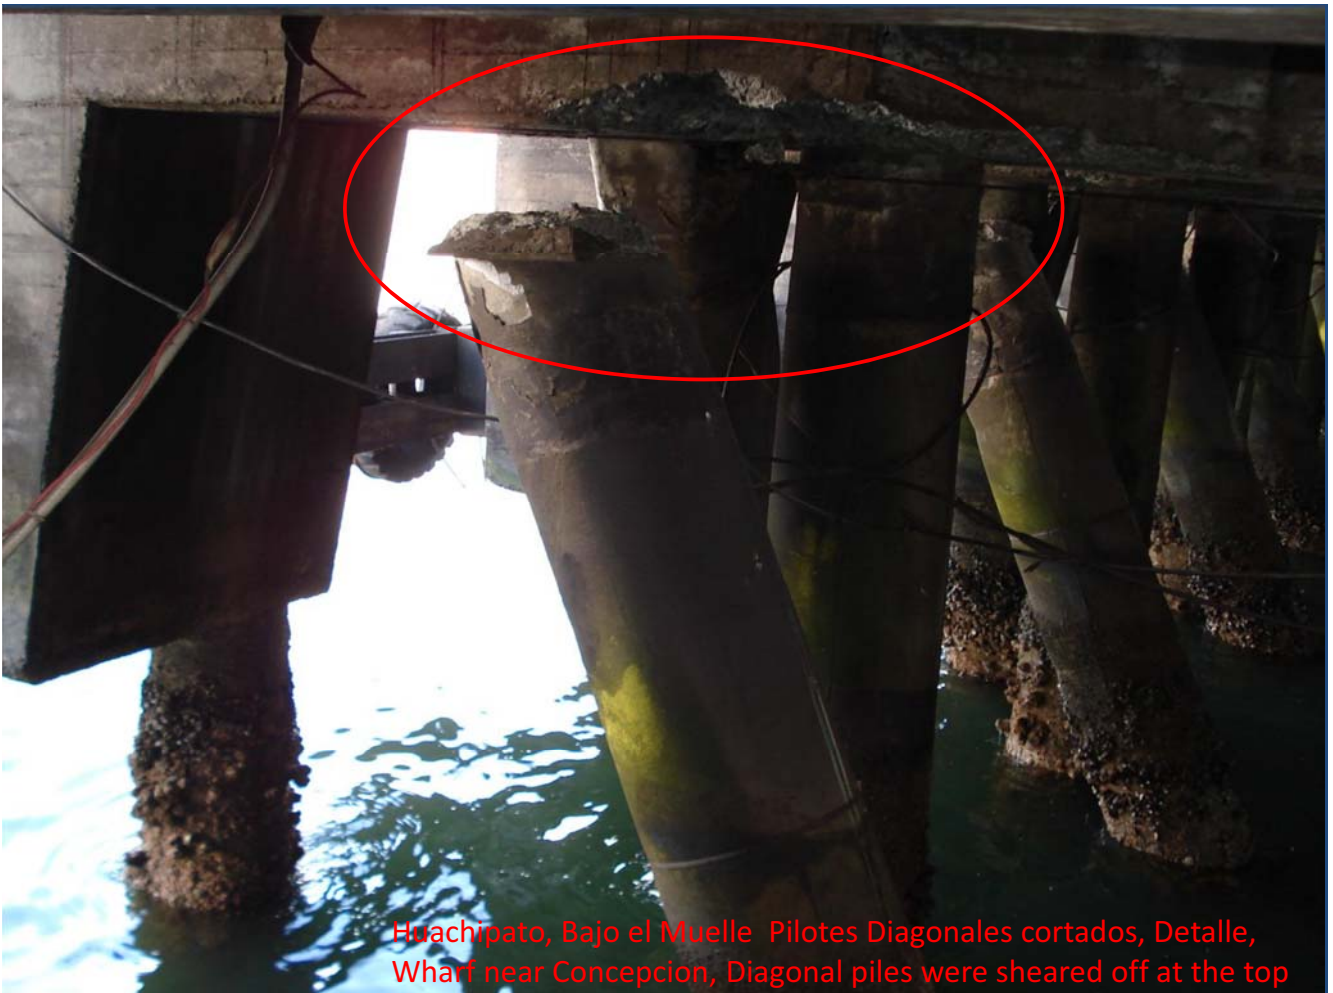
Huachipato, Bajo el Muelle Pilotes Diagonales cortados, Detalle,
Wharf near Concepcion, Diagonal piles were sheared off at the top

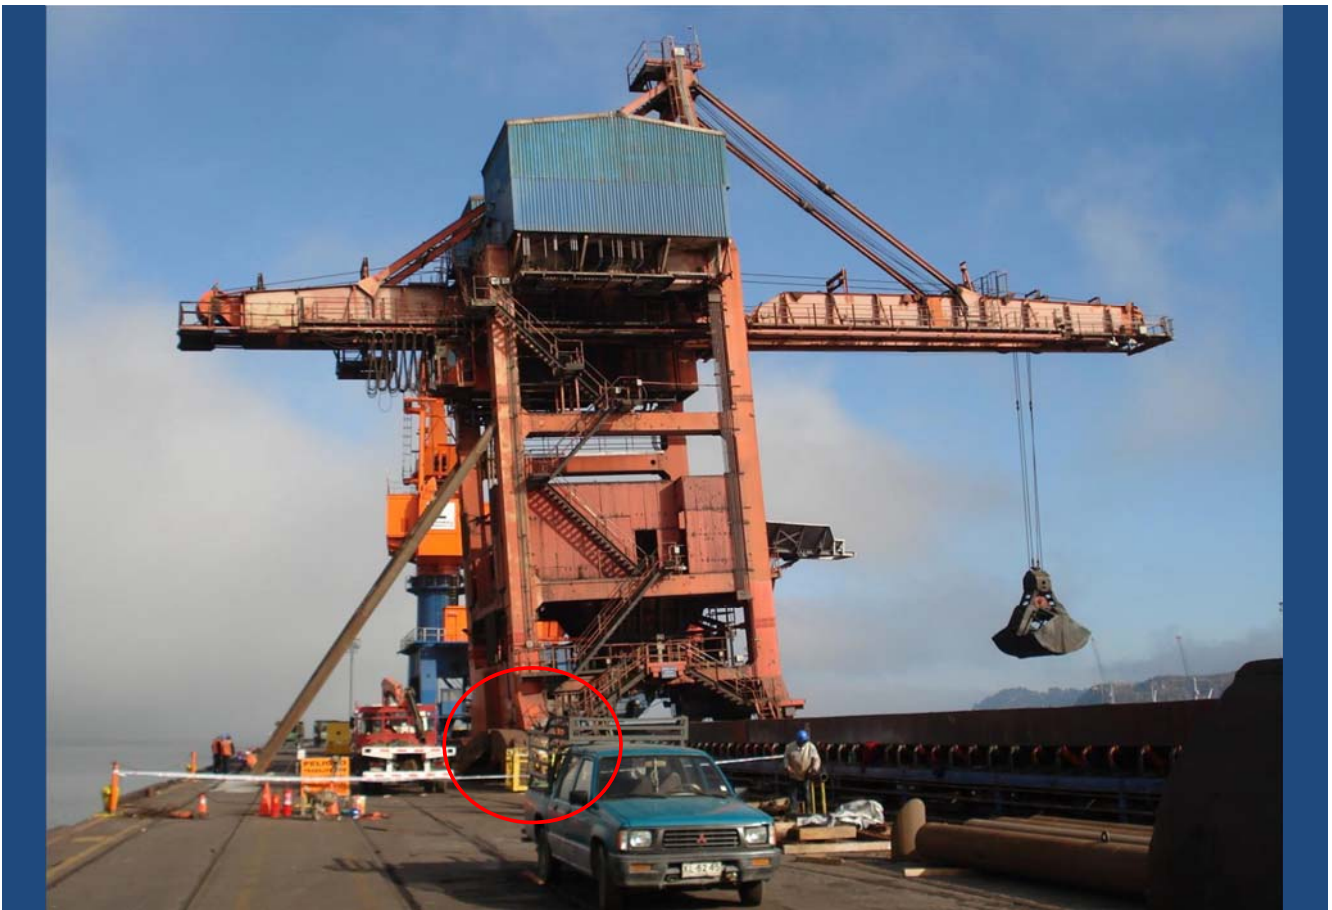
Huachipato, Large crane for Bulk cargo, Failure of columns at base (rails), due to overturning. Temporary diagonal support.

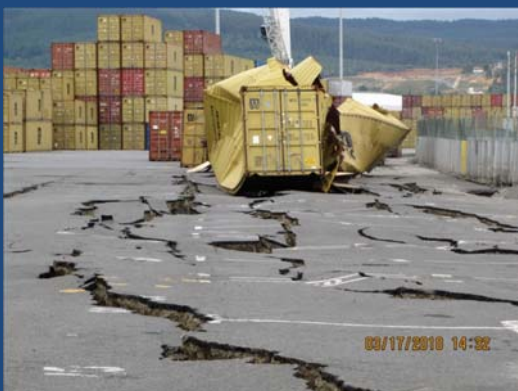
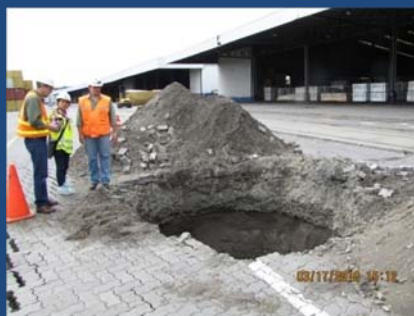
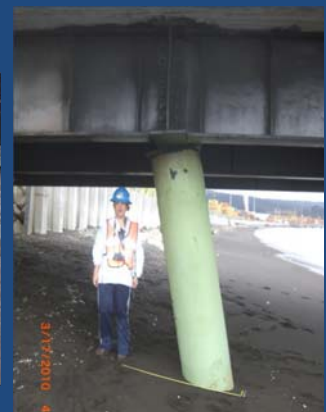
Coronel : Settlements / Displacements, Sand boils, Piles damage
