2nd Japan-Peru Workshop on Enhancement of Earthquake and
Tsunami Disaster Mitigation Technology,
Chiba University, March 9-11, 2011

Effects of the 27 February 2010 Earthquake in (Industrial Facilities) in Chile

Ernesto F. Cruz, Ph.D. and Dania Valdivia, M.Sc.

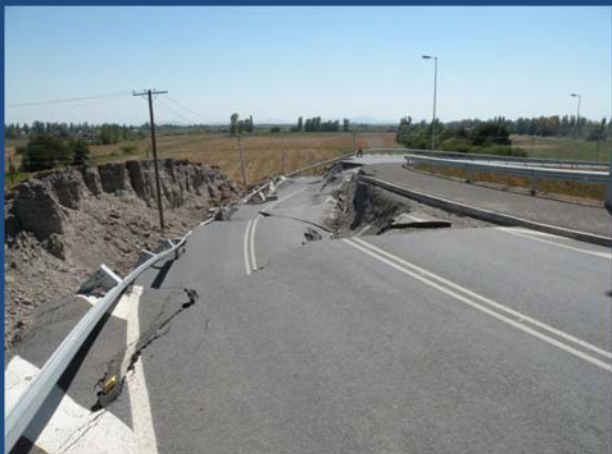
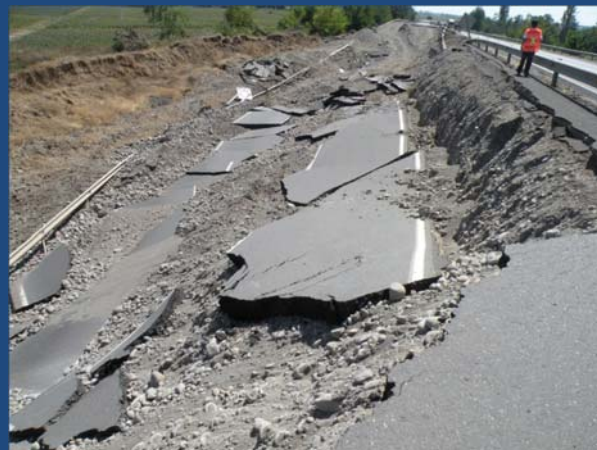
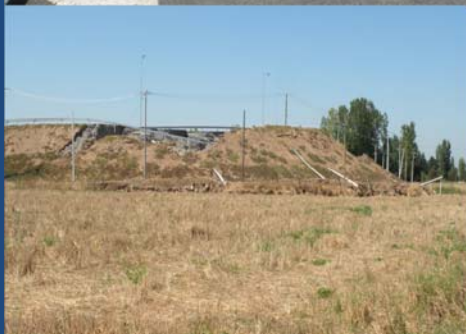
Embankment Failures along Ruta 5

Possible liquefaction
of thin soil layers
under the main fill
caused lateral
spreading

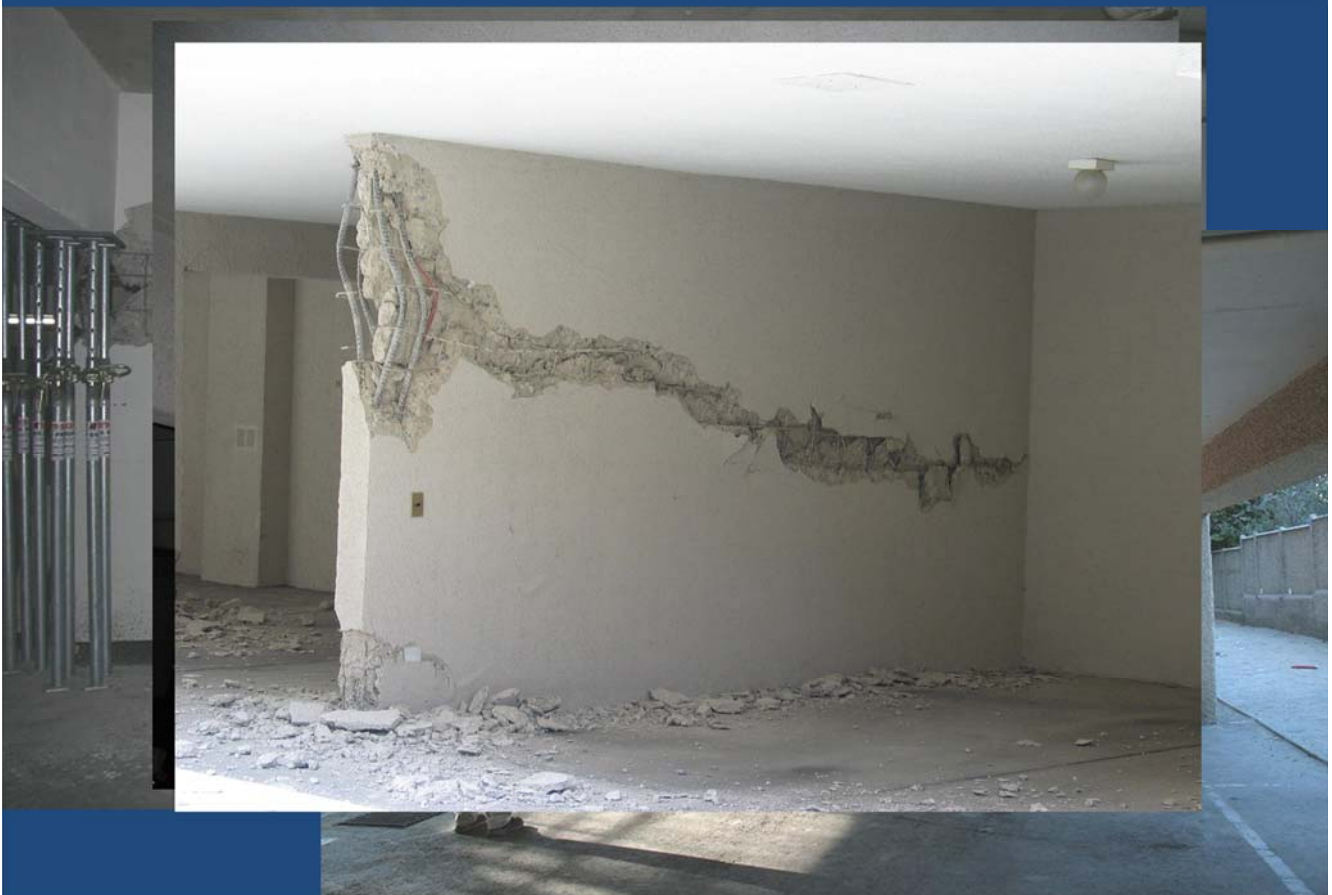
Viña del Mar, V Region

Compression failure in walls at ground or basement levels
