The 2nd Japan-Peru Workshop on
Enhancement of Earthquake and Tsunami Disaster Mitigation Technology

THE INFLUENCE OF CONSTRUCTION PROCEDURES IN THE SEISMIC VULNERABILITY OF NON ENGINEERING HOUSINGS IN TACNA CITY

By: Dina COTRADO FLORES
March, 2011

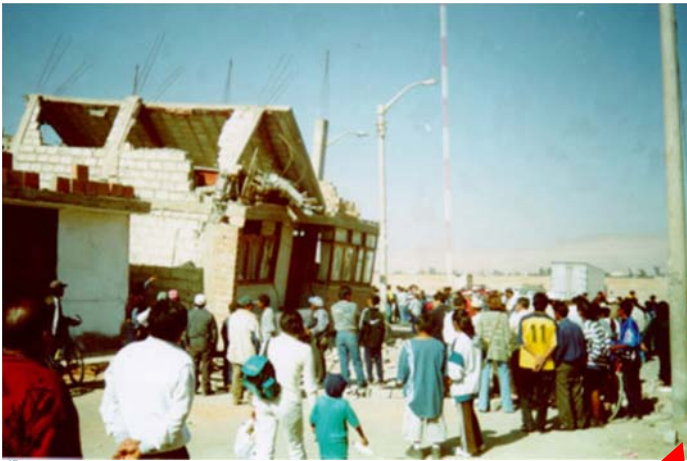
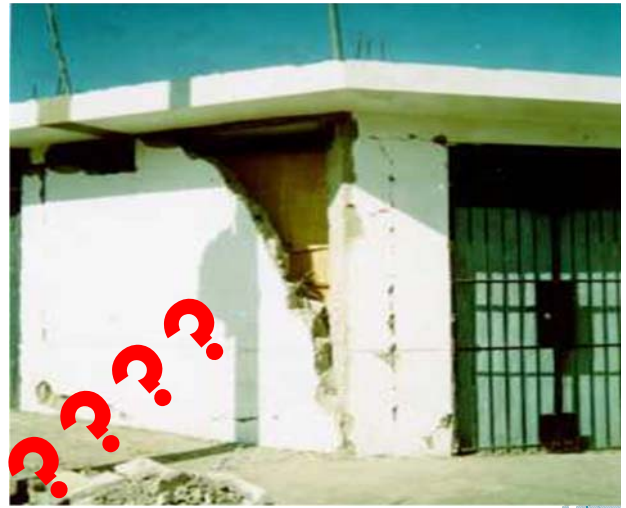
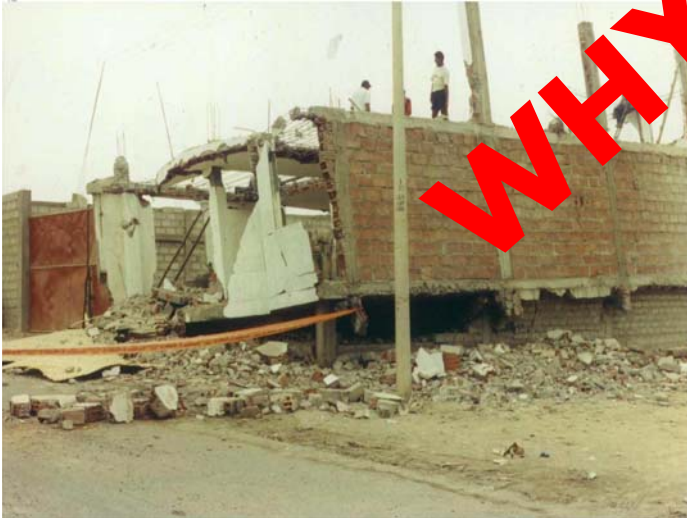
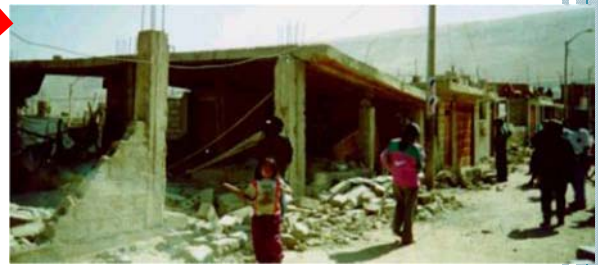
Damage to masonry buildings
(Earthquake 23/06/2001,
Magnitude $m_v = 6.9$ (igp)
Magnitude $m_s = 7.9$ (igp)
Epicenter: Front Ocoña)

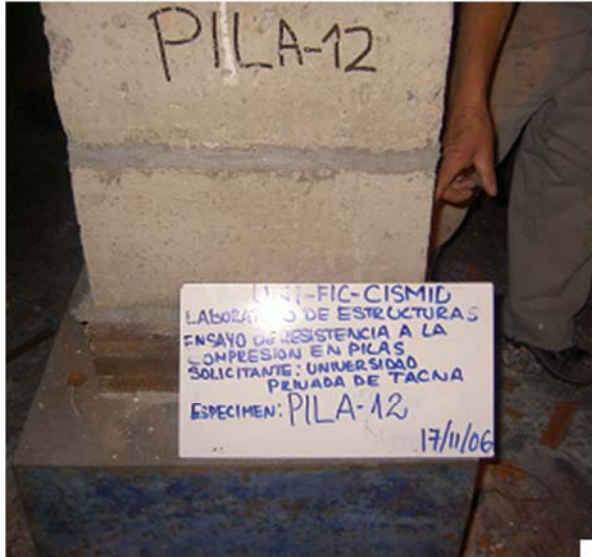
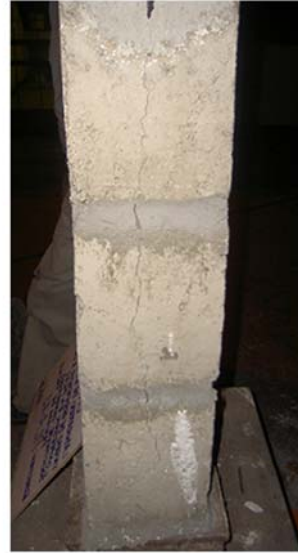
$f'm = 23.04 \text{ Kg/cm}^2$
 $f'b = 18.48 \text{ Kg/cm}^2$

values below the peruvian standard

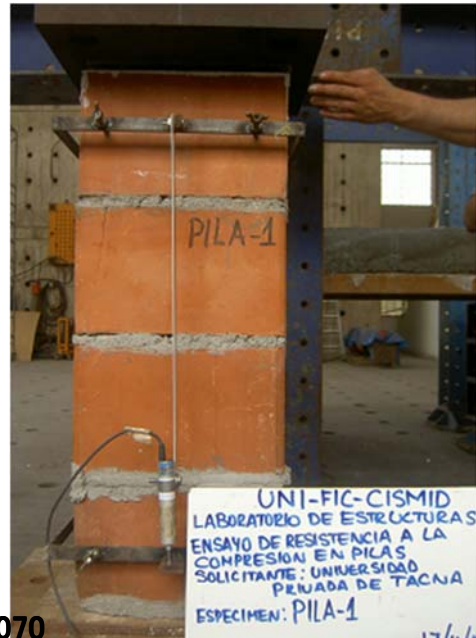
$$f' m = 77.17 \text{ Kg/cm}^2$$

the hollow area exceeds the peruvian standard

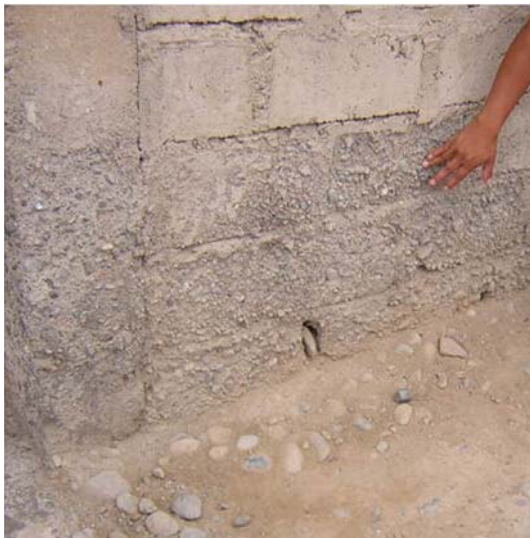
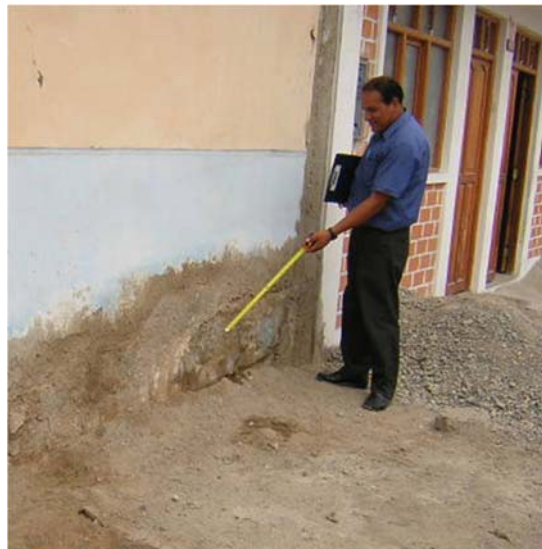
...WHAT HAPPENS IF ANOTHER PROBLEM IS THE PRESENCE OF SALTS IN THE SOIL

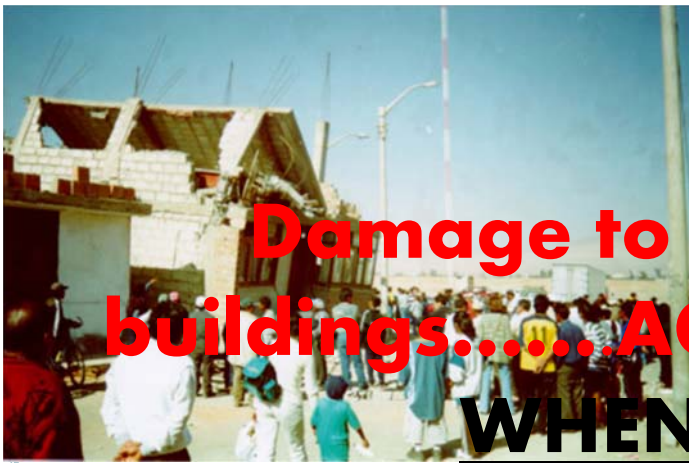
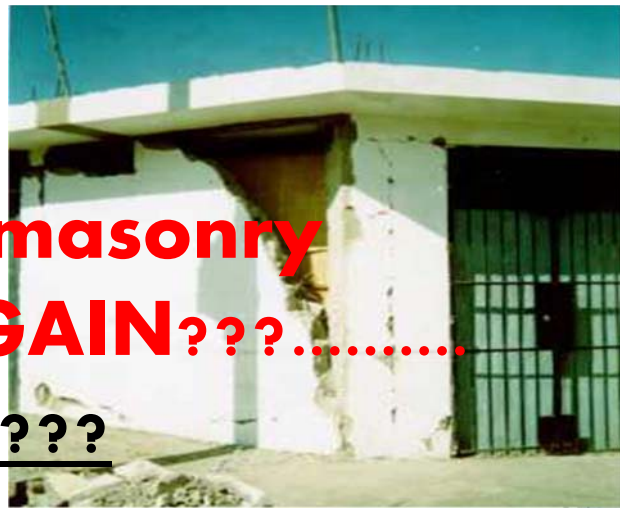
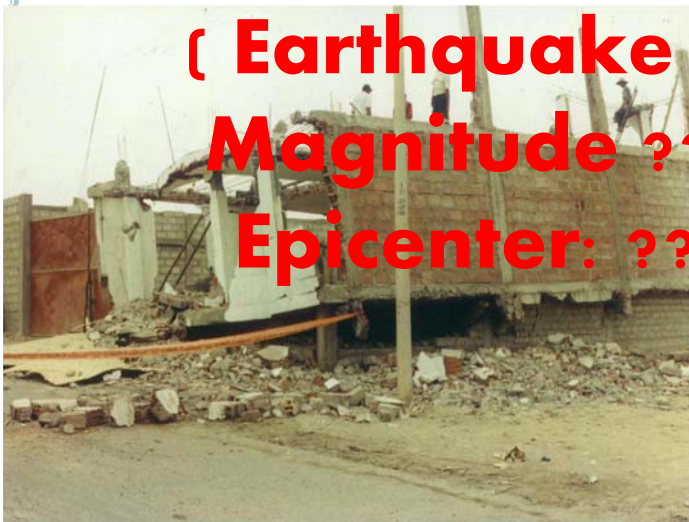
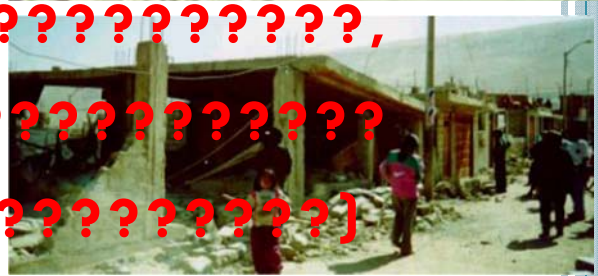
Damage to masonry buildings.....AGAIN???.
