## DAMAGE DUE TO LIQUEFACTION DURING THE 2011 TOHOKU EARTHQUAKE

Shoichi Nakai<sup>1</sup> and Toru Sekiguchi<sup>2</sup>

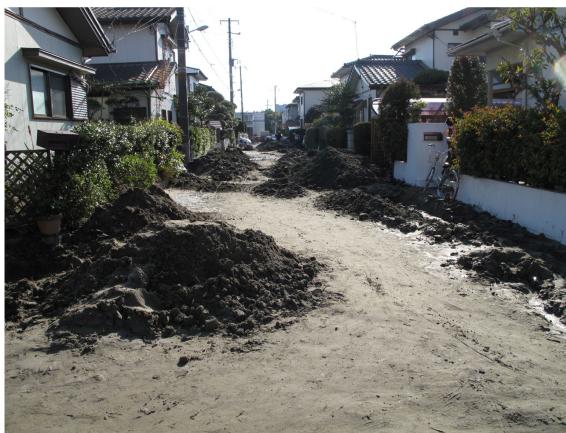
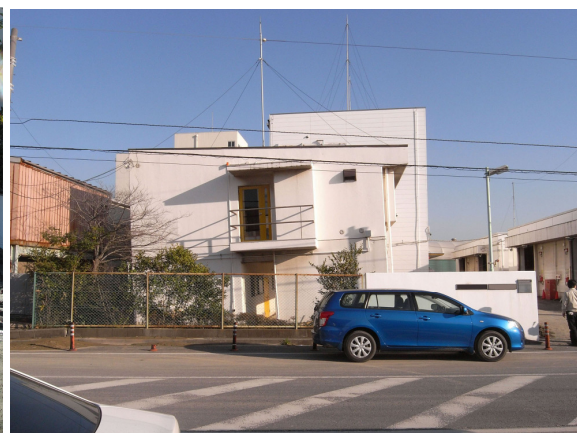
Although small sand boiling was found on the main road, narrower streets inside a city block were almost completely covered with sand boiling as thick as 45 cm. One of the interesting phenomena, however, is that there are some no-damage blocks right next to heavily damaged blocks, in other

(a) Residential area

(b) Business/industrial area

Photo 1 Typical liquefaction damage in Mihama ward, Chiba city

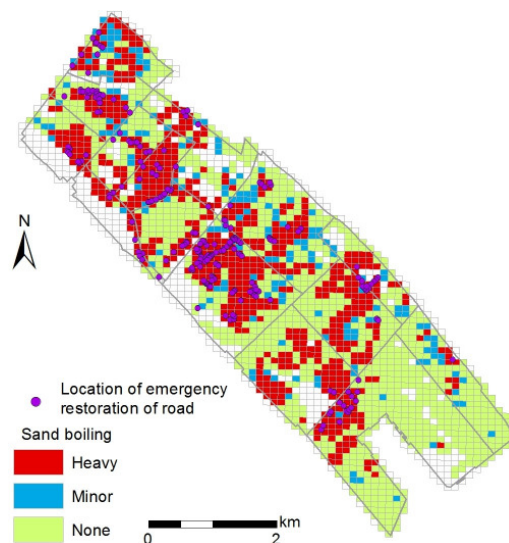
Figure 3 Distribution of sand boiling

A huge amount of sand boiling due to soil liquefaction occurred in almost all areas in Mihama ward during the earthquake. Sand boiling was hardly found on the main road and small sand boiling was found at the edge of the asphaltic pavement or on the sidewalk of the main road. On the other hand, some narrower streets inside a city block were almost completely covered with sand boiling as thick as 45 cm.

Figure 3 shows the distribution of sand boiling using 100 m square grids together with the locations of emergency restoration of roads conducted by the Chuo-Mihama civil engineering office. White grids indicate the areas which could not be entered. Heavy sand boiling and road restoration locations are densely distributed in the coastal area when compared to the inland area. A number of spots associated with minor sand boiling are found in the inland area. The districts where widespread heavy sand boiling was found include Nakase, Hibino, Isobe, Takasu, Takahama and western part of Shinminato as shown in Figure 3. On the other hand, there are some districts, where only small sand boiling was found, namely Utase, the area between Isobe and Takahama and the inland part of Shinminato.

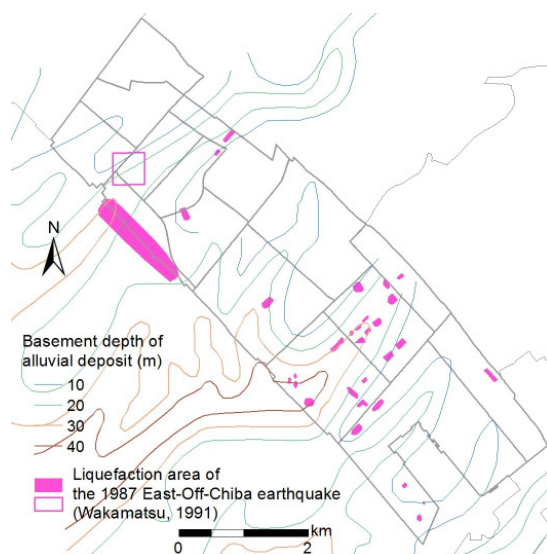
Figure 4 Historical liquefaction sites and alluvial deposit basement

Figure 4 shows the distribution of liquefaction during the 1987 Chibaken-toho-oki earthquake [2] in addition to contour lines of the basement depth of an alluvial deposit [3]. Most of the past liquefaction areas are inclusive to the damage area shown in Figure 3. It is also seen from these figures that the liquefaction damage area of the 2011 earthquake is more widespread than that of the

In the districts of Nakase, Hibino, Takasu and Takahama where heavy sand boiling was found, the basement depth of the alluvial deposit is deep compared to other districts, meaning that these districts are located on the so-called alluvial valley where thick alluvial deposits are accumulated. The areas in the northern part of Isobe and the western part of Shinminato where heavy sand boiling was also found, however, are situated on the ridge in the old times which is covered with thinner alluvial deposits in the present time.

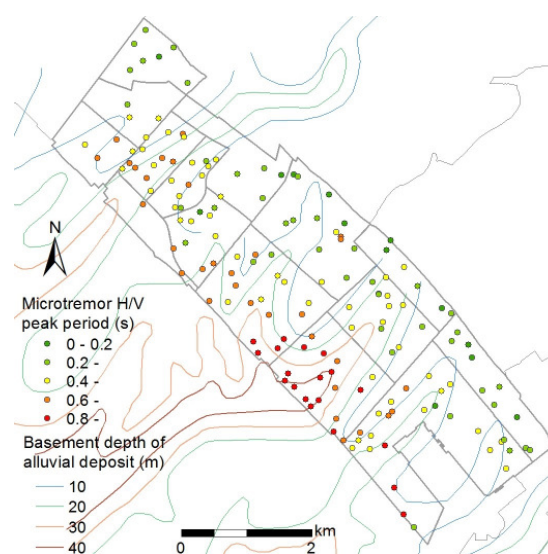
Figure 5 Peak period distribution obtained from microtremor measurements

In order to estimate the natural period of the surface soil, microtremor measurements with a three-component sensor were conducted at 163 sites in Mihama ward. Figure 5 shows the peak periods of H/V spectra calculated from the three component motions of observed microtremors. The peak periods of microtremor H/V spectra are in fairly good agreement with the basement depth of alluvial deposits. The peak periods in the coastal area tend to be longer than those in the inland area. The peak periods in the districts such as Nakase, Isobe, Takahama and the western part of Shinminato, where heavy sand boiling was observed, tend to be longer than those in other districts. In addition the peak periods in Utase where only a small sand boiling was observed are shorter. However, in the area where small sand boiling was found such as the area between Isobe and Takahama, the long peak periods of microtremor H/V spectra are observed. This indicates that the severity of sand boiling cannot be explained only by the thickness of alluvial deposits.

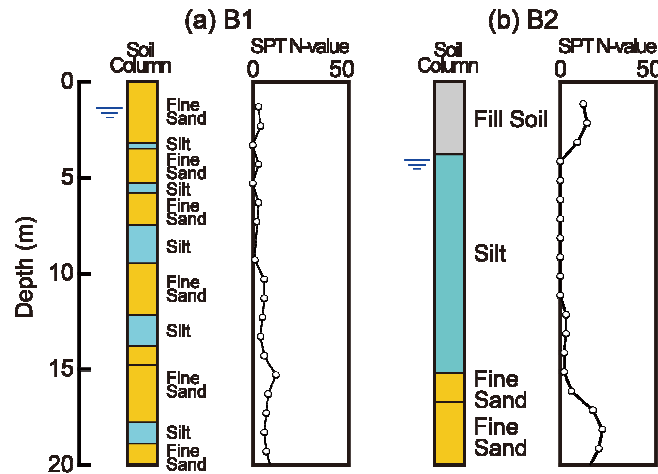
Figure 6 Boring logs in Isobe district

Figure 6 shows the borehole logs at site B1 where heavy sand boiling was observed and site B2 where no sand boiling was observed. Site locations are shown in Figure 2. The thickness of the reclaimed soil is estimated to be 5 to 10 m at these sites. At site B1 whose natural period from

microtremor measurements is estimated to be longer compared to other areas, fine sand and silt with low SPT- $N$  values are found to accumulate alternately. At site B2 whose natural period is also estimated to be longer, the surface soil, in contrast, consists of fills with  $N$  values of about 10 and silts with low  $N$  values with the thickness of 11 m, which is underlain by fine sands with  $N$  values of more than 10. It seems that this is the reason why liquefaction damage is different between the two sites despite the similar peak periods of microtremor H/V spectra.

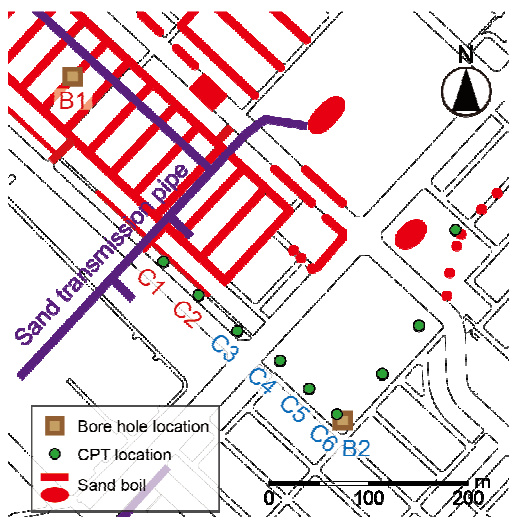
Figure 7 CPT locations

A series of cone penetrometer tests (CPT's) were conducted along a line crossing the border between heavily and less damaged areas in Isobe district as shown in Figure 7 in which the areas where sand boiling was observed are also shown. Figure 8 shows the estimated profiles of soil types obtained from CPT loggings at 6 locations. At the locations C1 and C2 near the damaged area by sand boiling, sand prevails to the depth of about 10 m. At the locations C3, C5 and C6 where no sand boiling was observed, silt and clay are predominant to the depth of 20 m.

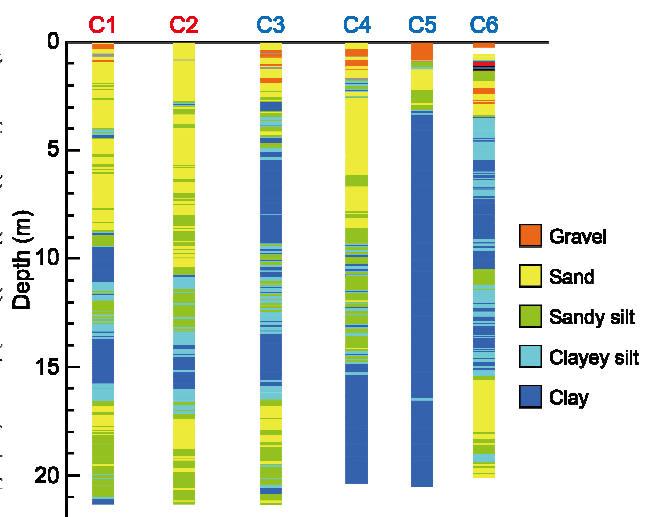
Figure 8 CPT logs

The above findings and discussions indicate that the difference in type of surface soil as well as the soil amplification characteristics significantly affected the difference in liquefaction damage in Mihama ward during the 2011 Tohoku earthquake.

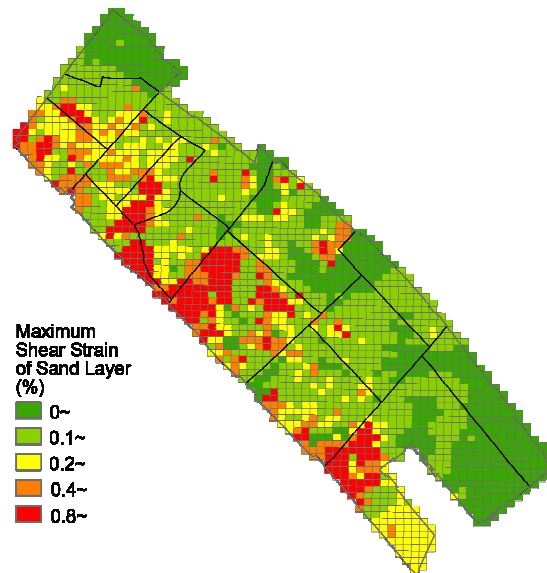
Figure 10 Maximum shear strain distribution

The ground motions during the main shock were recorded at a number of locations in the target area, among which the recorded ground motion at Masago, where no sand boiling was observed, has been used to obtain the input motion to the bedrock by the deconvolution process. This input motion to the bedrock was then applied to each of the soil model constructed above. Since liquefaction occurs in a sand layer, the maximum shear strain of sand layers up to the depth of 20 m from the ground surface was selected for each subdivided area. Figure 10 shows the distribution of maximum shear strain of sands. By the comparison of Figures 3 and 10, it can be pointed out that the assumption of two main factors for liquefaction damage being amplification due to soft soil deposits and dominance of sands in its profile explains well about the damage distribution.

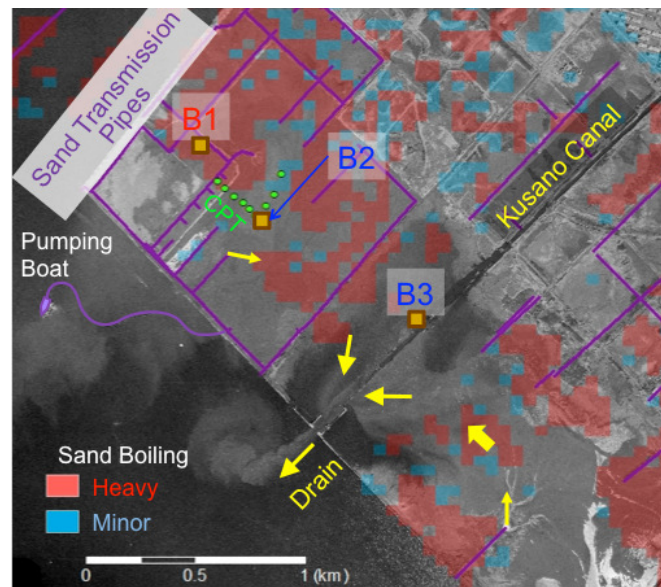
Figure 11 shows the aerial photography of Isobe and Takahama districts shown in Figure 2 at the time of land reclamation back in 1972. The sand transmission pipes are found in this photography and are indicated by the purple lines. The pipe layout is indicated also in Figure 7. Sand boiling is found near the pipes such as CPT locations C1 and C2. CPT locations C3, C5 and C6 where surface soils mainly consist of silt are situated between the pipes, as can be seen in Figure 11.

There is a drainage canal called Kusano canal that runs between Isobe and Takahama districts crossing the reclaimed ground from inland to Tokyo Bay as shown in Figure 11. The surplus water contained in pumped dredge soils was drained away through Kusano canal to Tokyo Bay. There used to exist storage reservoirs in the both sides of Kusano canal that were used to precipitate fine grains in the drained water. It is understood from Figure 11 that site B3 where the surface soil mainly consists of silt is situated in this reservoir.

From the above findings and discussions, it is possible to suggest that the distance from the outlet of sand transmission pipes affected the distribution of liquefaction damage in Mihama ward due to the 2011 Tohoku earthquake.

Figure 11 Aerial photography of Isobe and Takahama districts at the time of reclamation in 1972
