After the 2011 Great East Japan Earthquake, an investigation team consisted by the members from NILIM (National Institute of Land, Infrastructure and Management) and BRI (Building Research Institute) was dispatched to the disaster areas on July 1<sup>st</sup> and 2<sup>nd</sup> to examine performance of SI buildings. The seismically isolated buildings showed excellent performance without any severe damage even to nonstructural elements in superstructure. However, some damage to isolation dampers and expansion joints were observed. This paper introduces some cases to explain seismic performance of seismically isolated buildings.

## PERFORMANCE OF HIGH-RISE BUILDINGS

## PERFORMANCE OF SEISMICALLY ISOLATED BUILDINGS

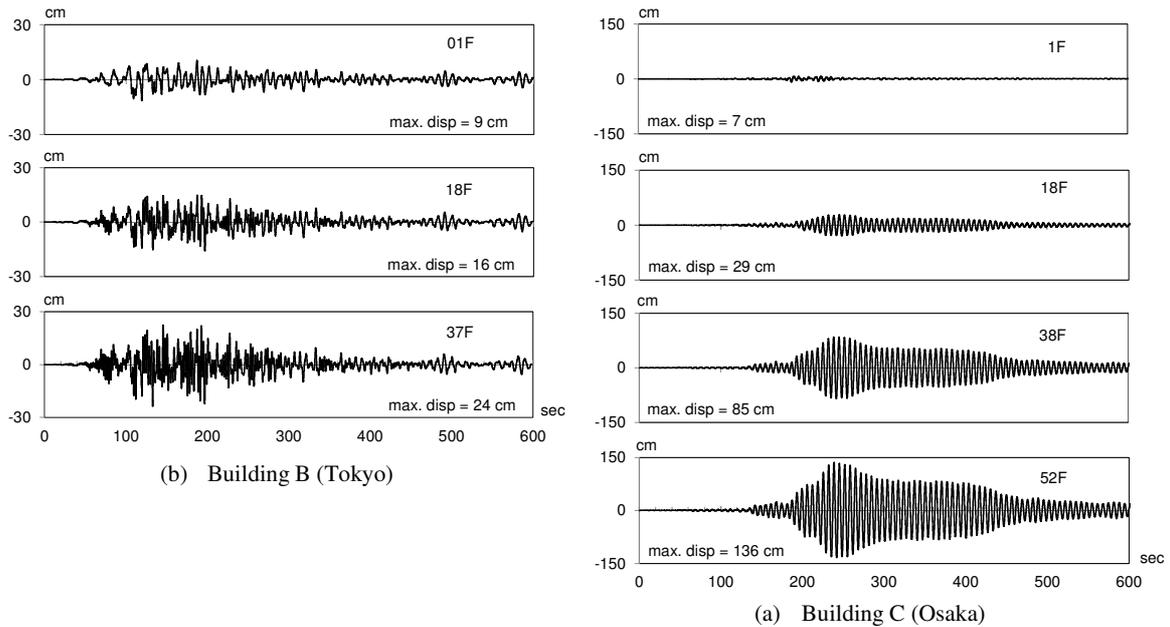
**Figure 3.** Displacement records of high-rise buildings in Tokyo and Osaka

Figure 3 shows the displacement records observed in different floors of high-rise buildings in Tokyo and Osaka. Whereas the maximum displacement at the top floor of Building B in Tokyo, 385 km away from the epicentre, was 24 cm, the large floor movement of 136 cm amplitude was observed at the 52<sup>nd</sup> floor of Building C in Osaka, 770 km away from the epicentre. By this shaking, in Building E, all 32 lifts stopped and people were trapped in four of them. Damage to non-structural members such as falling of gypsum board and ceiling panels were observed extensively.

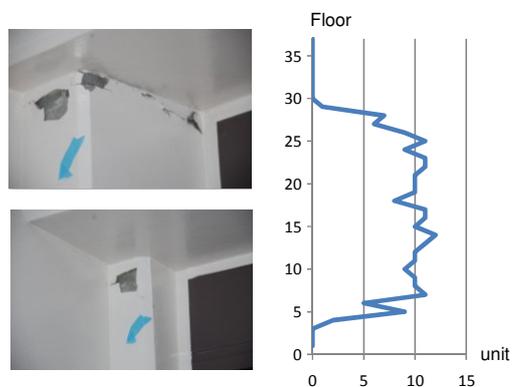
**Figure 5.** Damage distribution in each floor

Figure 4 shows the Fourier spectra of acceleration records observed at 1<sup>st</sup>, 18<sup>th</sup> and 37<sup>th</sup> floor of the high-rise building B in Tokyo. The spectra of the records at 18<sup>th</sup> and 37<sup>th</sup> floors have two peaks which correspond to the first and second mode vibrations. Minor damage around the entrance of each residential unit was observed as shown in Figure 5. The number of units which suffered damage was counted in each floor and it is seen that the damage distributes in the medium floors. This fact suggests the effect of second mode vibration.

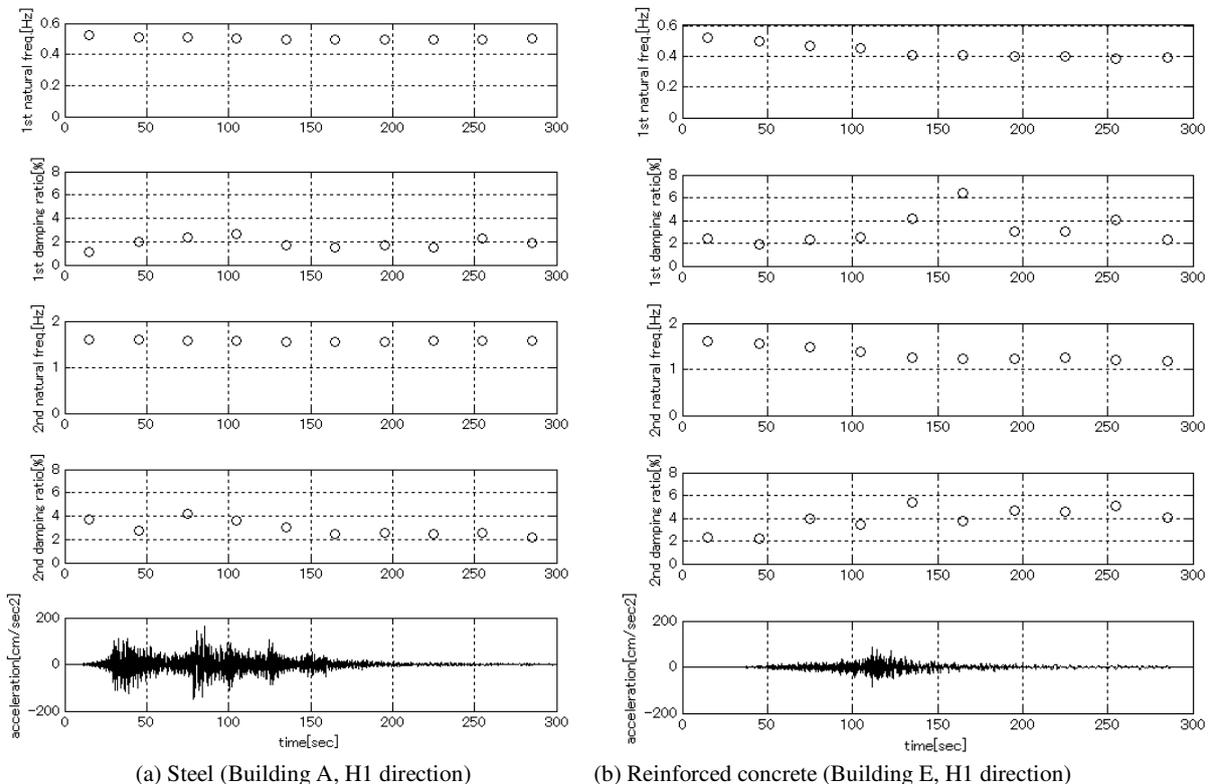
Figure 6. Change of vibration characteristics of high-rise buildings during the earthquake

Building A is a 17-story steel building built in Miyagi Prefecture, and seismic dampers are not installed in the building. To split every 30 seconds of the observation record, natural frequency and damping factor were identified for every interval. Figure 6-(a) shows the results of identification. It can be seen that the first and second natural frequencies do not change very much during the earthquake. The first mode damping factor slightly increases up to 3% when ground motion becomes large and then reduces to 2%. A similar trend was also observed in other steel high-rise buildings. Damage of structural members has not been reported in any building.

Building B is a 37-story reinforced concrete building built in Tokyo, and seismic dampers are not installed in the building. Figure 6-(b) shows the results of identification. The first natural frequency has declined about 25% compared to the initial value during the earthquake. The first mode damping factor increases up to 6% after ground motion becomes large. This change is considered to be due to crack of structural element occurred at the main shock.

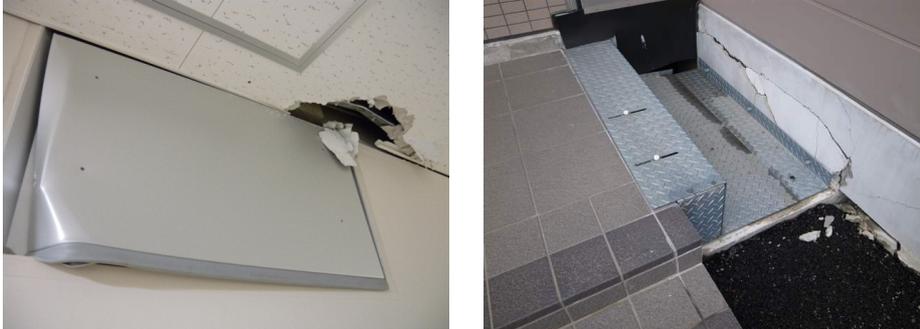
**Figure 7.** Damage at the expansion joints

- Super-structures of SI buildings suffered almost no damage even under strong shaking with JMA intensity 6 plus. It verifies the excellent performance of SI buildings.
- In some buildings, damage was observed at the expansion joints. It seems that parts of expansion joints were not well operated due to the large displacement of SI floor during earthquake (Figure 7).
- Subsidence of ground around the building was observed in some buildings.
- Many cracks were found in lead dampers. These cracks might be increased by the aftershocks (Figure 8).
- Peeling off of paint was observed widely for U-shape steel dampers. In some cases, residual deformation of steel was remained (Figure 9).

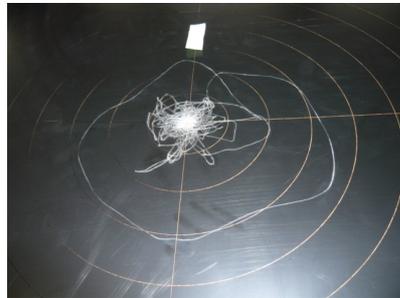
There are 8 buildings with scratch boards to measure displacement of the SI floor. As shown in Figure 10, in most cases, the maximum displacement has been estimated around 20 cm. There is a one case with the maximum displacement estimated over 40 cm. For two buildings, there are accelerometers in the building and the observed maximum accelerations are listed in Table 3. Around 40-60% reduction was achieved by SI system.

(a) Around 18cm (Building D)

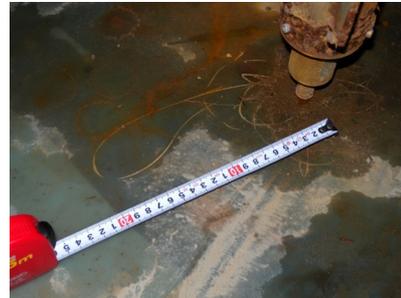
(b) Around 21cm (Building E)

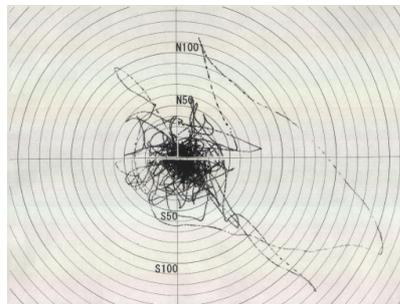
(c) Around 21cm (Building J)

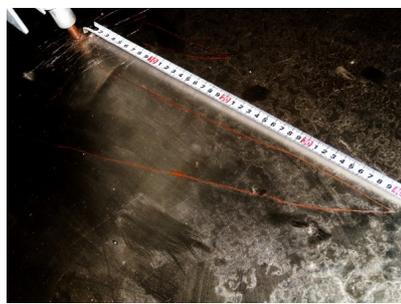
(d) Around 40cm (Building O)

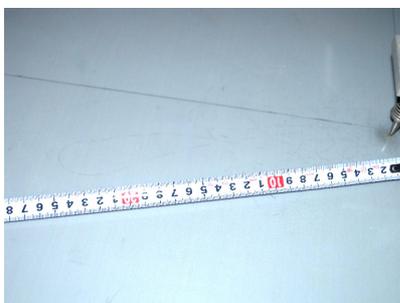
(e) Around 25cm (Building P)

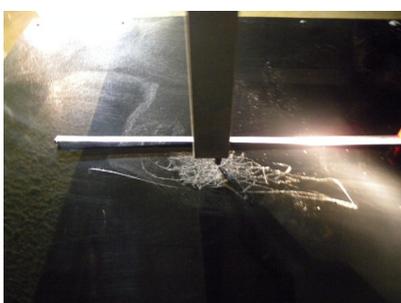
(f) Around 25cm (Building Q)
