## **BEHAVIOR OF RC STRUCTURES UNDER TSUNAMI TRIGGERED BY THE GREAT EAST JAPAN EARTHQUAKE**

**Carlos CUADRA<sup>1</sup>**

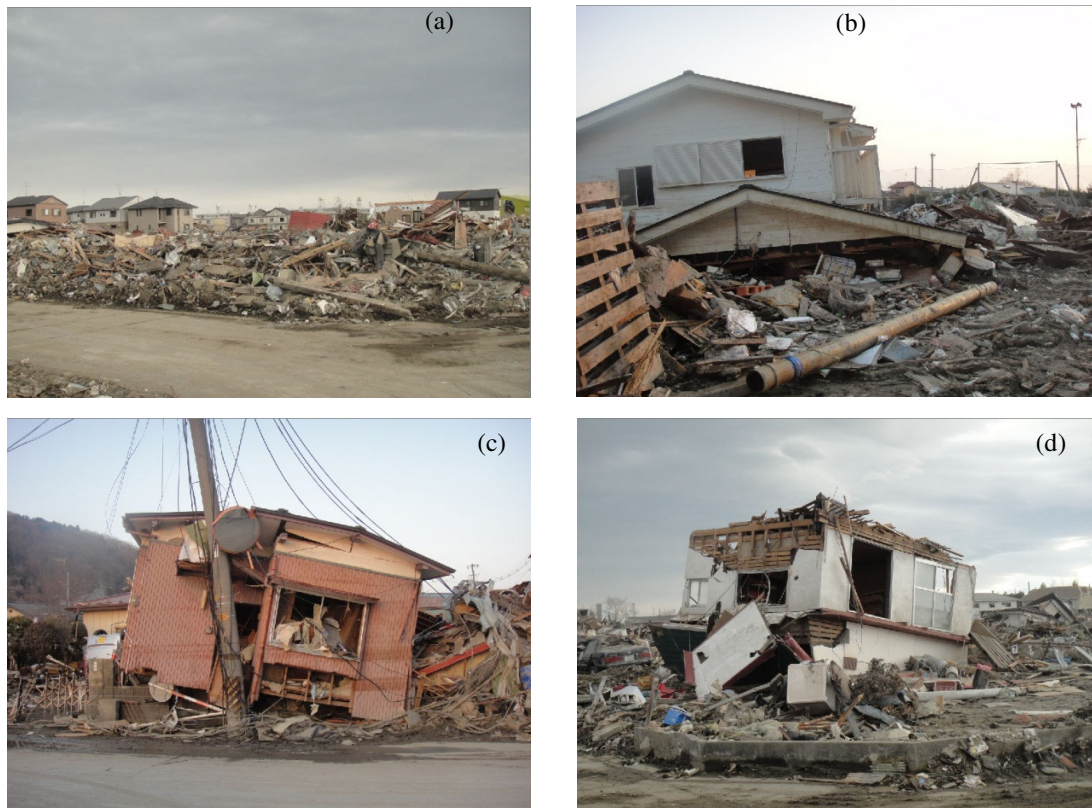
Figure 3: Damages on wooden houses

Figure 3 shows some typical damages on wooden houses that were produced by the tsunami. In Figure 3(a) it can be observed that wooden houses were completely destroyed by the tsunami action. It can be also observed that houses located on high sites are not affected. In Figures 3(b) and 3(c) the first floor was destroyed by the tsunami and the upper parts of the houses were transported and then left by the tsunami on a different place from their original location. In the case of Figure 3(d) the tsunami destroyed the first floor and also produced the overturning of the remaining upper floor.

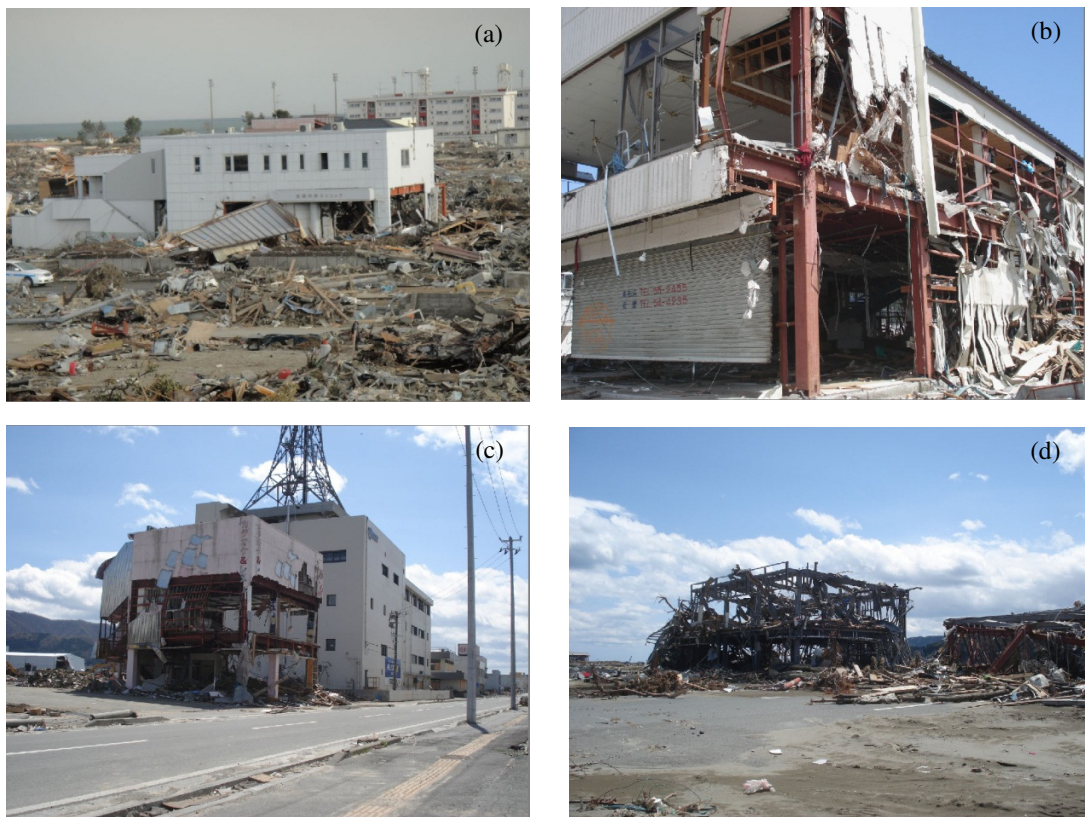
Figure 4: Damages on steel structures

Damages on Steel structures can be observed in Figure 4. When the inundation depth reaches only the first floor the structure remains almost intact however the wall panels of the first floor suffered some damages as can be observed in Figure 4(a). In Figures 4(b) and 4(c) the inundation depth reached the second floor and wall panels and ceiling are destroyed. In this case the structures remain stand up however some local failure of the structural elements were observed. Figure 4(d) shows a total collapse of steel structures. In this case the building was completely covered by the water.

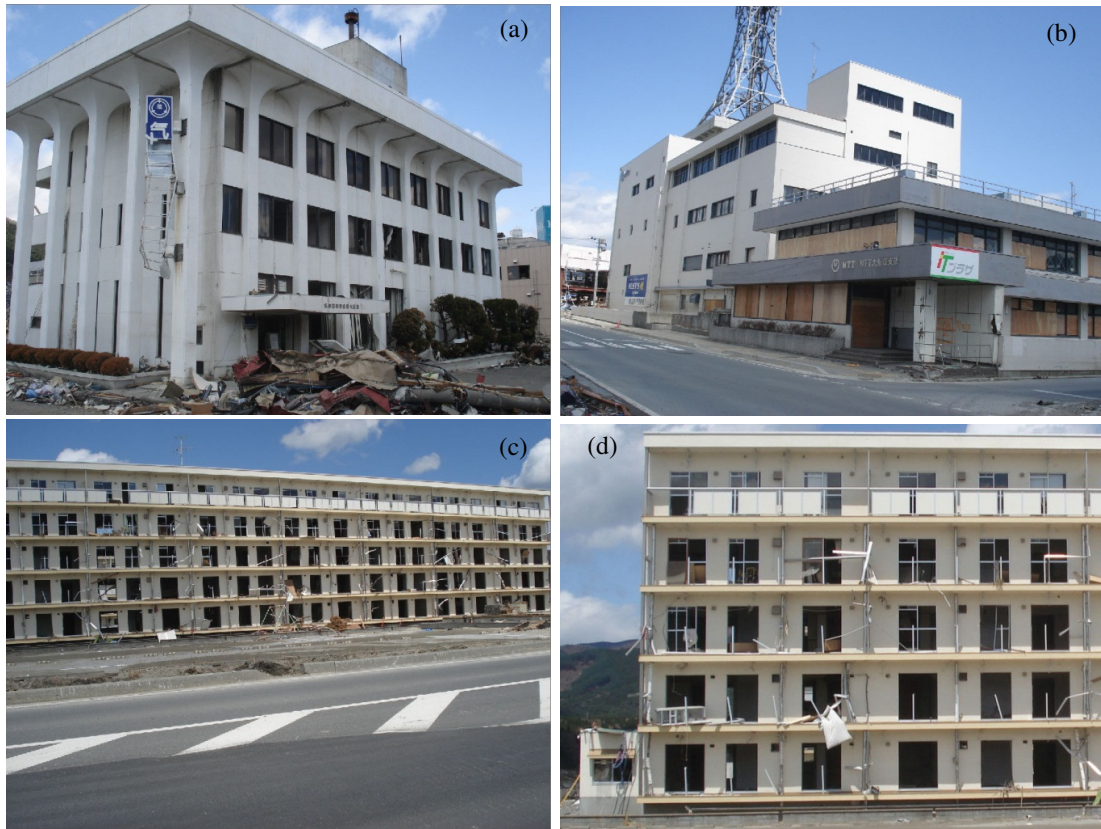
Figure 5: RC buildings after tsunami attack

Many reinforced concrete structures resisted the tsunami action without collapse as can be observed in Figure 5. Figure 5(a) is the building of a local bank located at Ofunato city, and it can be observed from the damages of the windows and the damage of the advertisement panel of the left corner of the building that the tsunami reach the third floor. In Figure 5(b) it is also inferred that the tsunami covered the 2-story building by observing that the windows glasses were destroyed and now are replaced by wood panels. Figure 5(c) is an apartment building located at Rikusentakata city and from the damages of the balconies it is inferred that the tsunami reaches the fourth floor. Detailed of the damages of the balconies can be observed in Figure 5(d), where the panels of the balconies of the fifth floor are intact while the panels of the lower floors are completely destroyed.

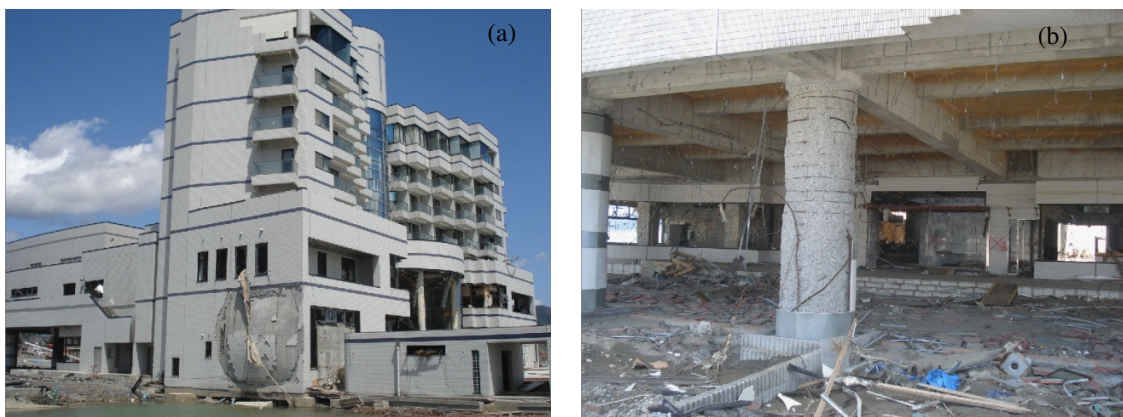
Figure 6: Condition of RC Building (hotel) near shoreline

Figure 6 shows the condition of a hotel building located very near the shoreline in Rikuzentakata city. The building resists the tsunami attack however the lower floors suffered the destruction of the non-structural elements and also, as it is observed in the Figure 6(a), the damage of a reinforced concrete wall due to the lateral water pressure. In this building it was also observed that the cover concrete of structural elements like columns was spall-out, probably due to a combination of earthquake vibration action and posterior tsunami action as can be observed in Figure 6(b).

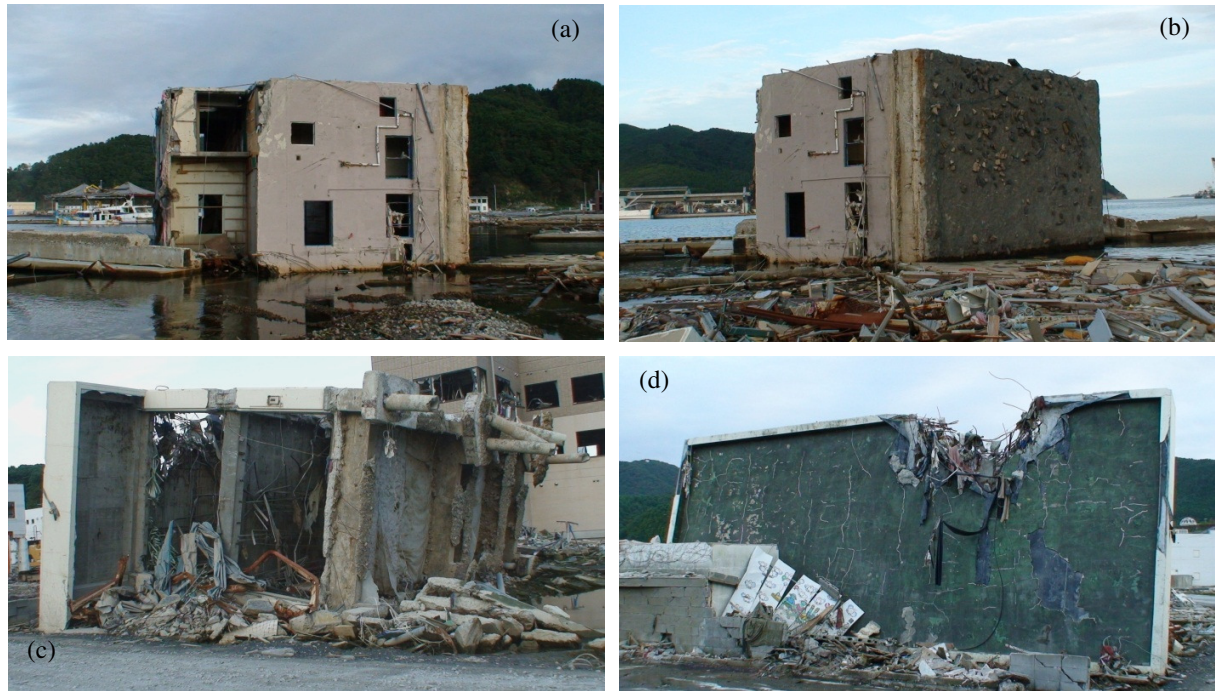
Figure 7: Damages on Reinforced Concrete buildings

In general reinforced concrete buildings did not collapse however under certain conditions the tsunami action caused the overturning and even the translation of building from its original location. This was reported by a survey team of the Tohoku Branch of the Architectural Institute of Japan (ref. 5) and verification survey was carried out by the author. These damages occurred at Onagawa town and the affected buildings were buildings with weak foundation, and with shape like boxes that do not permit the transit of the water and facilitate the action of the floating force. In Figure 7 damages of these buildings are shown.

Figures 7(a) shows an overturned 3-story building with a shape of box and few openings. This building was completely covered by the tsunami water and as it is shown in Figure 7(b) it has a shallow slab foundation that together with the shape of the building facilitates the action of the floating forces. Figure 7(c) shows the overturning of a 2-story building with exposition of the pile foundation. The use of piles for lower rise buildings indicates the poor quality of the foundation ground. On the other hand in the Figure 7(d) it can be observed that the building has suffered the impact of some body (probably a ship) that could originate the overturning of the building.

If reinforced concrete buildings are intended to be used as refuge, buildings of more than four floors or more than 15 meters are recommend. It is also important to check the condition of the foundation of the

structures that are designated as refuge since the failure of the foundation could originate the overturning of the building. Additionally, this selected building must be verified to resist some impact forces or in any case must be located in places where the impact of displaced ships or other building can be avoided. The survey has permitted to understand the behaviour of reinforced concrete buildings under tsunami attack and it can be state that these kind of buildings could be used to take refuge from tsunami in places where natural topography make impossible to reach hilltops or other safer places.
