Development of Building Damage and Tsunami Inundation GIS Dataset following the 2010 Chile Earthquake

Summary

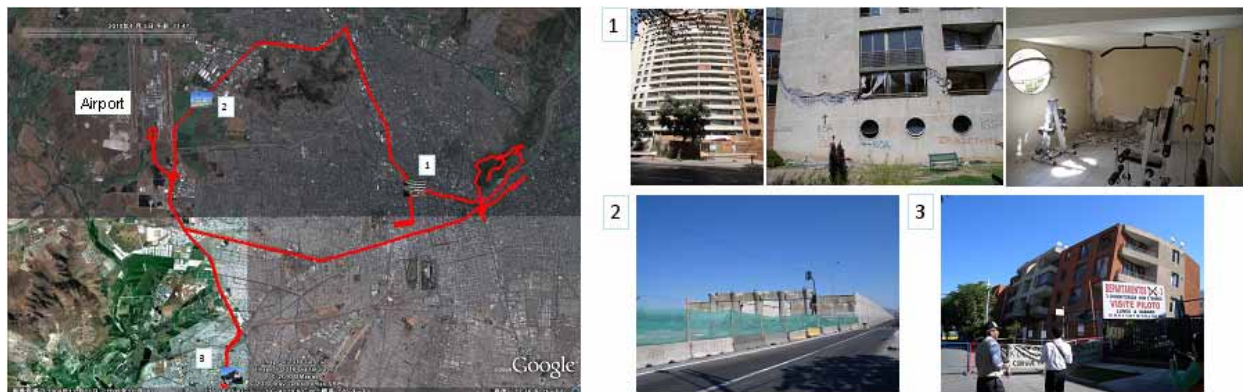
Figure 2 shows the route of our field survey in Santiago and some field photographs. The route was recorded by a portable GPS device during the survey and the location of the photo shooting could be identified as the location data were embedded in the Exchangeable Image File Format (EXIF). An RC building with 20 stories constructed in 2003 suffered from shear failures in columns and walls at the first and the second stories. A collapsed highway bridge and an RC building with the collapsed first floor were found. The locations of these sites are also shown in the survey route in Fig. 2.

Fig. 2: Survey route and field photos in Santiago—April 2, 2010

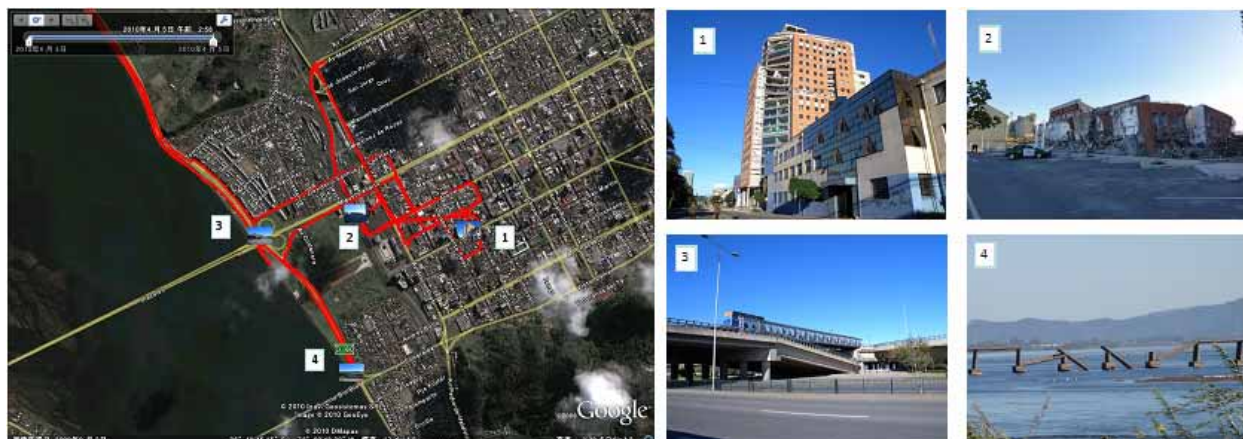
Figure 3 shows the survey route in Concepción. An RC building with the damaged middle floor was found at the site numbered 1. An RC

Fig. 3: Survey route and field photos in Concepción—April 4, 2010

building with 15 stories had collapsed completely at the site numbered 2. The road bridges collapsed at sites 3 and 4. The temporary bridge girder was constructed two days after the earthquake at site 3. Although the photos are not shown in this paper, the adobe and unreinforced masonry constructions were severely damaged in the urban area.

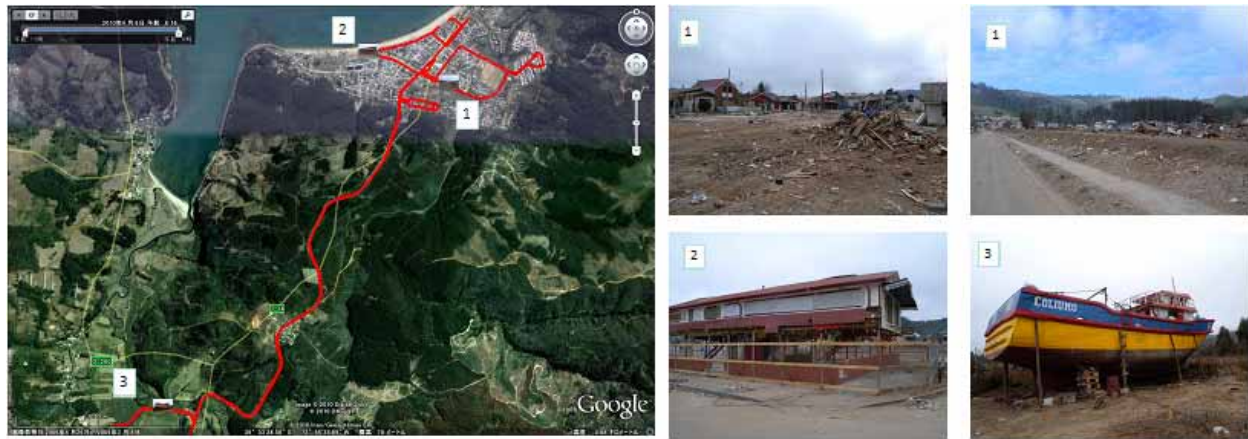
Fig. 4: Survey route and field photos in Dichato—April 5, 2010

Figure 4 shows the survey route in Dichato. It is reported that more than 80% of the built-up area in Dichato suffered from tsunami [5]. As shown in the field photos, the buildings collapsed because of the tsunami waves. A ship was conveyed against the river flow because of the tsunami and eventually found at site 3.

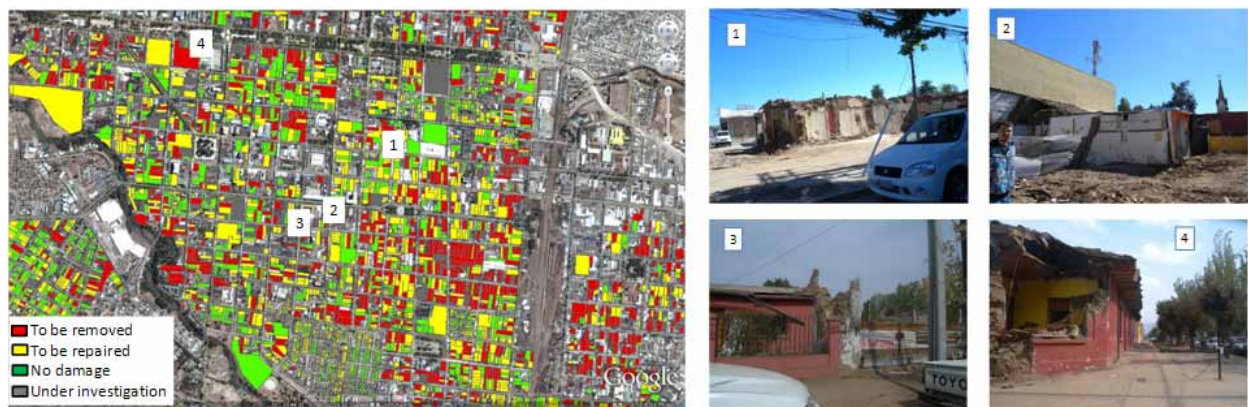
Fig. 5: GIS file to show the damage levels of buildings in Talca and locations of field photos

In all, 5617 polygons were projected to the map coordinate system. 1559 (27.8%), 1872 (33.3%), and 1864 (33.2%) buildings were classified as to be removed, to be repaired, and no damage, respectively. The typical construction types in Talca are adobe and unreinforced masonry buildings, which are primarily used for older constructions with 2–4 stories (dating back to before the 1960s–70s). Modern buildings that were designed according to the current codes suffered minor, repairable damage, while a large number of adobe and unreinforced masonry constructions suffered significant damage [6].

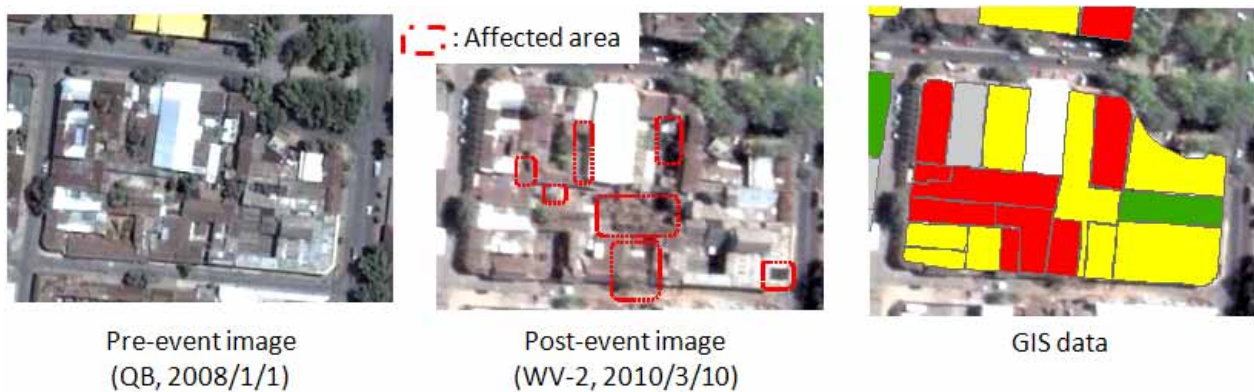
Fig. 7: Comparison between pre- and post-event satellite images to detect affected buildings

Recent advancements in remote sensing technologies and their applications have made it possible to use remotely sensed imagery for estimating the damage distribution due to natural disasters. Among them, high-resolution optical satellite imagery, which has become available in the last decade, has made satellite remote sensing more useful in disaster management since even the damage status of individual buildings can be identified [7–8]. Figure 7 compares the pre- and post-event high-resolution optical satellite images with the GIS dataset shown in Fig. 5. As for the pre- and post-event images, the image captured by QuickBird [9] on January 1, 2008, which is presented in Google Earth, and that captured by WorldView-2 [10] on March 10, 2010, are employed in this study. A comparison of the pre- and post-event images revealed that some of the affected buildings could be visually detected, but not all the damaged ones could be identified appropriately. Since the

post-event image was captured with the large off-Nadia angle (40.3°), the quality of image is not sufficient for visual damage inspection. Moreover, the number of affected buildings whose roofs had completely collapsed is small in Talca. Hence, it can be concluded that the damaged buildings in Talca are difficult to be detected through visual damage inspection using satellite images.

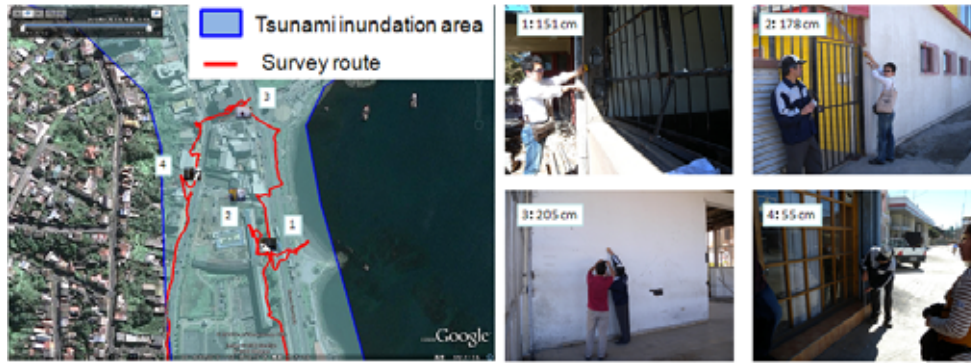
Fig. 10: Measurement of tsunami inundation depth in Talcahuano

As shown in Fig. 10, the inundation depth was measured at several sites in the three cities. The inundation depth along the beachfront street in Talcahuano was larger than 150 cm, but a depth of 55 cm was observed in its bystreet (site 4). Figure 11 summarizes the measurements in the three cities. The inundation depth is presented with respect to the elevation and the distance from the coastline. As for the results in Constitución, the records are shown with respect to the distance from the Maule River. A clear tendency is not seen in the relationship between the tsunami inundation depth and the elevation. The recorded depth in Talcahuano and Constitución decreased with an
