# Field survey of the 2010 tsunami in Chile

We conducted the field survey of the tsunami generated by the M8.8 great earthquake in Chile triggered on 27 February 2010 (UTC). The survey focused on the measurements of tsunami inundation/run-up height, flow depth, extent of inundation zone, structural damage inspection, and collecting eyewitness accounts. In total, tsunami heights and flow depths at approximately 155 points were measured along the coast of Biobío region, Chile, to understand the tsunami features during this event.

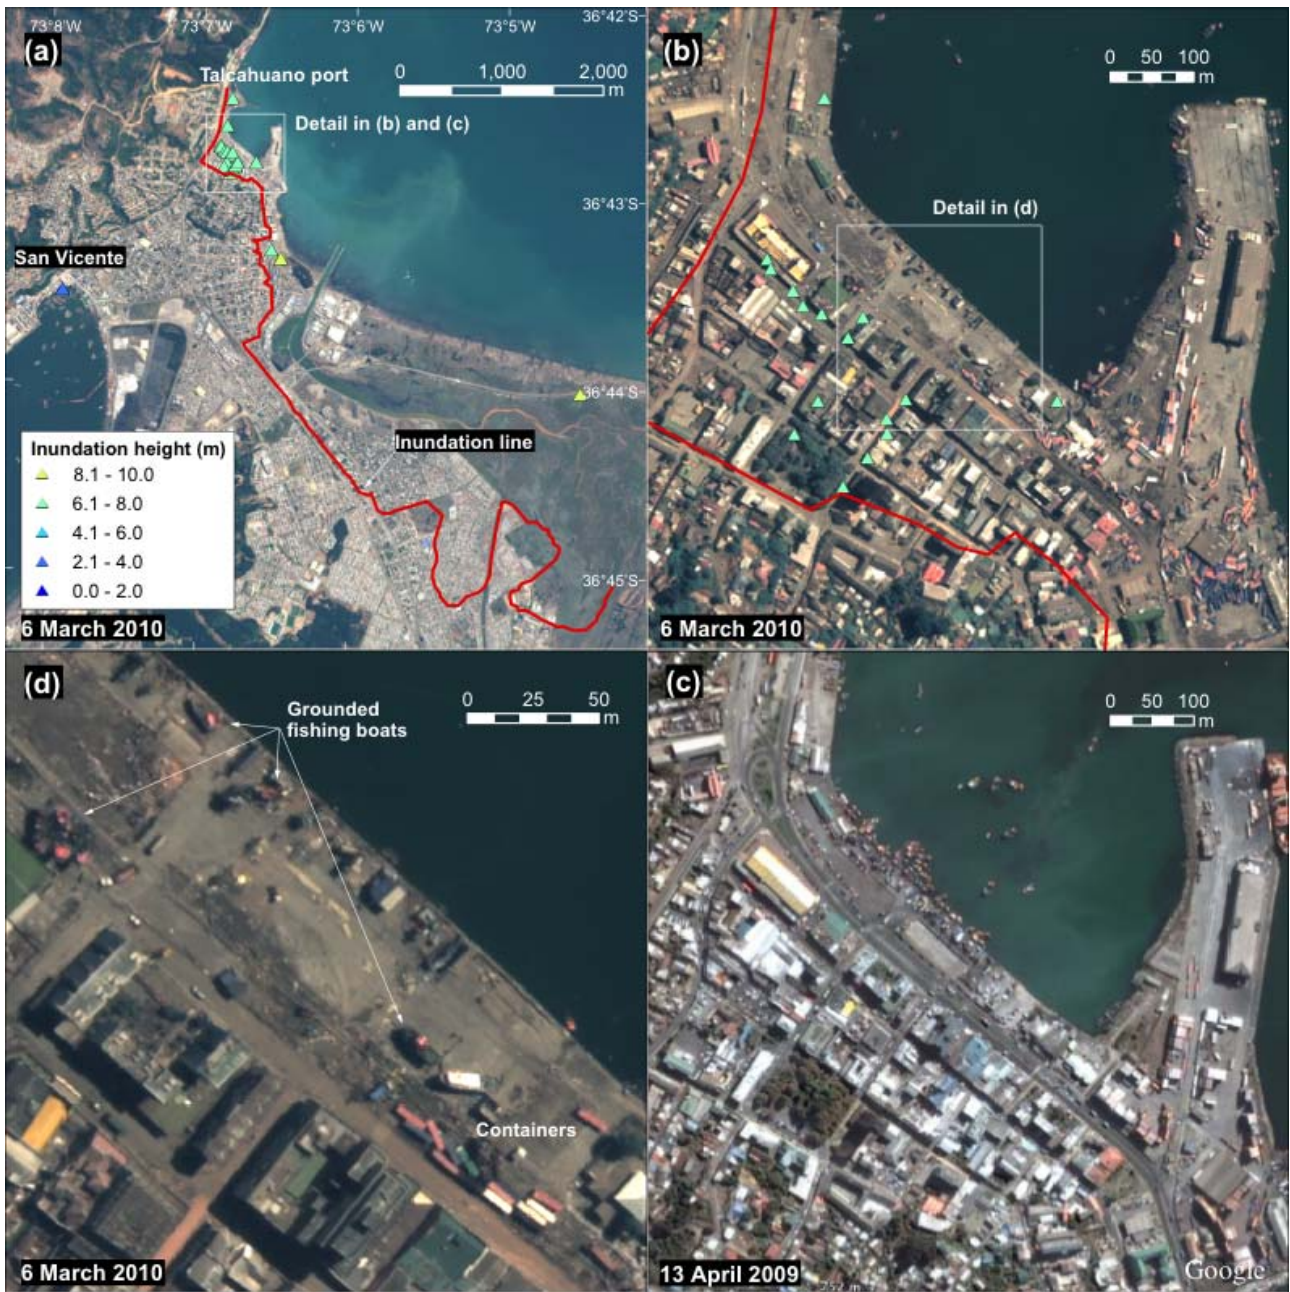
**Fig. 5** represents the result of tsunami inundation height measurement in Talcahuano. The tsunami penetrated approximately 300 m inland in the port-town area and more than 1 km in the southern coastal marsh. Tsunami inundation reached to 6-8 m in port-town area and 10 m in the coastal marsh. This figure also shows the comparison of pre and post event satellite images in Talcahuano port (**Figs. 5(b), (c)**). Significant amount of containers and fishing boats were left as tsunami debris, which caused long duration of failure of port and harbor facilities. While the tsunami left considerable damage to the town of Talcahuano (eastern bottom of the bay), no damage was found in the western port area (San Vicente). The measured tsunami run-up height in San Vicente was 3.4 m (**Fig. 5(a)**).

**Fig. 5** (a) Result of tsunami height measurement in Talcahuano. The red line indicates the extent of inundation zone which was obtained by the interview with CATOE (Centro de Alertamiento Temprano y Oficina de Emergencia). (b) Damage in Talcahuano found in the post-event satellite image (WorldView-2). (c) Satellite image of Talcahuano before the tsunami attack (13 April 2009, from Google) (d) Close-up view of port of Talcahuano. Grounded fishing boats and drifted containers were seen.

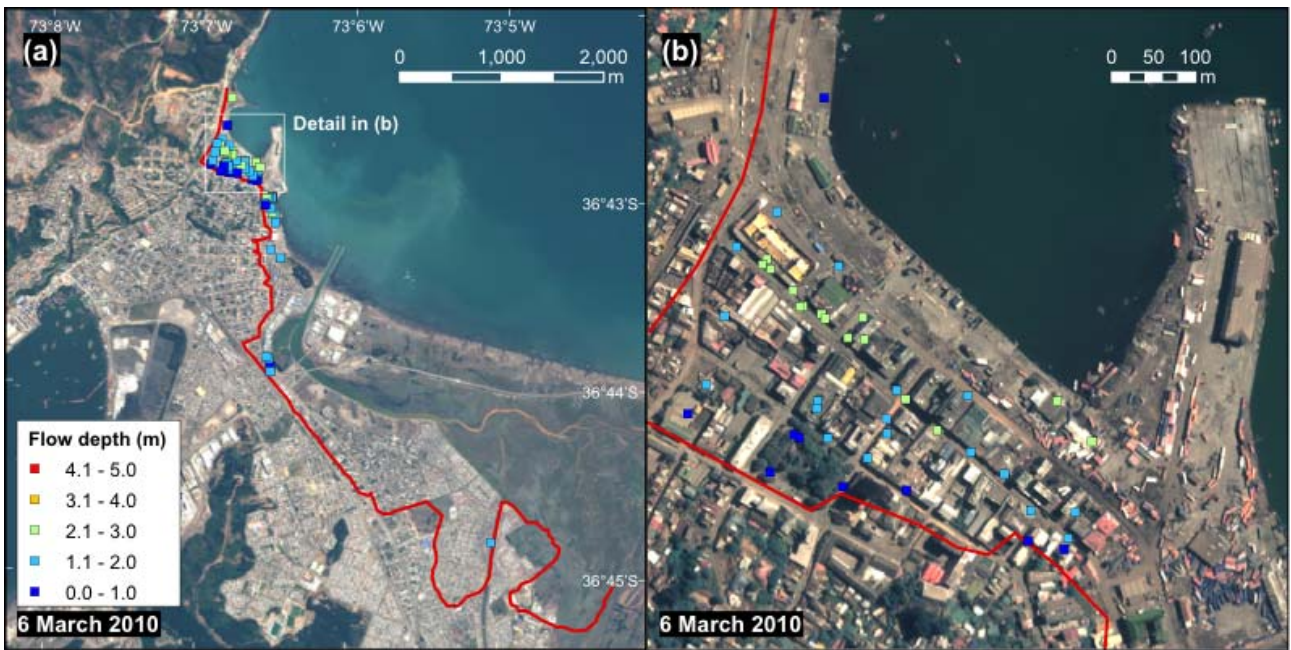
**Fig. 6** Result of tsunami flow depth measurement in the town of Talcahuano. The tsunami penetrated approximately 100 m inland with the flow depth of up to 2-3 m.

In the town of Talcahuano, the tsunami penetrated with up to 2-3 m of flow depth (**Fig. 6**). After inspecting the structural damage in the town, some washed-away structures were found, but it was limited within the port facilities (north-west) and industrial area (south-west). Most of the structural damage in the town was likely to be caused by ground shaking, but minor damage, e.g. bending shutters of commercial buildings and broken windows.

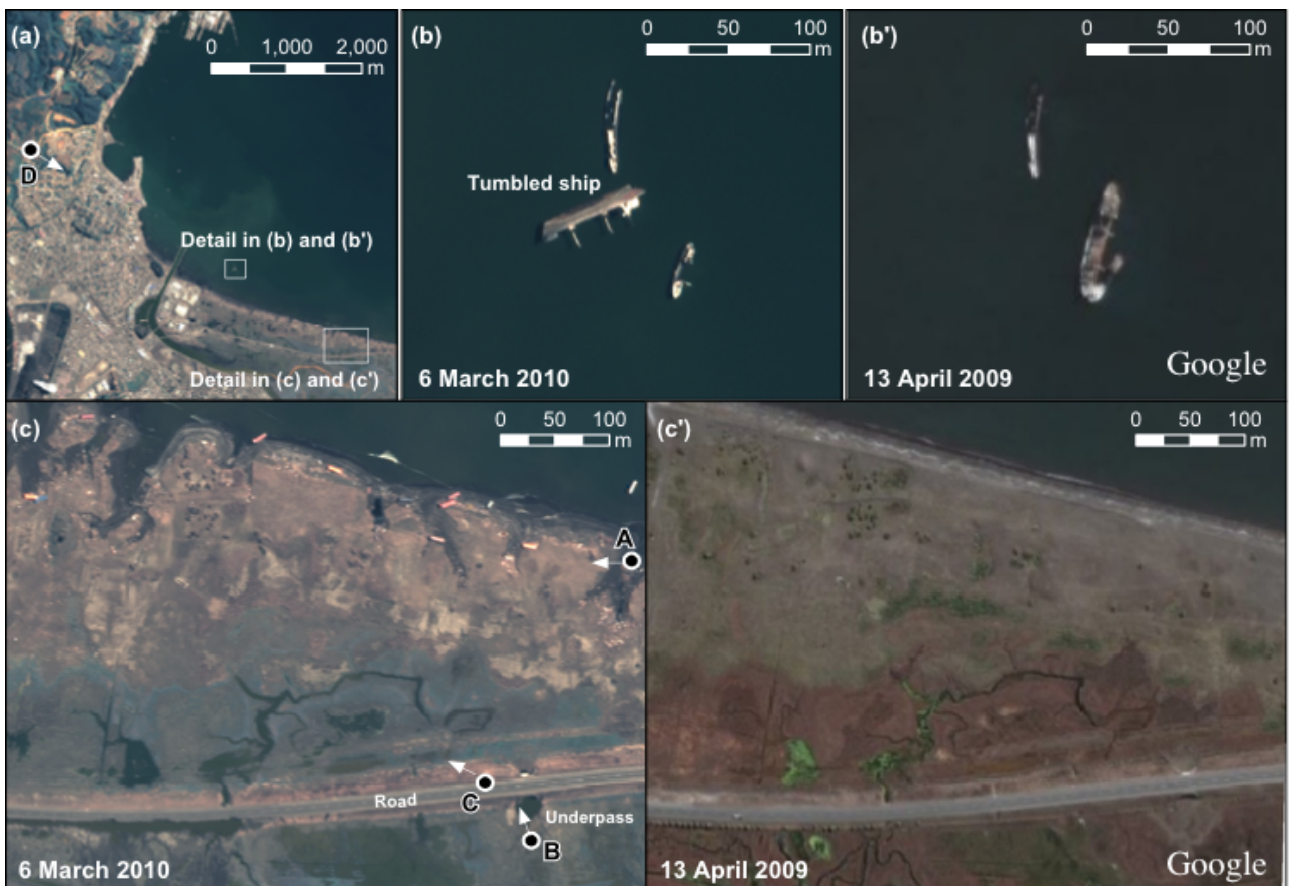
**Fig. 7** Pre and post event satellite images in Talcahuano. Points A to D represent the position of ground photos taken by the authors (**Fig. 8**). White arrow is approximate direction of the camera focus. (a) Overview of Talcahuano port. (b) and (b') A 70m-long tumbled ship found the east of waterway. (c) and (c') Considerable change of coastline and drifted containers in the coastal marsh.

Inspecting pre and post event satellite images and ground photos helps to understand multi aspects of tsunami disaster. **Fig. 7** is the comparison of pre and post event satellite images in Talcahuano. We acquired the pre-tsunami image from GoogleEarth (QuickBird image taken on 13 April, 2009), and used WorldView-2 pan-sharpened composite image as post-tsunami image. From post-tsunami image and field survey, we found the tumbled ship at the west of waterway in Tulcahuano bay that has been stably stood in the bay (even though it was not in use). In the coastal marsh, considerable changes of shoreline and tsunami debris are seen in the satellite images, and it was found from the ground photos (**Fig. 8**) that the coastal sand were eroded by inland penetration of tsunami.

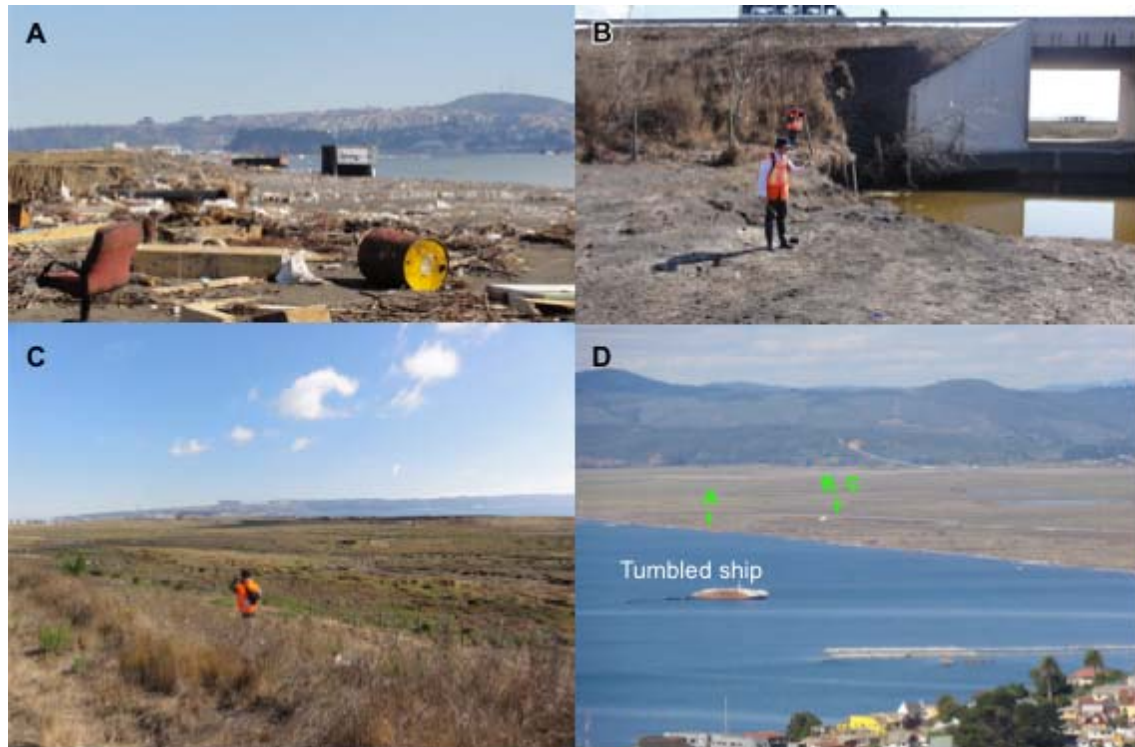
**Fig. 8** Ground photos in Talcahuano taken by the authors. Each point is identified in **Fig. 7**. A : Tsunami debris and drifted containers in the coastal marsh. B : Erosion by the tsunami inundation found at the underpass. C : Overview of the coastal marsh inundated by the tsunami. D : Panoramic view of the coastal marsh from the hill.

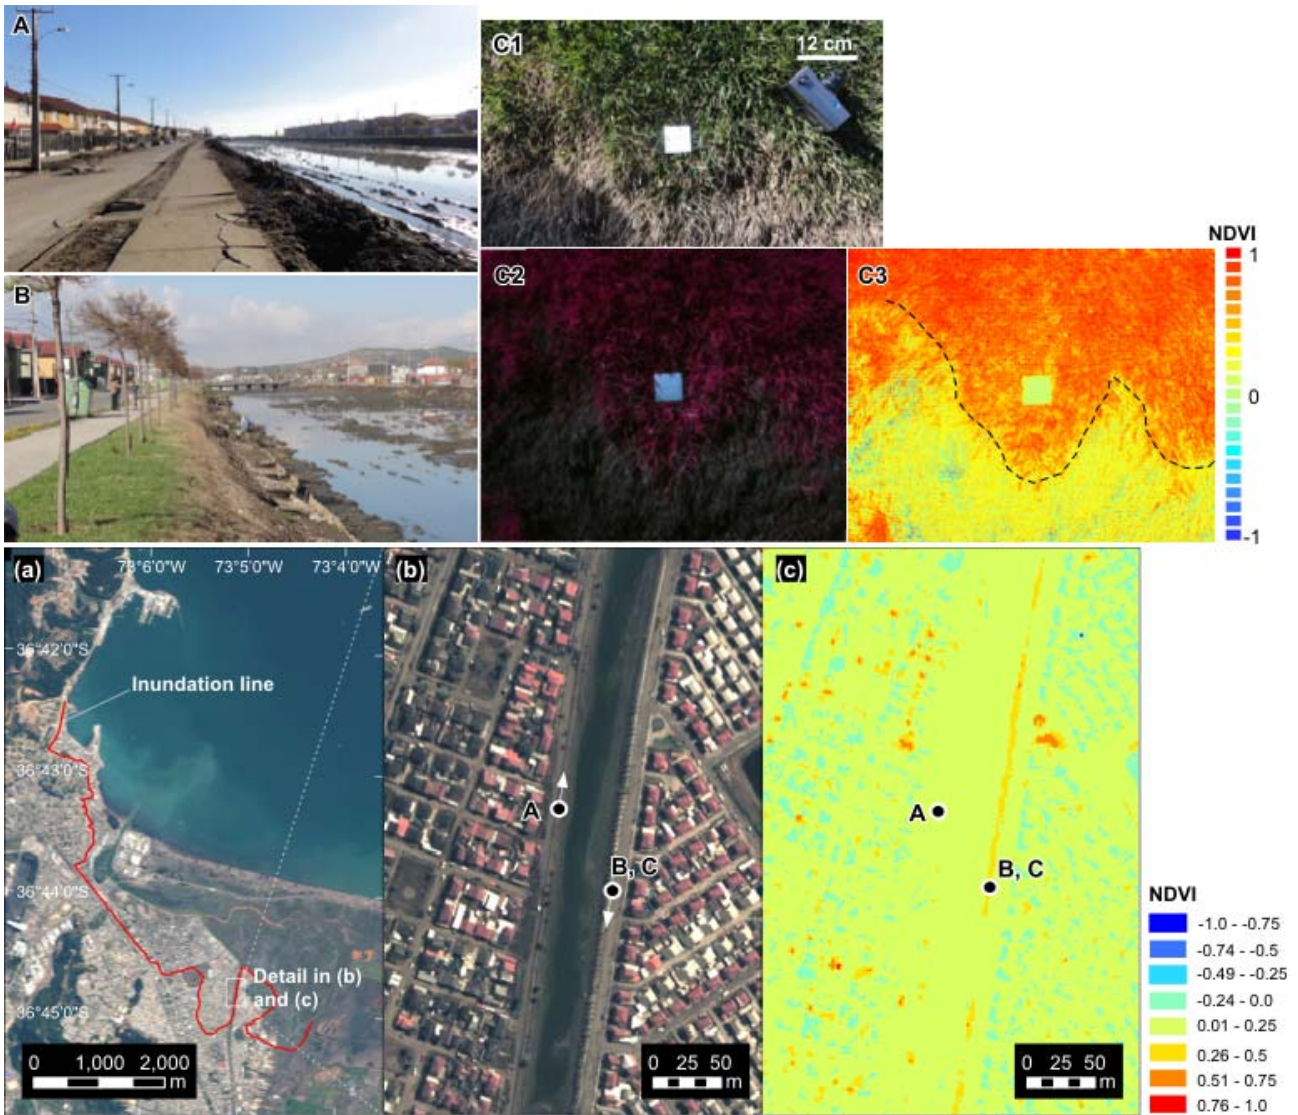
**Fig. 9** (a) Inspection area of salt-water penetration, (b) Pan-sharpened multi-spectral image of WorldView-2 acquired on 6 March 2010. A, B and C is the point of ground photos, White arrow is approximate direction of camera focus. (c) Spatial distribution of NDVI Western. A and B : Ground photos taken on the western and eastern bank of the canal respectively. C1 is the ground photo for inspecting vegetation activity (Same position as B). C2 and C3 : False color composite image and NDVI taken by the multi spectral camera (Tetracam ADC3). White plate is the reflector used for calibration.

Here, we focused on the eastern bank of the canal in Talcahuano. **Fig. 9** indicates the area of investigation and illustrates the result of detecting tsunami penetration by the analysis of WorldView-2 pan-sharpened multi-spectral image and the multi spectral camera (Tetracam ADC3). As shown in the ground photos (**Figs. 9 A and B**), considerable inundation was found on the western bank of the canal while the eyewitness testified that the tsunami slightly overtopped the eastern bank (no inundation in houses). Using the multi spectral camera that takes visible red, green and near infrared bands, we first calculated NDVI at the top of the bank where the tsunami did not overtop (**Fig. 9B**). As a result, we found that NDVI of the dead vegetation becomes less than 0.3. Using the threshold value determined by the spectral camera, we discuss the salt-water penetration on the eastern bank of the canal. **Fig. 9 (c)** shows the distribution of NDVI calculated from the post-tsunami WorldView-2 image (pan-sharpened). NDVI indicates lower value on the western bank (inundated) while relatively higher value on eastern bank (not inundated), and these features are quite consistent with the ground photos A and B.

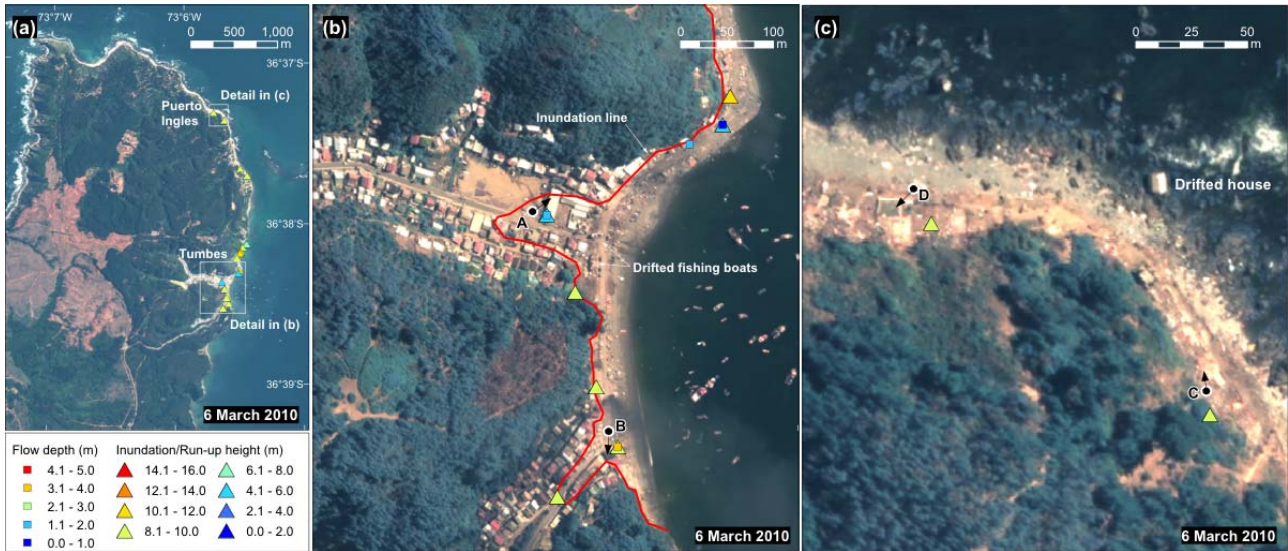
Tumbes locates and Puerto Ingles are the coastal communities, which were isolated by the limited road access. **Fig.10** represents the overview of tsunami height measurements. Tsunami attacked these communities with up to 11 m height and caused significant damage. Along the coast from Tumbes to Puerto Ingles, the tsunami was particularly devastating to demolish the houses of isolated villages (**Fig.11**). Some survivors mentioned that the first wave was withdrawal and the 2nd wave was the largest. Having the experience and lessons from the 1960 Chilean tsunami, most of the village people evacuated to the hill immediately after the ground shaking. They mentioned that the tsunami in 1960 was witnessed only as receded sea and did not cause inundation.

**Fig. 10** (a) Overview of tsunami measurements (inundation and run-up heights) in Tumbes and Puerto Ingles. (b) Detailed features of the measurements and the damage in Tumbes. (c) Devastated damage in Puerto Ingles. Point A to D is the position of ground photos in **Fig. 11** respectively with the arrow of focus direction.

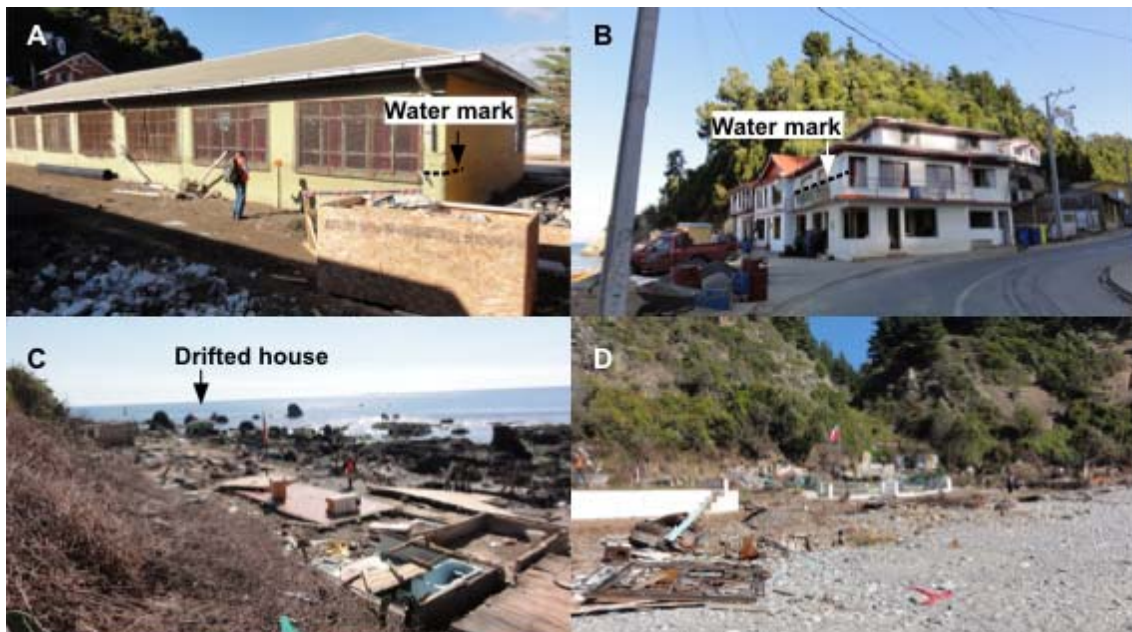
**Fig. 11** Ground photos from Tumbes (A, B) and from Puerto Ingles (C, D). A : Watermark on school building. B : Watermark on the house of Tumbes, C and D : Completely devastated village of Puerto Ingles.

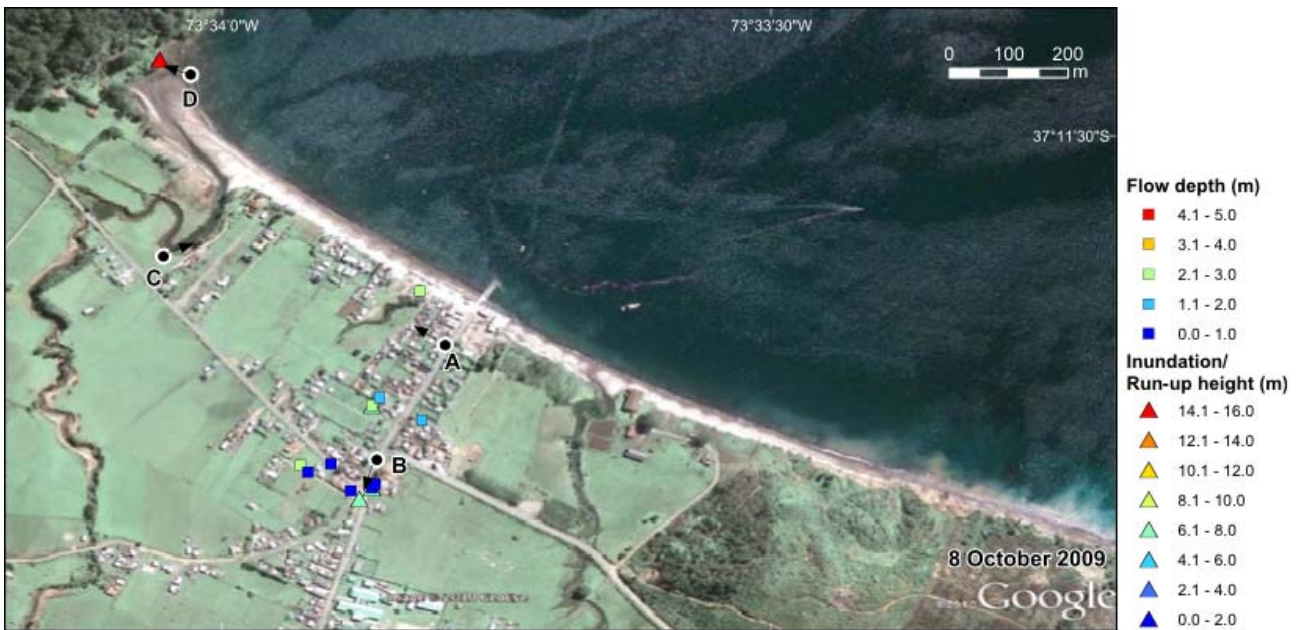
**Fig 12.** Result of tsunami height measurement in Llico. Point A to D are the position of ground photos with the arrow of focus direction shown in Fig. 13.

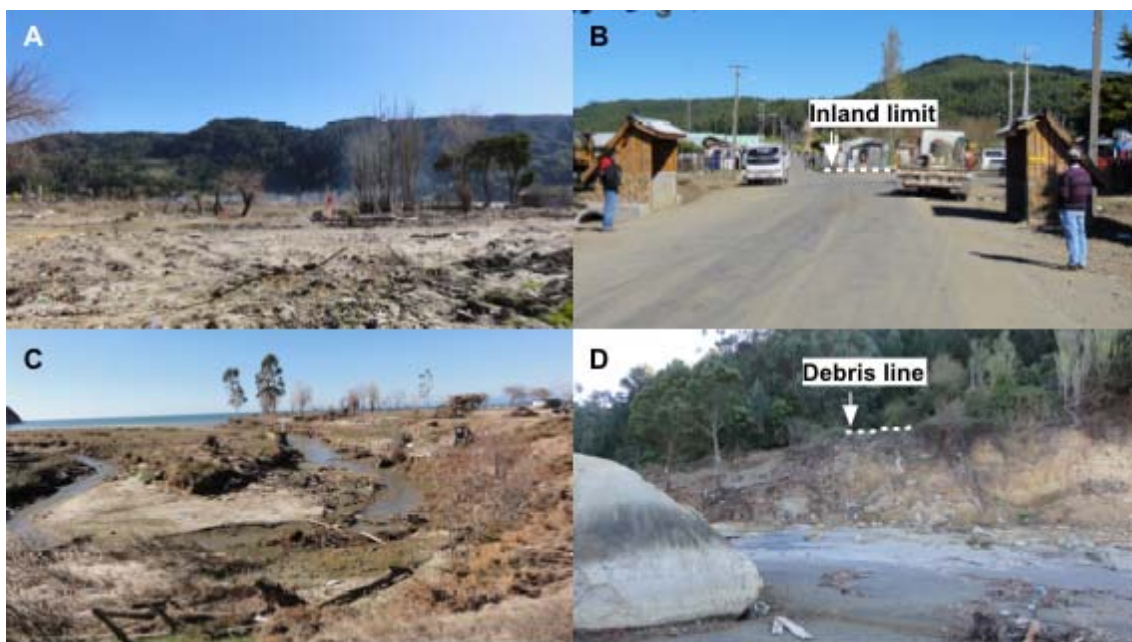
**Fig. 13** Ground photos from Llico. A : Completely devastated village. In the village, there were around 60 houses before tsunami. Almost all the houses were washed-away. B : Inland limit of tsunami inundation that is approximately 400 m from the shoreline. C : Tsunami run-up along the river. D : Tsunami debris line above 14.8 m pre-tsunami sea level.

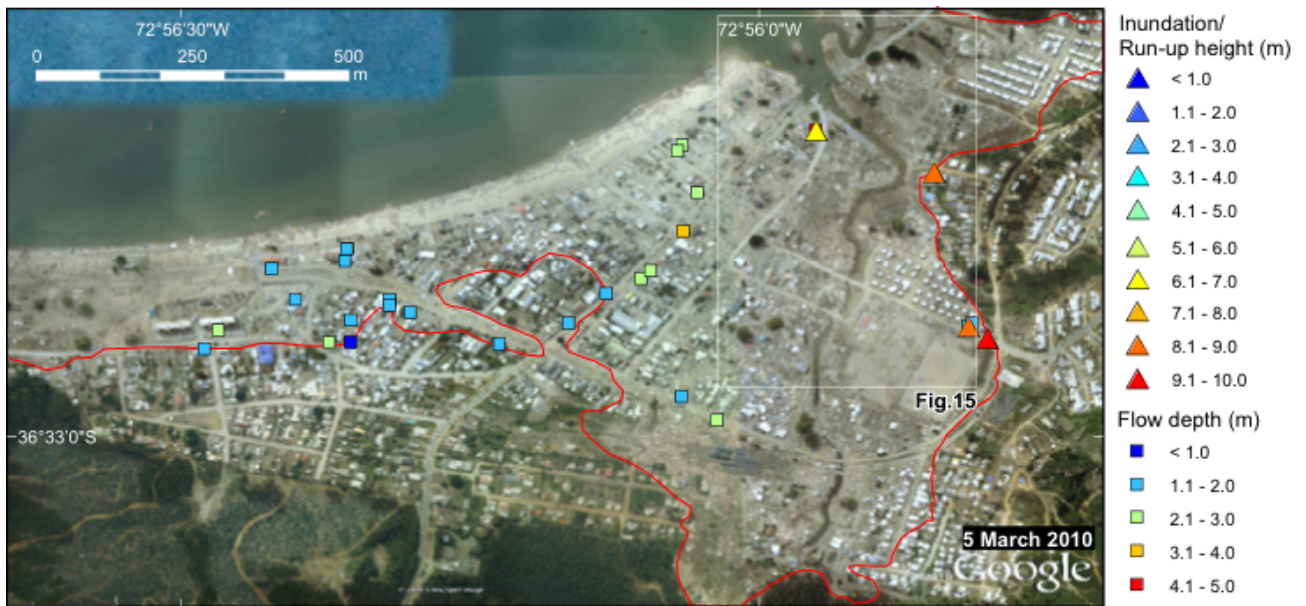
**Fig. 14** Tsunami height, flow depth and extent of inundation in Dichato.

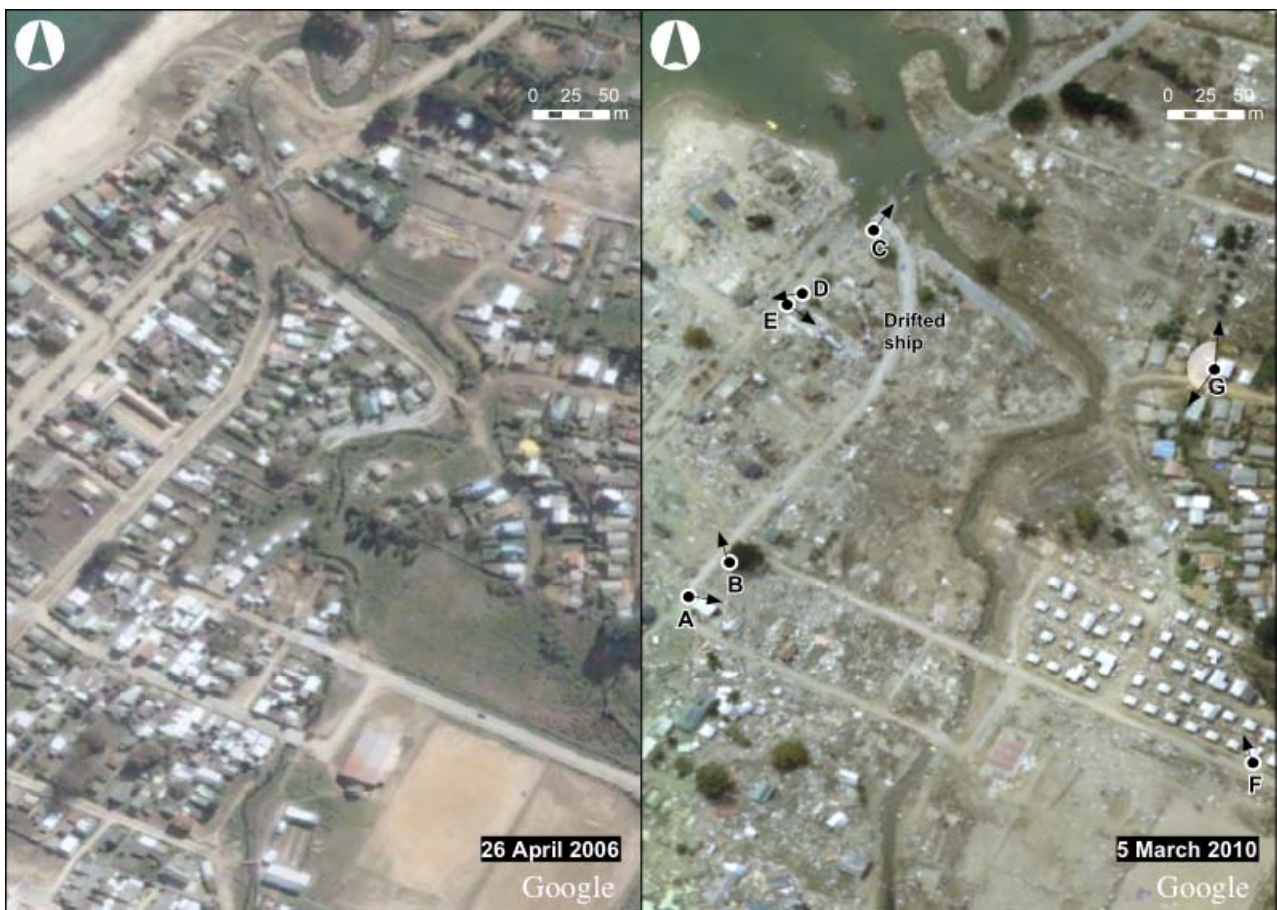
**Fig. 15** Pre and post event satellite images of the most devastated area in Dichato. Points A to G represent the position of ground photos taken by the authors (**Fig. 16**). White arrow is approximate direction of the camera focus.

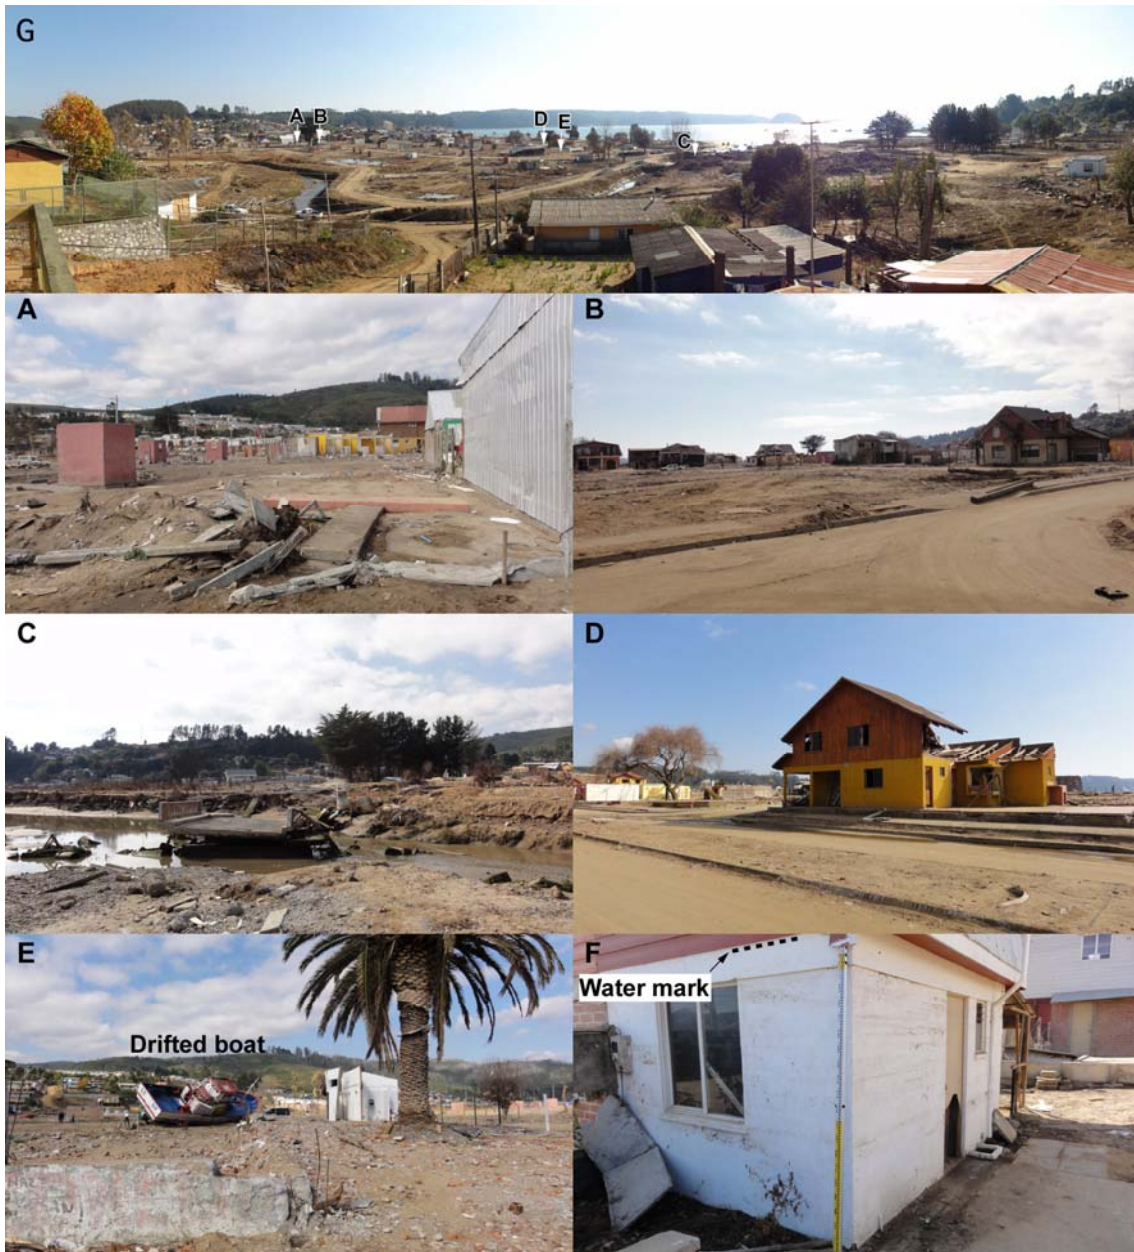
**Fig. 16** Ground photos from Dichato. A and B : Most devastated area. Only the unit of bathroom is remained. C : Damage on a bridge and erosion by tsunami inundation. D: Withstanding house, but significant damage. E : Drifted boat. F : Watermark on the house (approximately 2 m of flow depth). G : Panoramic view of the town of Dichato.
