# Building Damage Investigation of the 2010 Chile Earthquake and Tsunami Disaster

A great earthquake of magnitude 8.8 struck on the Pacific coast of Chile, at 3:34a.m. local time on February 27, 2010, and the earthquake and Tsunami caused widespread damage in Chile. The group of Japanese and Peruvian researchers conducted disaster investigation especially for buildings from 26 April to 3 May, 2010.

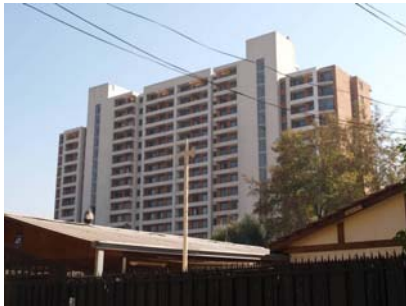
Photo 1  
Appearance of the building

It is an apartment complex constructed of box-frame-type reinforced concrete in 2007 with 18 stories above

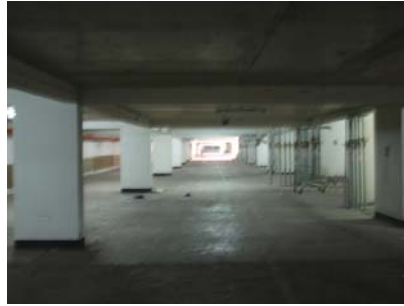
Photo 2  
Underground parking lot

ground (2 stories underground) (Photo 1). The building was damaged particularly on the first basement level of the underground self parking lot (Photos 2, 3). The structural features and the summary of damage are follows:

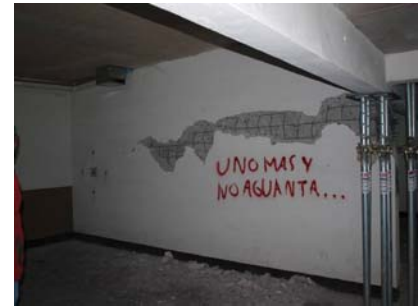
Photo 3  
Shear wall on the first basement

- Multi-story shear wall structure connected by flat slabs.
- Flexural tension failure occurred in three structure planes out of five 4-span ones on the first basement. An end main reinforcement ruptured.
- The height of the north side multi-story shear wall on the basement is shorter by 1200 mm than on higher floors. In addition, only the northern end of the north side multi-story shear wall lacks an orthogonal wall (Figures 2, 3). Accordingly, the flexural strength of the north side multi-story shear wall is low on the first basement, likely resulting in the flexural tension failure in the south direction on the north side multi-story shear wall.

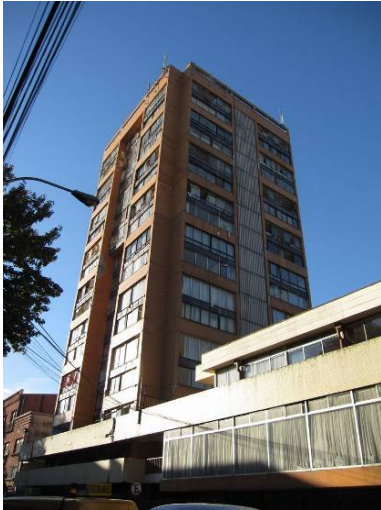
Photo 4  
Appearance of the building

It is an RC wall flat slab structure constructed in 1973. The building has 17 stories above ground and one basement (with no underground car park), of which the three lower floors are occupied by commercial tenants and the fourth and above floors are used for housing (Photo 4). The machine room on the first basement was hardly damaged. The non-structural brick wall collapsed more seriously on upper floors. The walls on the first

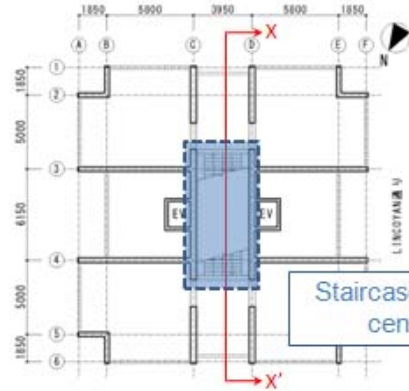
Figure 4  
Building plan view

and second floors failed in flexural tension with the wall-end main reinforcement fractured or buckled (Photo 5). While the building was damaged particularly on the walls in the northeast and southwest directions, little damage was observed on the walls in the orthogonal direction. The damage concentrated on the wall footing is likely attributable to the lack of flexural strength of the T section web resulting from the respective bending deformation of two multi-story shear walls arranged in parallel due to the limited floor slab area in the staircase (Figures 4, 5, 6).

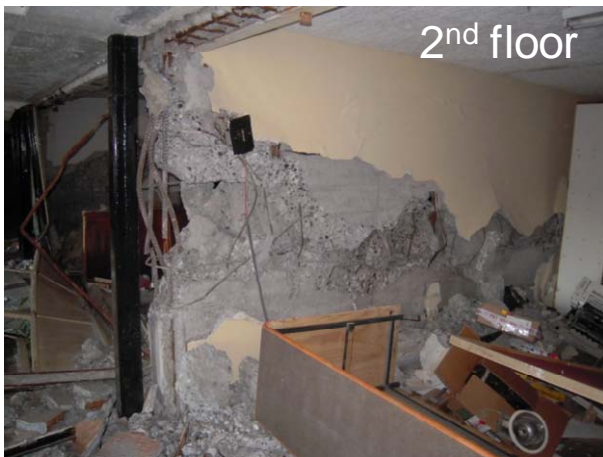
Photo 5  
Wall fracture

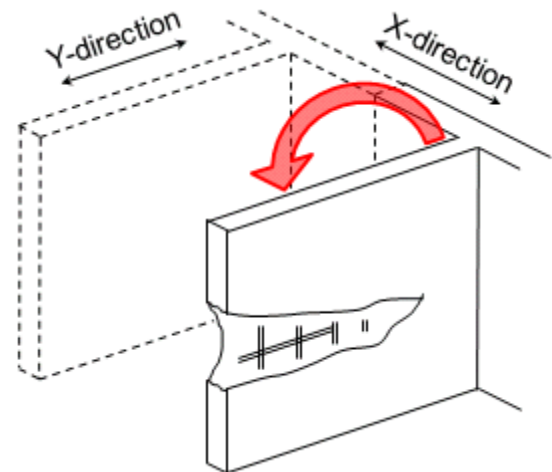
Figure 6  
Failure mechanism of T-shaped section wall

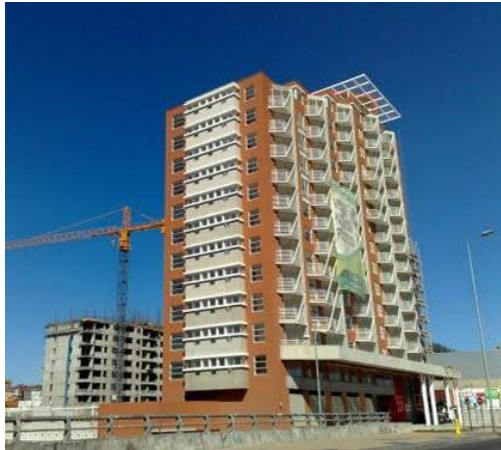
Photo 6  
Photo of the building before collapsed  
(excerpted from the Web Page)

It is a reinforced concrete apartment complex constructed in 2008 with 15 stories above ground and two stories underground (parking lot). The building completely fell down from the base on the first floor (Photo 6, 7). Photo 7 shows the appearance of all the reinforcing bars on the first floor having been pulled out or cut down from the wall pillars and load-bearing walls on the first floor during the overturning of the building. Conversely, little damage was observed on the underground end plane walls. As shown in the plan view of Figure 7, the walls on the first floor and the basements (parking lot) are smaller than those on the second and above floors in both length and volume. This fact may have resulted in the damage particularly on the wall footing on the basements.

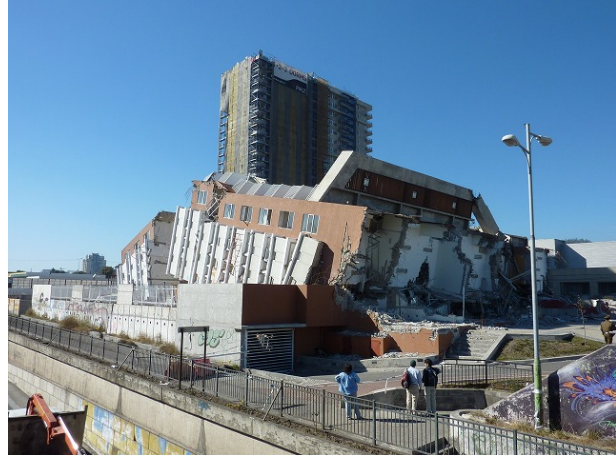
Photo 7  
Collapsed building

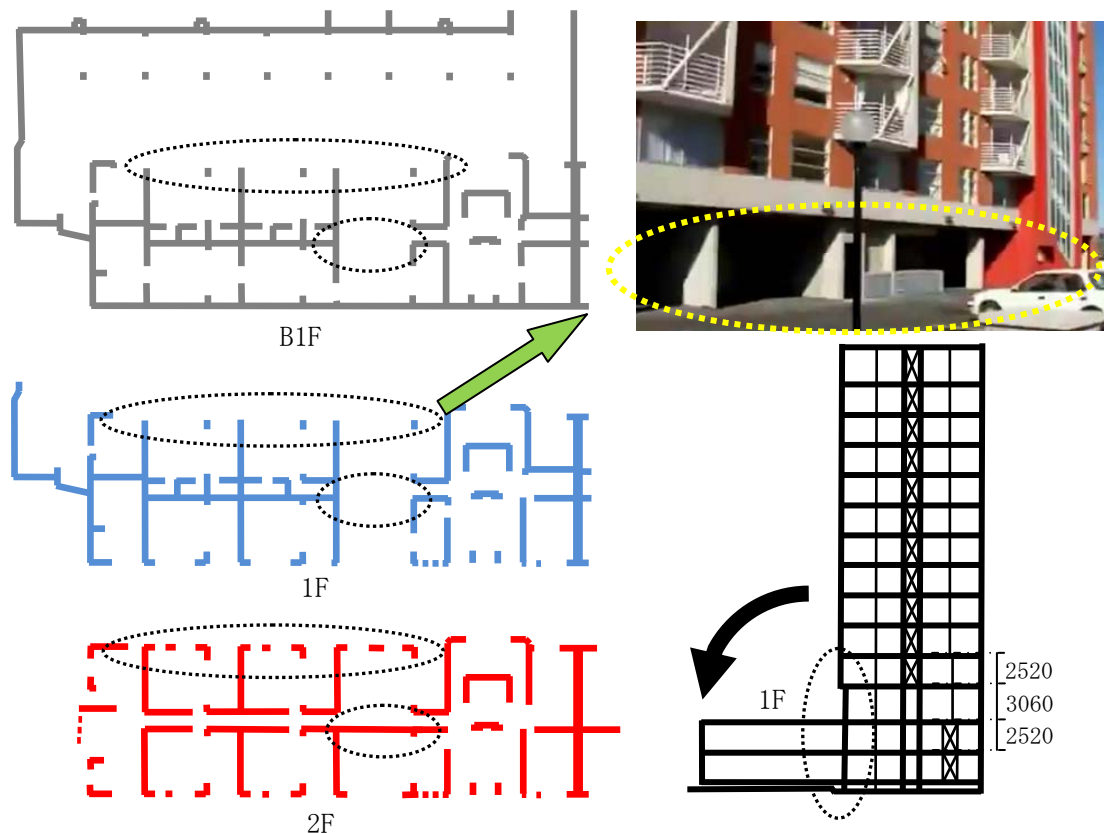
Figure 7 Difference in wall volume and layout among basement, first floor, and second floor

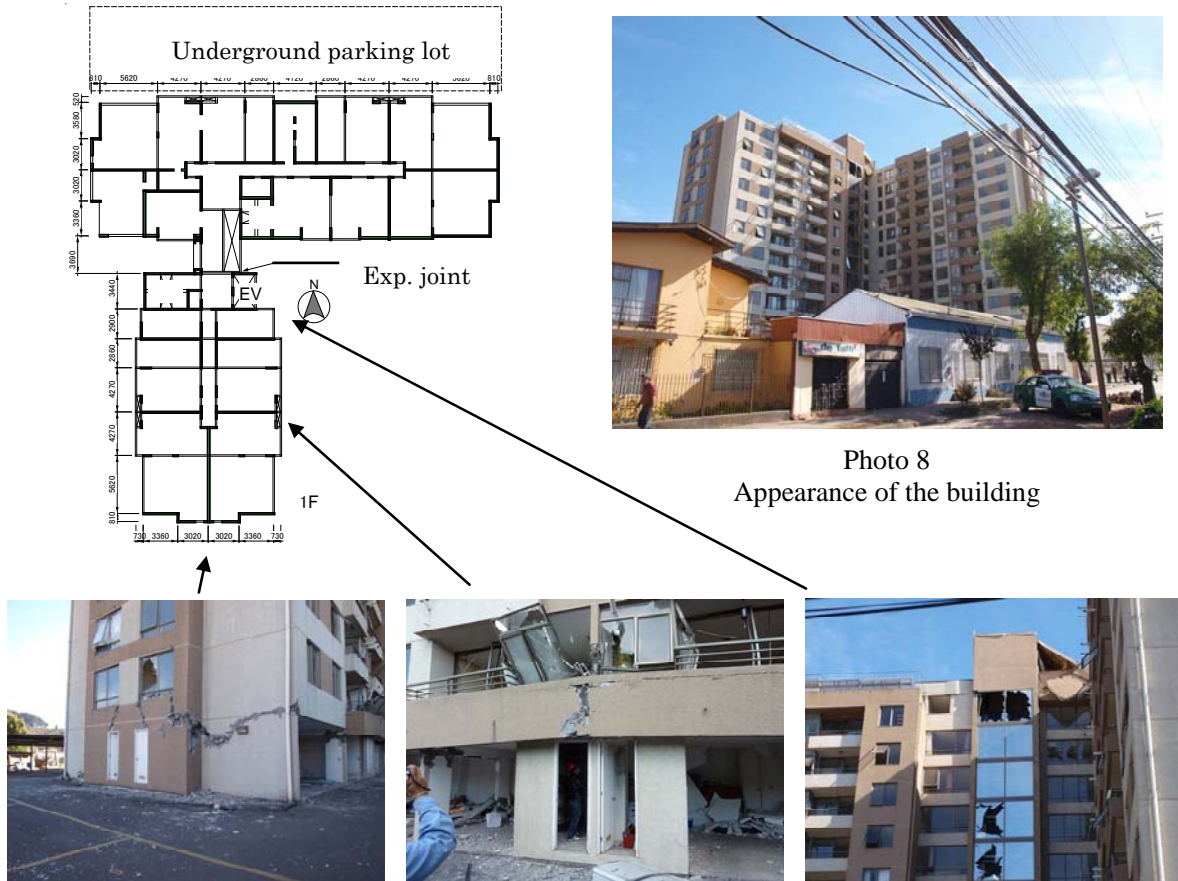
It is an apartment complex constructed in 2007 with 13 stories above ground and an underground car park provided beside the building. It consists of two buildings arranged in L shape and connected with an expansion joint (Photo 8, Figure 8). It is constructed with a middle corridor in planar shape with more wall volume in the ridge direction. While the south side building was seriously damaged, the north side building was slightly damaged. The south side building seems to have suffered torsional vibration caused by stiffness eccentricity resulting from the many walls in the surrounding of elevators and staircases.

Figure 8 Plan view and damage

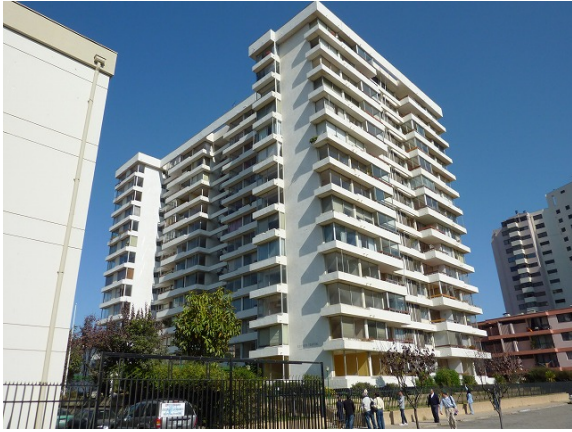
Photo 9  
Appearance of the building

It is an apartment complex (wall-type flat slab structure) with 14 stories above ground and one basement. It was severely damaged (Photo 9). The building had undergone seismic retrofitting such as the placement of additional concrete for walls and beams and the additional installation of walls in response to the earthquake in 1985, but suffered damage in the recent earthquake such as flexural tension failure and separation of concrete-added walls in the wall footing (Photo 10, Figure 9).

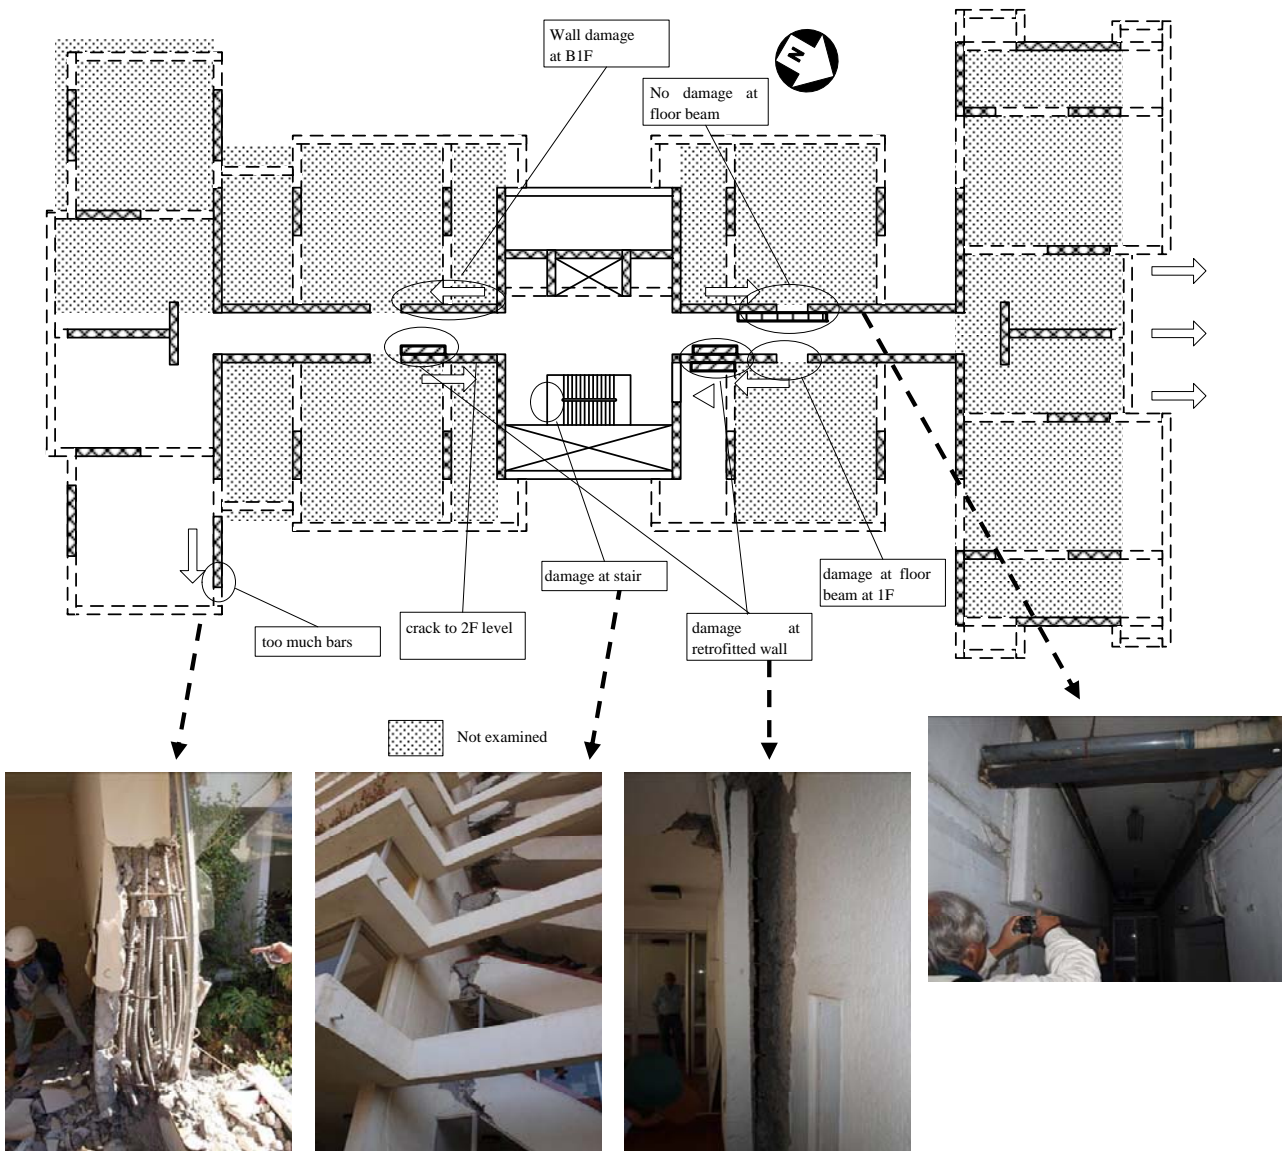
Figure 9 Plan view and damage
