Damage Investigation of the 2010 Chile Earthquake and Tsunami - Consideration to the Damage of a Structure subjected to a Seismic Excitation and a Following Tsunami Wave Load -

We show the investigation results on the tsunami-induced damage of houses and infrastructures after subjected to a seismic excitation in the 2010 Chile earthquake and tsunami, from the field survey from 26 April to 3 May, 2010 for the affected areas.

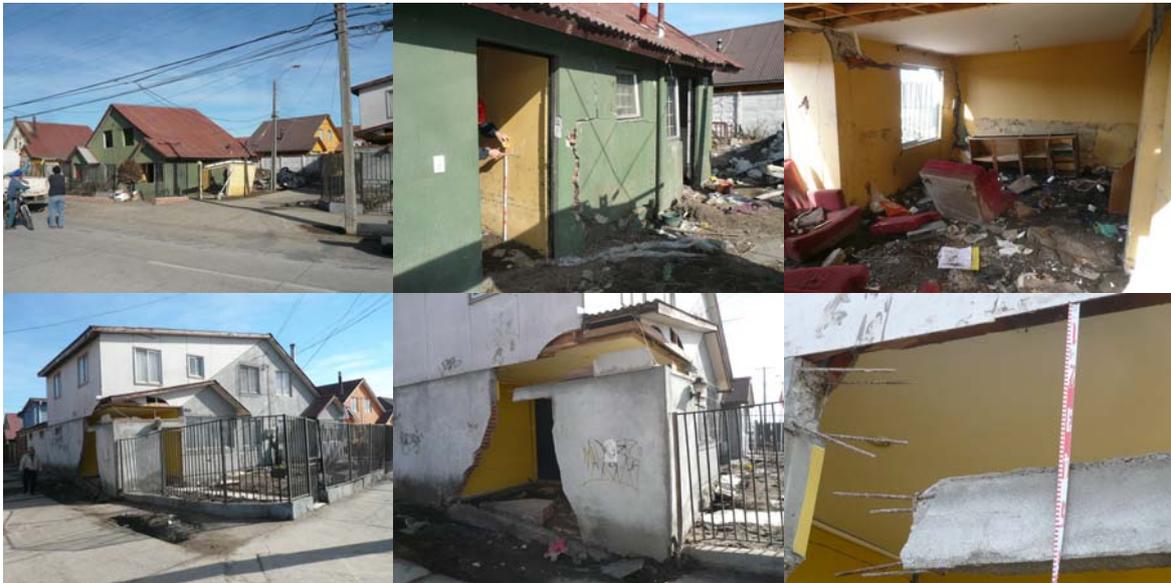
Fig.5 Damage of houses at the east part of Talcahuano

Figure 5 show the damage of houses at the east part of Talcahuano, which are RC masonry ones.

The house in the upper part of **Fig. 5** seems to be suffered by about 1m inundation after the occurrence of subsidence and declination equivalent to about 40cm to 50cm height of the house due to ground motions. The subsidence and declination cause dominant shear crack between bricks and mortar in the sidewall of the house. We can measure the inundation height at the site by the inundation horizontal marks remained in the 1st floor of the house.

Similarly, the house in the lower part of **Fig. 5** seems to be suffered by about 20cm subsidence of the ground, which is due to the liquefaction of surrounding soil subjected to ground motions. Consequently, it causes that the RC-framed beam is pulled down locally about 40cm at the joint corner between a column and a beam. The failure of the upper beam causes the failure of the sidewall in the house. These structural damage of the house is due to the forced displacement due to the liquefaction.

It is inferred that the houses in the areas are subjected more dominantly to the forced displacement due to the liquefaction, than to the inundation after the tsunami run-up along the river.
