**2010 CHILE EARTHQUAKE AND TSUNAMI
TECHNICAL REPORT**

**JST-JICA SATREPS PERU PROJECT
CHILE EARTHQUAKE FIELD INVESTIGATION TEAM**

DECEMBER 2010

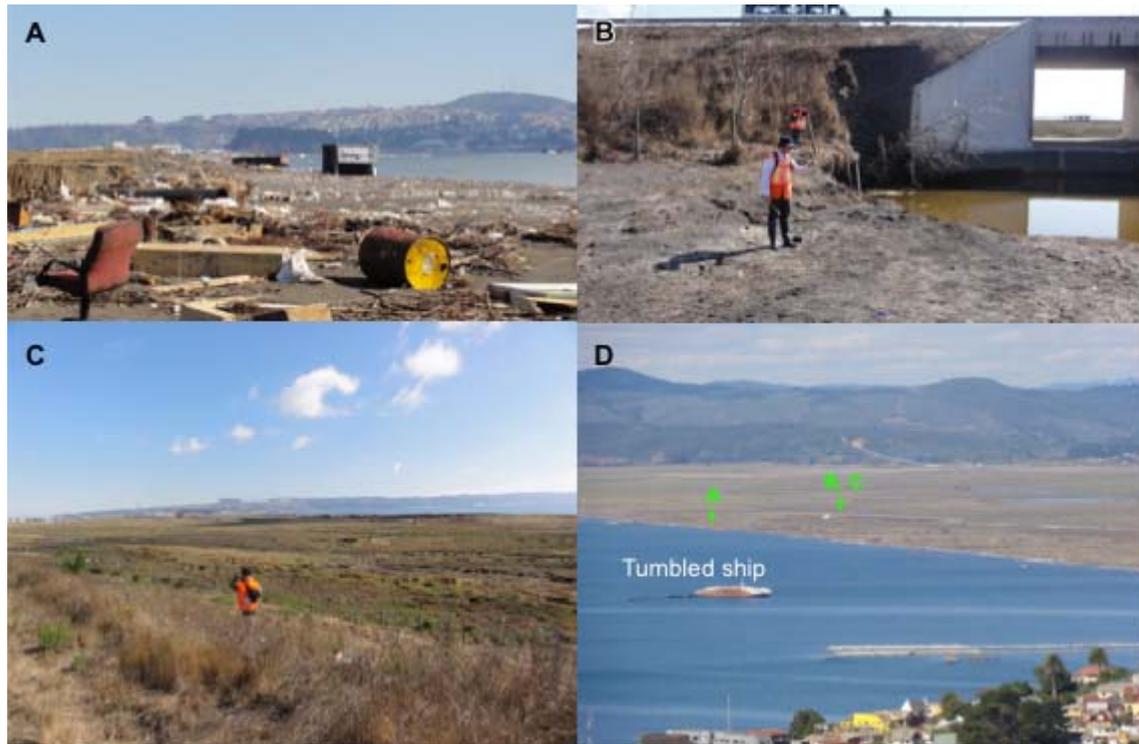
Fig. 8 Ground photos in Talcahuano taken by the authors. Each point is identified in **Fig. 7**. A : Tsunami debris and drifted containers in the coastal marsh. B : Erosion by the tsunami inundation found at the underpass. C : Overview of the coastal marsh inundated by the tsunami. D : Panoramic view of the coastal marsh from the hill.

Inspecting pre and post event satellite images and ground photos helps to understand multi aspects of tsunami disaster. **Fig. 7** is the comparison of pre and post event satellite images in Talcahuano. We acquired the pre-tsunami image from GoogleEarth (QuickBird image taken on 13 April, 2009), and used WorldView-2 pan-sharpened composite image as post-tsunami image. From post-tsunami image and field survey, we found the tumbled ship at the west of waterway in Tulcahuano bay that has been stably stood in the bay (even though it was not in use). In the coastal marsh, considerable changes of shoreline and tsunami debris are seen in the satellite images, and it was found from the ground photos (**Fig. 8**) that the coastal sand were eroded by inland penetration of tsunami.

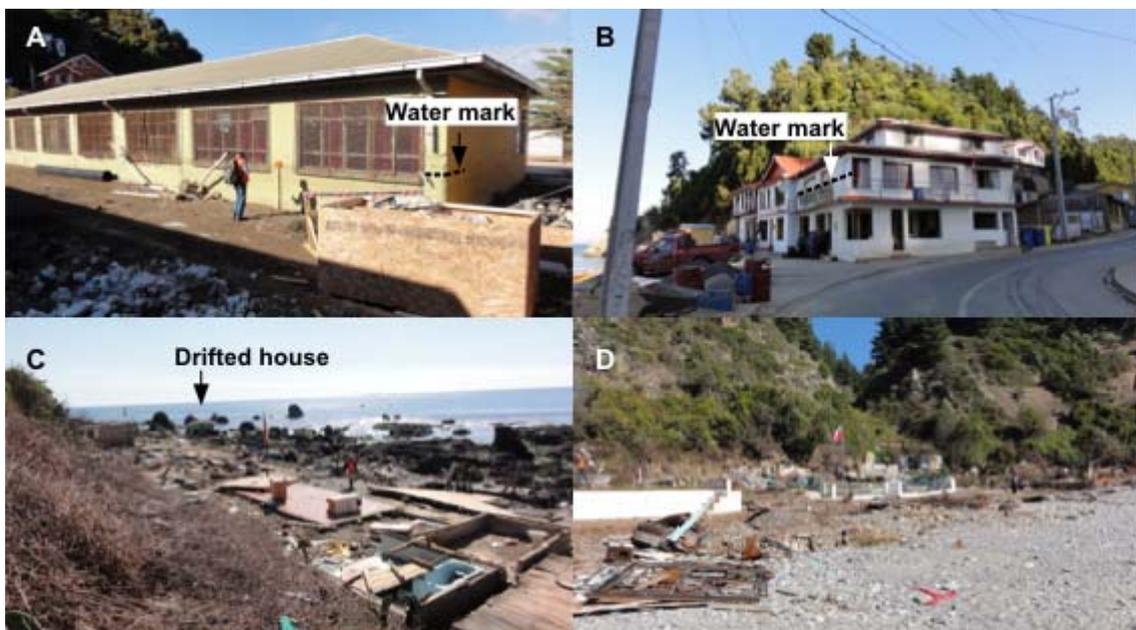
Fig. 11 Ground photos from Tumbes (A, B) and from Puerto Ingles (C, D). A : Watermark on school building. B : Watermark on the house of Tumbes, C and D : Completely devastated village of Puerto Ingles.

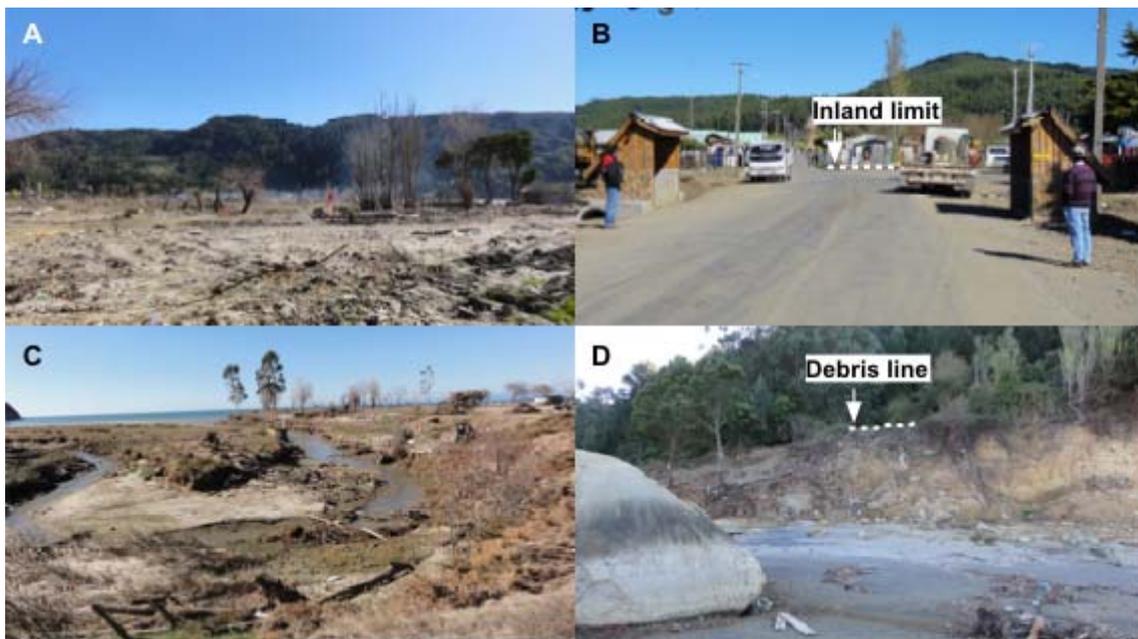
Fig. 13 Ground photos from Llico. A : Completely devastated village. In the village, there were around 60 houses before tsunami. Almost all the houses were washed-away. B : Inland limit of tsunami inundation that is approximately 400 m from the shoreline. C : Tsunami run-up along the river. D : Tsunami debris line above 14.8 m pre-tsunami sea level.

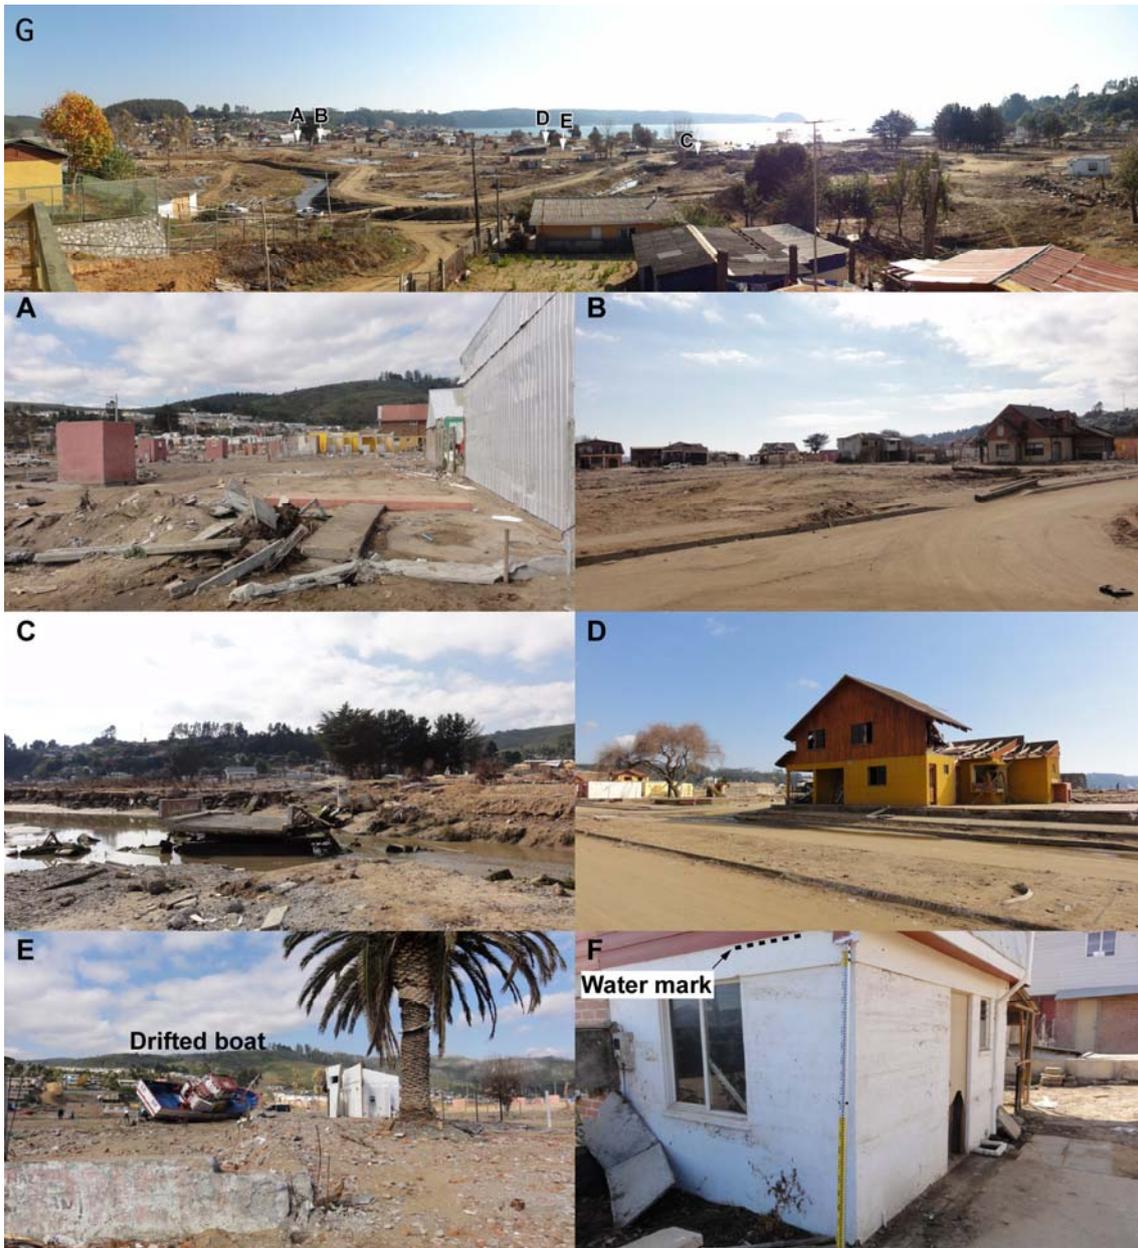
Fig. 16 Ground photos from Dichato. A and B : Most devastated area. Only the unit of bathroom is remained. C : Damage on a bridge and erosion by tsunami inundation. D: Withstanding house, but significant damage. E : Drifted boat. F : Watermark on the house (approximately 2 m of flow depth). G : Panoramic view of the town of Dichato.

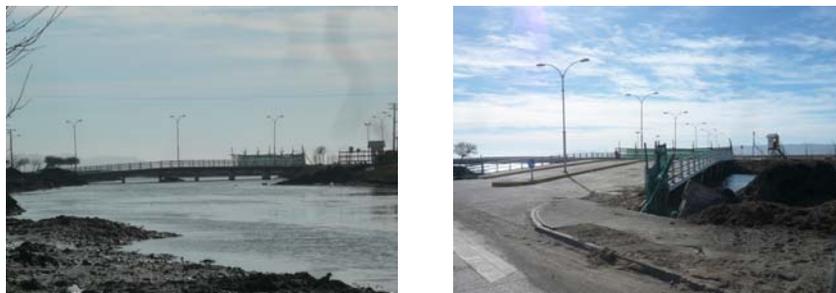
Figure 3 show the damage of a bridge at the east part of Talcahuano. The bridge is located at the river mouth and it is a six-spanned bridge with prestressed concrete girders. The span length is about 10m long and the total width of a deck is about 20m long. Significant liquefaction occurs along both riversides in the direction from the location of the bridge to the 30m - 50m upstream. Consequently, subsidence of both abutments and these backfill occurs although we can not observe significant physical damage of bridge girders and piers. We guess that severer subsidence of the abutment at the left bank of the river by scouring of the backfill subjected to tsunami compression and tensile waves, follows the subsidence by the liquefaction subjected to ground motions, than that at the right bank.

Fig.3 Damage of a bridge

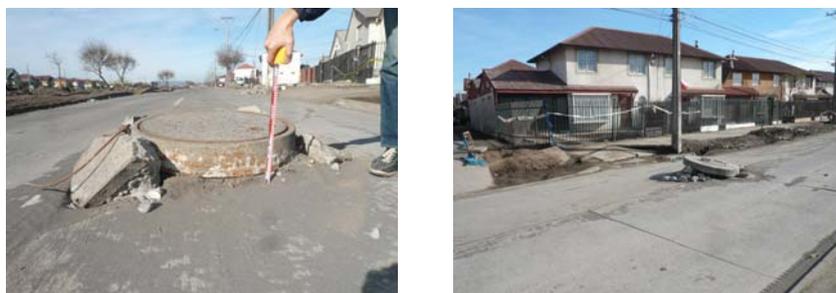
Fig.4 Damage of sewerage systems

Figure 4 show the damage of sewerage systems buried in adjacent road with the river at the east part of Talcahuano. Manholes of the systems are uplifted about 15cm to 25cm high from the road surface, and subsidence of buried pipelines and gaps between those spans occur at the side of the road in front of houses. It is

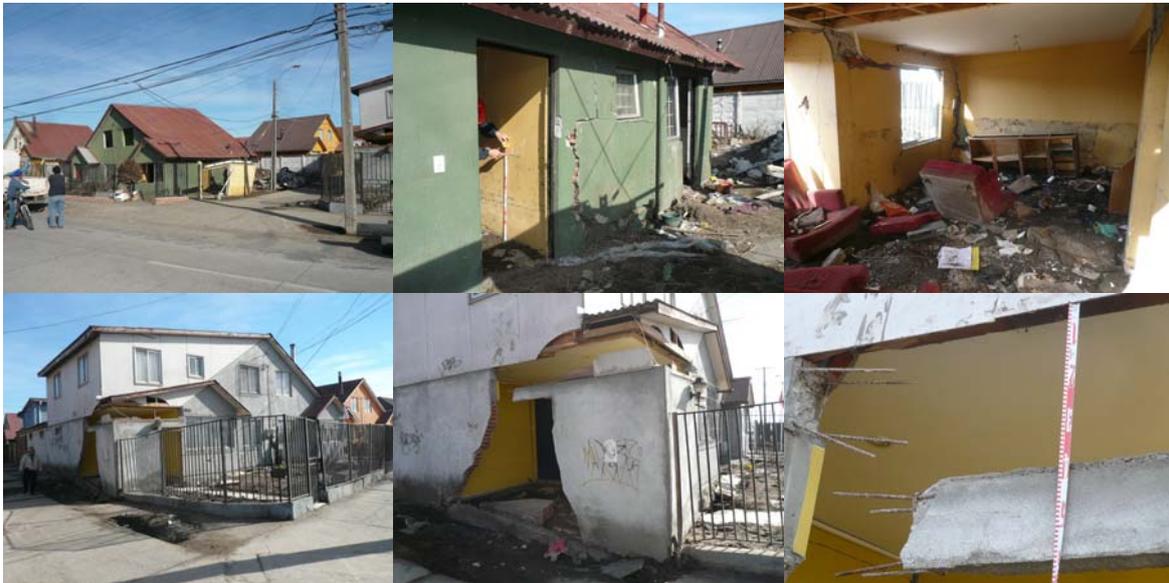
It is inferred that the houses in the areas are subjected more dominantly to the forced displacement due to the liquefaction, than to the inundation after the tsunami run-up along the river.

Fig.5 Damage of houses at the east part of Talcahuano

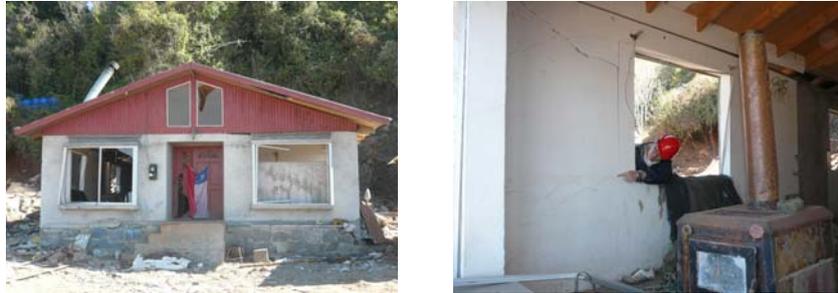
the height of the upper beam at the second floor of the house. It is inferred from his evidence that the inundation height at the house is about 7m - 8m from the ground level, which can be interpreted as very high inundation height to a house. The guideline on the tsunami-proof design for a building offered by Japanese Cabinet Office ⁴⁾ describes how to design a building resisting the tsunami wave load of about 8m inundation height. The damage of this house should be further analyzed based on the evaluation framework of a tsunami wave load to a structural component by the guideline.

Fig.6 Damage of a house by combination of seismic and tsunami wave loads at Coliumu

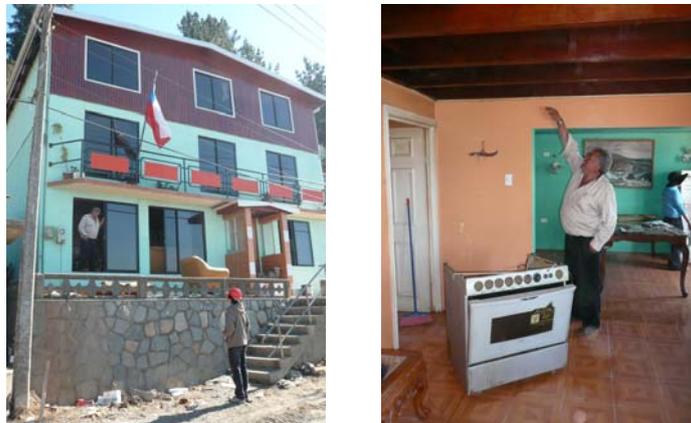
Fig.7 Minor functional damage of a house by combination of seismic and tsunami wave loads at Coliumu

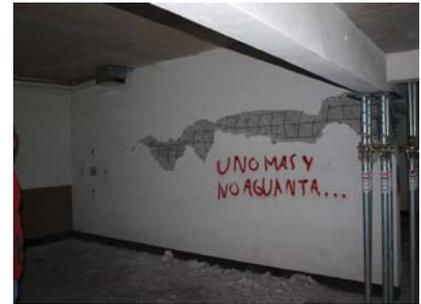
- Multi-story shear wall structure connected by flat slabs.
- Flexural tension failure occurred in three structure planes out of five 4-span ones on the first basement. An end main reinforcement ruptured.
- The height of the north side multi-story shear wall on the basement is shorter by 1200 mm than on higher floors. In addition, only the northern end of the north side multi-story shear wall lacks an orthogonal wall (Figures 2, 3). Accordingly, the flexural strength of the north side multi-story shear wall is low on the first basement, likely resulting in the flexural tension failure in the south direction on the north side multi-story shear wall.

Photo 3
Shear wall on the first basement

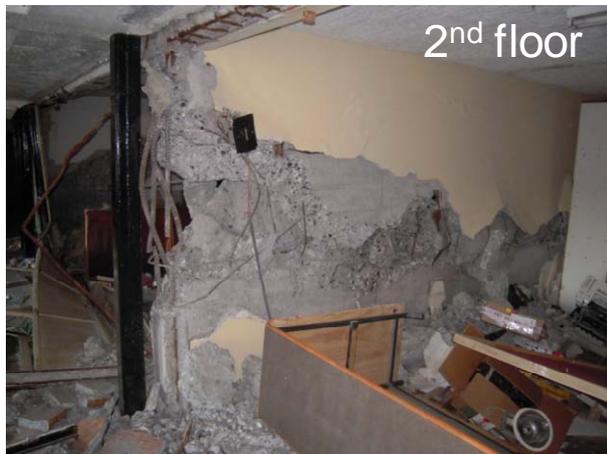
and second floors failed in flexural tension with the wall-end main reinforcement fractured or buckled (Photo 5). While the building was damaged particularly on the walls in the northeast and southwest directions, little damage was observed on the walls in the orthogonal direction. The damage concentrated on the wall footing is likely attributable to the lack of flexural strength of the T section web resulting from the respective bending deformation of two multi-story shear walls arranged in parallel due to the limited floor slab area in the staircase (Figures 4, 5, 6).

Photo 5
Wall fracture

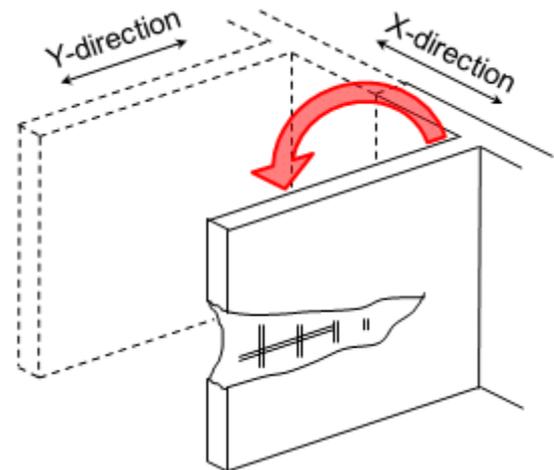
Figure 6
Failure mechanism of T-shaped section wall

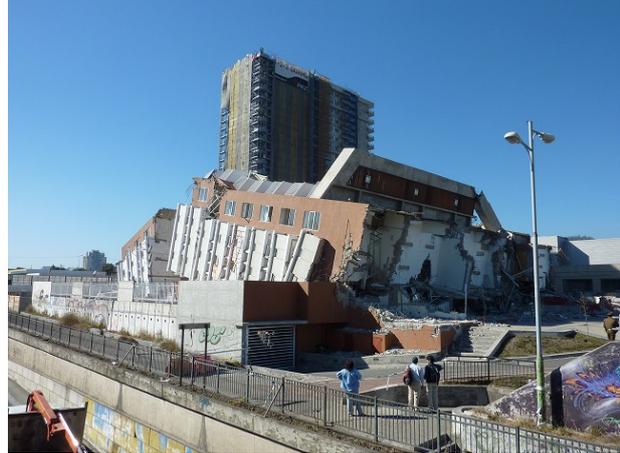
It is a reinforced concrete apartment complex constructed in 2008 with 15 stories above ground and two stories underground (parking lot). The building completely fell down from the base on the first floor (Photo 6, 7). Photo 7 shows the appearance of all the reinforcing bars on the first floor having been pulled out or cut down from the wall pillars and load-bearing walls on the first floor during the overturning of the building. Conversely, little damage was observed on the underground end plane walls. As shown in the plan view of Figure 7, the walls on the first floor and the basements (parking lot) are smaller than those on the second and above floors in both length and volume. This fact may have resulted in the damage particularly on the wall footing on the basements.

Photo 7
Collapsed building

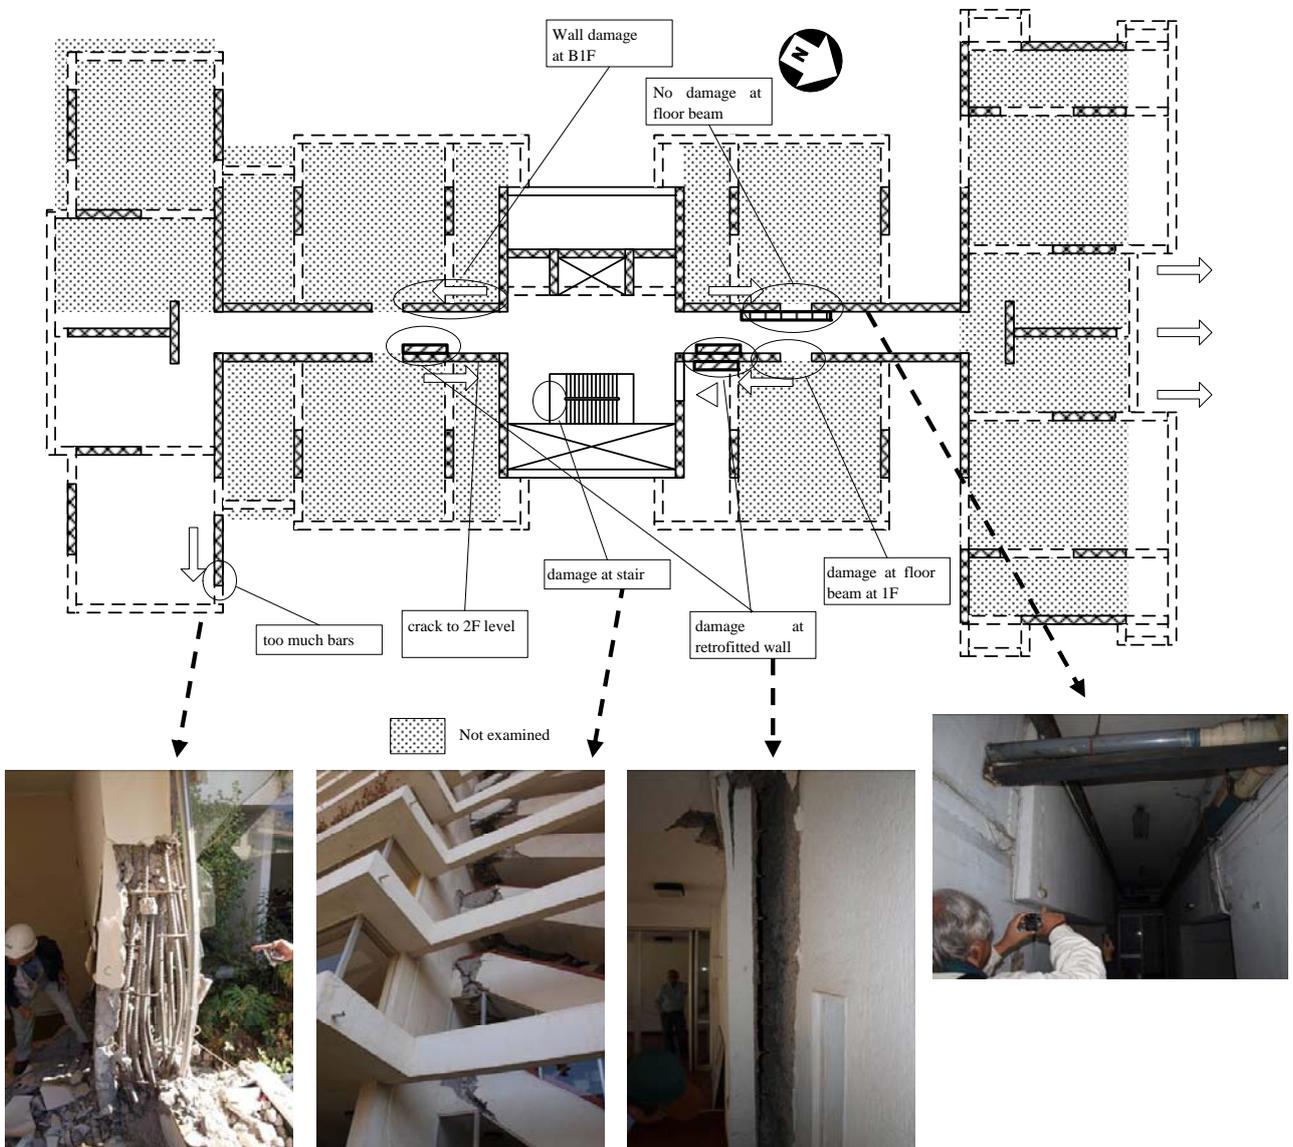
Figure 9 Plan view and damage
