Development of Spatial Information Database of Building Damage and Tsunami Inundation Areas following the 2010 Chile Earthquake

Fumio YAMAZAKI¹, Yoshihisa MARUYAMA², Hiroyuki MIURA³, Shizuko MATSUZAKI⁴ and Miguel ESTRADA⁵

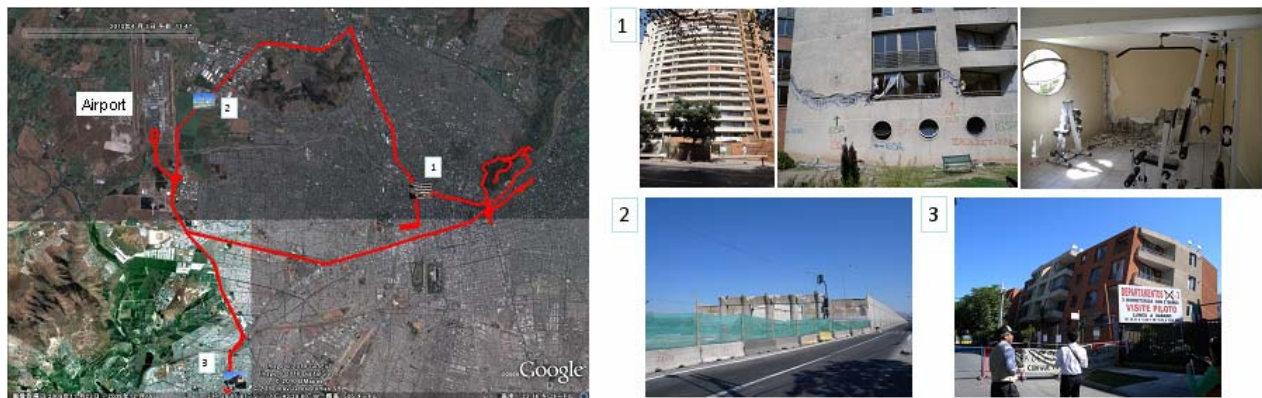
Fig. 2 Survey route and field photos in Santiago—April 2, 2010

Figure 2 shows the route of our field survey in Santiago and some field photographs. The route was recorded by a portable GPS device during the survey and the location of the photo shooting could be identified as the location data were embedded in the Exchangeable Image File Format (EXIF). An RC building with 20 stories constructed in 2003 suffered from shear failures in columns and walls at the first and the second stories. A collapsed highway bridge and an RC building with the collapsed first floor were found. The locations of these sites are also shown in the survey route in **Fig. 2**.

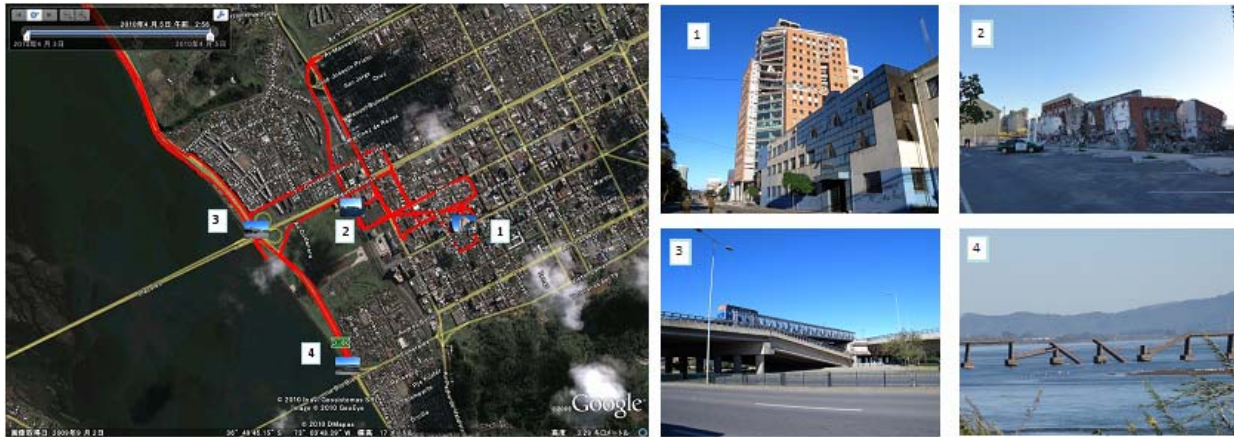
Fig. 3 Survey route and field photos in Concepción—April 4, 2010

Figure 3 shows the survey route in Concepción. An RC building with the damaged middle floor was found at the site numbered 1. An RC building with 15 stories had collapsed completely at the site numbered 2. The road bridges collapsed at sites 3 and 4. The temporary bridge girder was constructed two days after the earthquake at site 3. Although the photos are not shown in this paper, the adobe and unreinforced masonry constructions were severely damaged in the urban area.

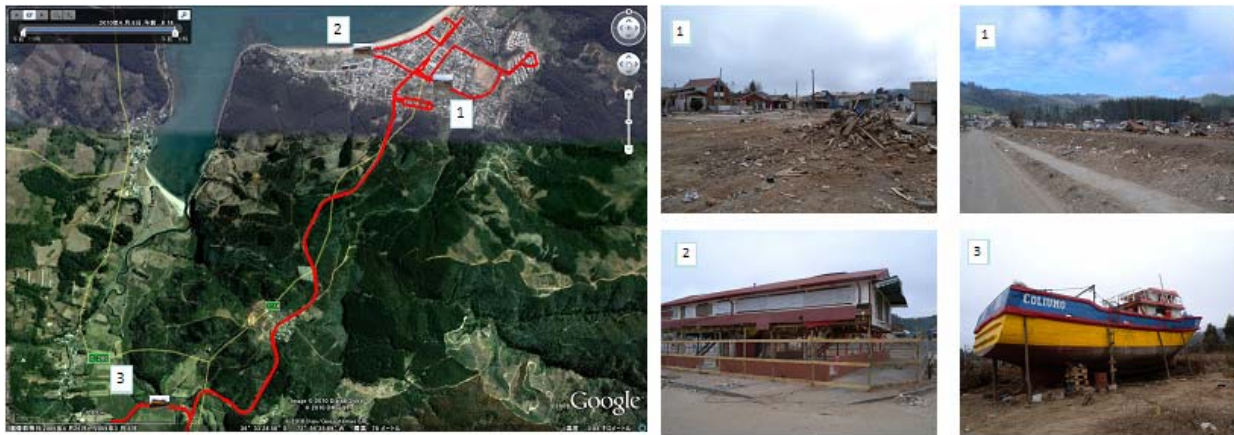
Fig. 4 Survey route and field photos in Dichato—April 5, 2010

Figure 4 shows the survey route in Dichato. It is reported that more than 80% of the built-up area in Dichato suffered from tsunami⁵⁾. As shown in the field photos, the buildings collapsed because of the tsunami waves. A ship was conveyed against the river flow because of the tsunami and eventually found at site 3.

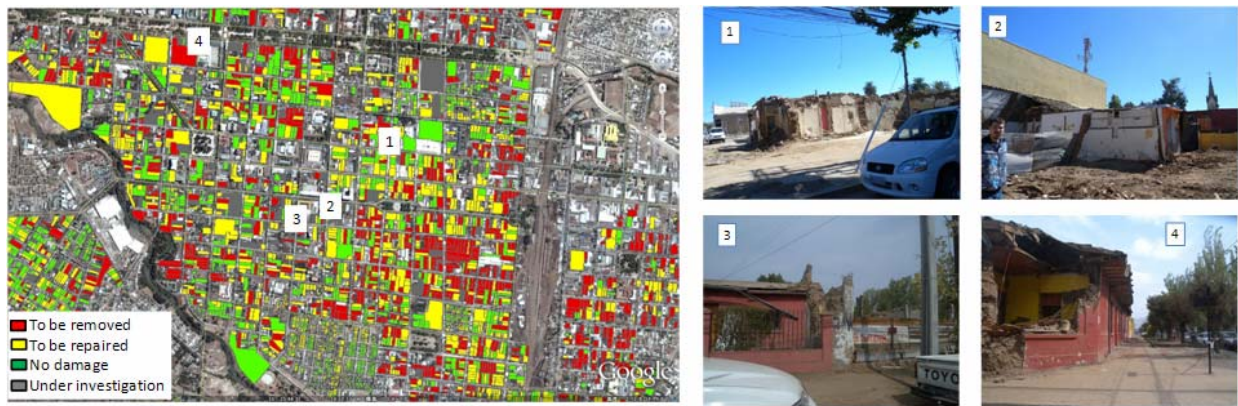
Fig. 5 GIS file to show the damage levels of buildings in Talca and locations of field photos

image file was converted to a GIS file with polygons to identify the damage levels of buildings. **Figure 5** shows the developed GIS file presented by Google Earth and some field photos to show the examples of damaged buildings.

In all, 5617 polygons were projected to the map coordinate system. 1559 (27.8%), 1872 (33.3%), and 1864 (33.2%) buildings were classified as to be removed, to be repaired, and no damage, respectively. The typical construction types in Talca are adobe and unreinforced masonry buildings, which are primarily used for older constructions with 2–4 stories (dating back to before the 1960s–70s). Modern buildings that were designed according to the current codes suffered minor, repairable damage, while a large number of adobe and unreinforced masonry constructions suffered significant damage⁶.

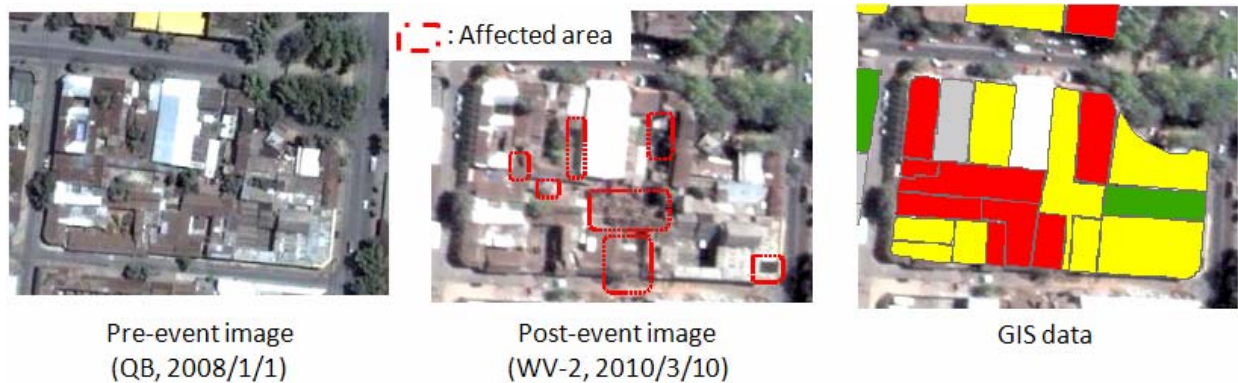
Fig. 7 Comparison between pre- and post-event satellite images to detect affected buildings

Recent advancements in remote sensing technologies and their applications have made it possible to use remotely sensed imagery for estimating the damage distribution due to natural disasters. Among them, high-resolution optical satellite imagery, which has become available in the last decade, has made satellite remote sensing more useful in disaster management since even the damage status of individual buildings can be identified^{7), 8)}. **Figure 7** compares the pre- and post-event high-resolution optical satellite images with the GIS dataset shown in **Fig. 5**. As for the pre- and post-event images, the image captured by QuickBird⁹⁾ on January 1, 2008, which is presented in Google Earth, and that captured by WorldView-2¹⁰⁾ on March 10, 2010, are employed in this study. A comparison of the pre- and post-event images revealed that some of the affected buildings could be visually detected, but not all the damaged ones could be identified appropriately. Since the post-event image was captured with the large off-Nadia angle (40.3°), the quality of image is not sufficient for visual damage inspection. Moreover, the number of affected buildings whose roofs had completely collapsed is small in Talca. Hence, it can be concluded that the damaged buildings in Talca are difficult to be detected through visual damage inspection using satellite images.

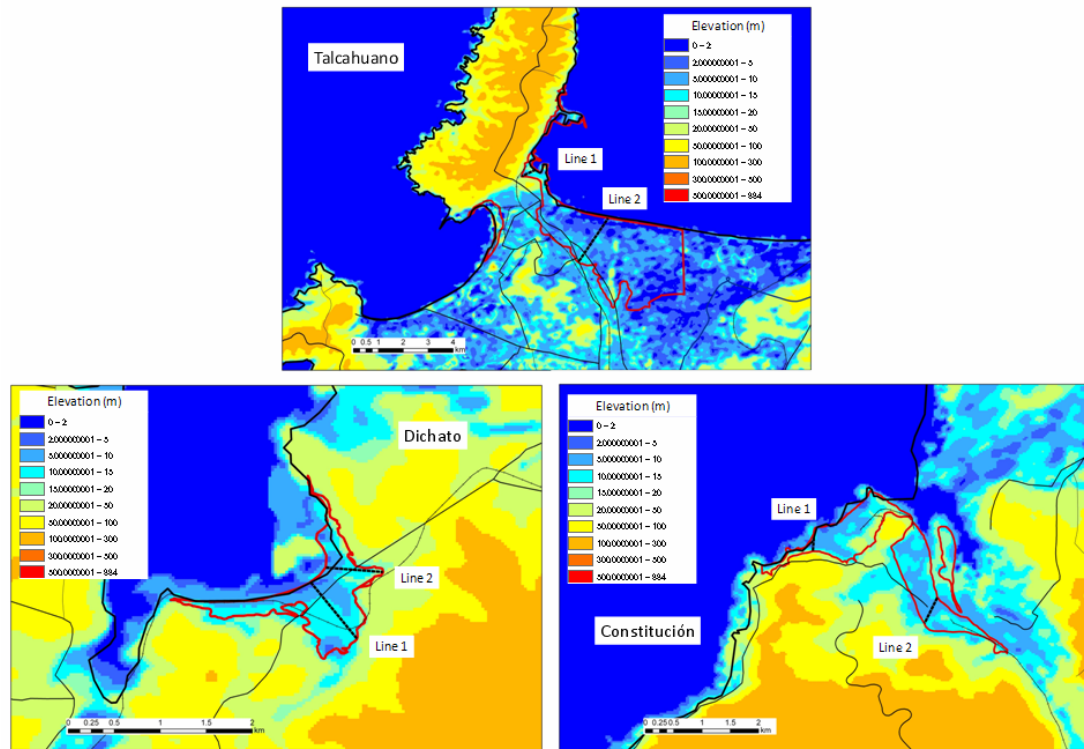
Fig. 8 Tsunami-inundated areas in Talcahuano, Dichato, and Constitución

Figure 8 shows the tsunami-inundated areas in Talcahuano, Dichato, and Constitución and the distributions of the elevation derived from the ASTER GDEM. The elevations in the inundated areas are lower than 20 m on the whole except for a certain area in Constitución. As shown in the figure, we set the two traverse lines in each inundated area. The elevations were extracted along the two lines. The extracted elevations are illustrated in terms of the distance from the coastline in Fig. 9. As for Line 2 in Constitución, the elevations are presented with respect to the distance from the Maule River. The relatively low elevations and slow grades result in long travel distances of the tsunami wave. According to Line 2 in Talcahuano, the tsunami wave could travel approximately 2000 m from the coastline. Line 1 in Constitución was assigned to identify the surveyed site by Imamura et al.¹³⁾. According to their report, the tsunami runup height was 28.3 m at the site. Since the DEM used in this study is a global dataset that consists of 30-m grid cells, the elevation at the site is estimated to be approximately 23 m. The slope is estimated to be approximately 67% and is almost equivalent to that reported by Imamura et al., which is 63.5%¹³⁾.

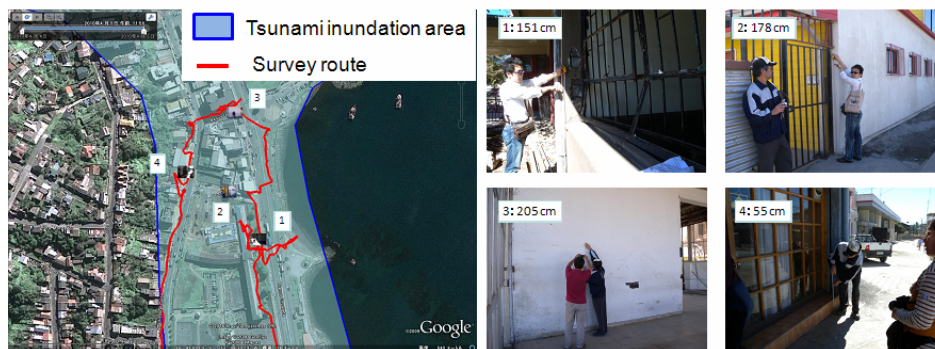
Fig. 10 Measurement of tsunami inundation depth in Talcahuano

As shown in Fig. 10, the inundation depth was measured at several sites in the three cities. The inundation depth along the beachfront street in Talcahuano was larger than 150 cm, but a depth of 55 cm was observed in its bystreet (site 4). Figure 11 summarizes the measurements in the three cities. The inundation depth is presented with respect to the elevation and the distance from the coastline. As for the results in Constitución, the records are shown with respect to the distance from the Maule River. A clear tendency is not seen in the rela-

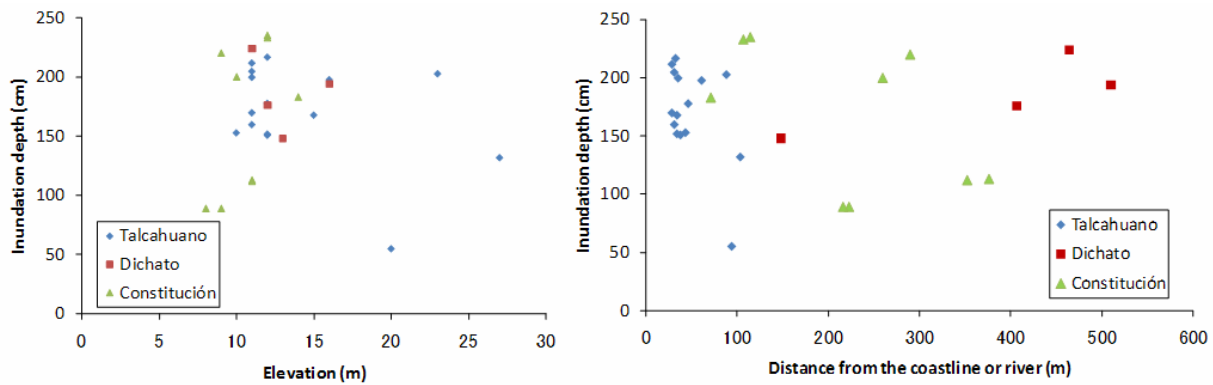
Fig. 11 Summary of the measurement of tsunami inundation depth

relationship between the tsunami inundation depth and the elevation. The recorded depth in Talcahuano and Constitución decreased with an increase in the distance from the coastline or the river; however, this tendency is not seen from the records in Dichato because of the insufficient number of measurements.
