BUILDING DAMAGE AND TSUNAMI INUNDATION GIS DATASETS AFTER THE 2010 CHILE EARTHQUAKE

Abstract: This paper presents the results of a field survey conducted by the authors after the 2010 Chile earthquake. The authors visited the affected area about a month after the earthquake. The GIS datasets for the damage levels of buildings in Talca and the tsunami-inundated areas in Talcahuano, Dichato, and Constitución are constructed in this study, and a series of fundamental analyses are performed using a digital elevation model (DEM). Further, the usefulness of satellite images captured after the earthquake to detect damaged buildings in Talca is discussed using the GIS datasets constructed in this study.

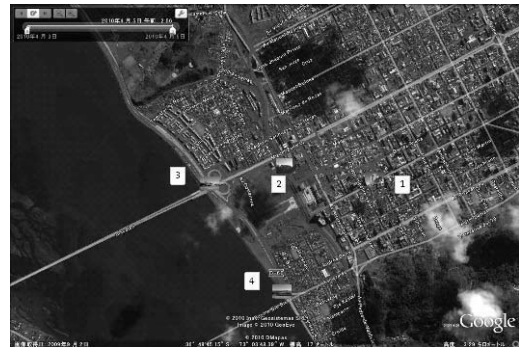
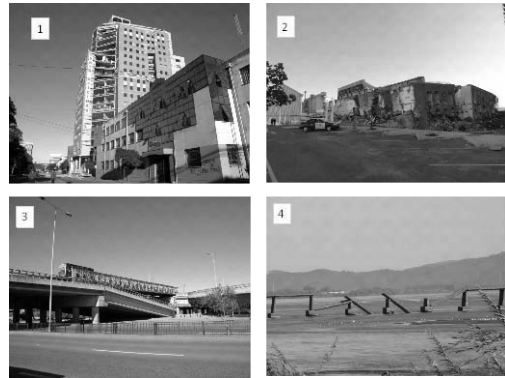
Figure 3 Survey route and field photos in Concepcion—April 4, 2010

Figure 3 shows the survey route in Concepcion. An RC

building with the damaged middle floor was found at the site numbered 1. An RC building with 15 stories had collapsed completely at the site numbered 2. The road bridges collapsed at sites 3 and 4. The temporary bridge girder was constructed two days after the earthquake at site 3. Although the photos are not shown in this paper, the adobe and unreinforced masonry constructions were severely damaged in the urban area.

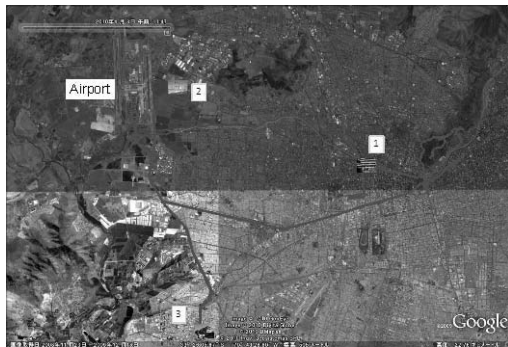
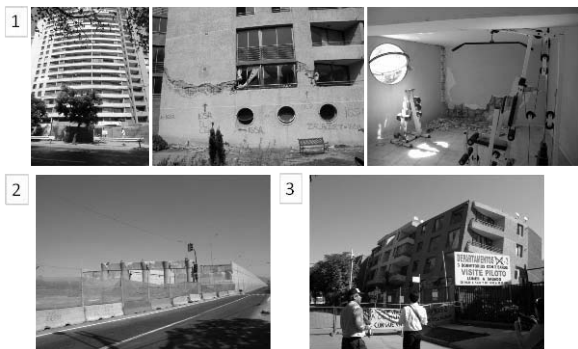
Figure 2 Survey route and field photos in Santiago—April 2, 2010

and some field photographs. The route was recorded by a portable GPS device during the survey and the location of the photo shooting could be identified as the location data were embedded in the Exchangeable Image File Format (EXIF). An RC building with 20 stories constructed in 2003 suffered from shear failures in columns and walls at the first and the second stories. A collapsed highway bridge and an

RC building with the collapsed first floor were found. The locations of these sites are also shown in the survey route in Fig. 2.

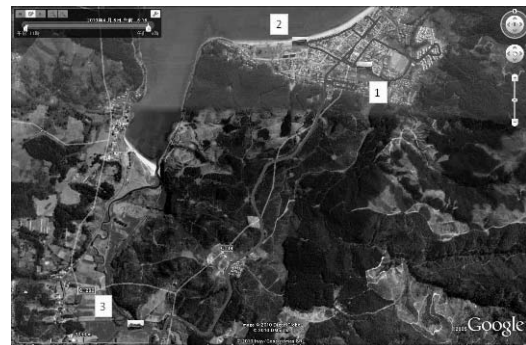
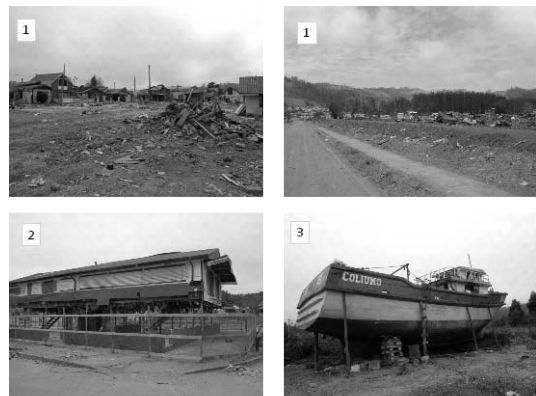
Figure 4 Survey route and field photos in Dichato—April 5, 2010

Figure 4 shows the survey route in Dichato. It is reported that more than 80% of the built-up area in Dichato suffered from tsunami (Humboldt State University Preliminary Tsunami Survey Team, 2010). As shown in the field photos, the buildings collapsed because of the tsunami waves. A ship was conveyed against the river flow because of the tsunami and eventually found at site 3.

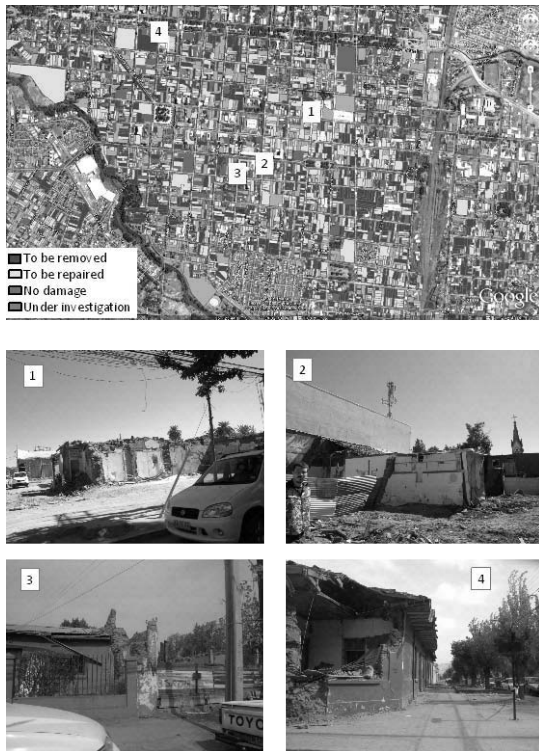
Figure 5 GIS file to show the damage levels of buildings in Talca and locations of field photos

In all, 5617 polygons were projected to the map coordinate system. 1559 (27.8%), 1872 (33.3%), and 1864 (33.2%) buildings were classified as to be removed, to be repaired, and no damage, respectively. The typical construction types in Talca are adobe and unreinforced masonry buildings, which are primarily used for older constructions with 2–4 stories (dating back to before the 1960s–70s). Modern buildings that were designed according to the current codes suffered minor, repairable damage, while a large number of adobe and unreinforced masonry constructions suffered significant damage (MCEER, 2010).

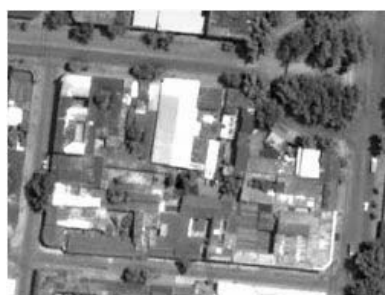
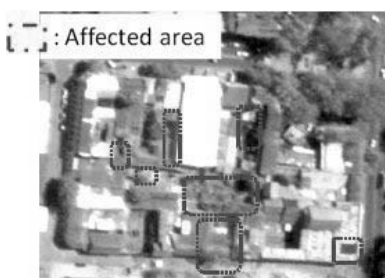
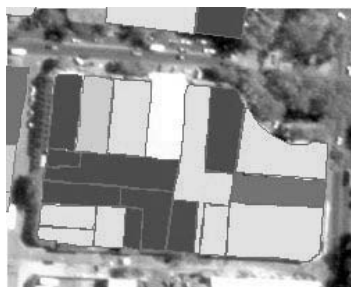
Figure 7 Comparison between pre- and post-event satellite images to detect affected buildings

post-event high-resolution optical satellite images with the GIS dataset shown in Fig. 5. As for the pre- and post-event images, the image captured by QuickBird on January 1, 2008, which is presented in Google Earth, and that captured by WorldView-2 on March 10, 2010, are employed in this study. A comparison of the pre- and post-event images revealed that some of the affected buildings could be visually detected, but not all the damaged ones could be identified appropriately. Since the post-event image was captured with the large off-Nadia angle (40.3°), the quality of image is not sufficient for visual damage inspection. Moreover, the number of affected buildings whose roofs had completely collapsed is small in Talca. Hence, it can be concluded that the damaged buildings in Talca are difficult to be detected through visual damage inspection using satellite images.

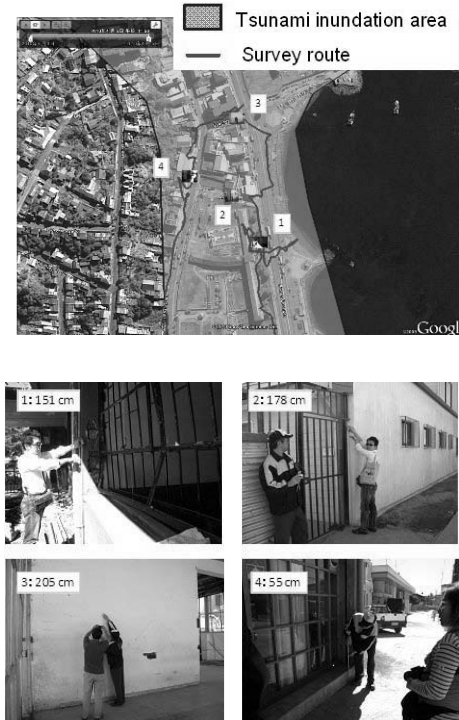
Figure 10 Measurement of tsunami inundation depth in Talcahuano

As shown in Fig. 10, the inundation depth was measured at several sites in the three cities. The inundation depth along the beachfront street in Talcahuano was larger than 150 cm, but a depth of 55 cm was observed in its bystreet (site 4). Figure 11 summarizes the measurements in the three cities. The inundation depth is presented with
