Evaluation of Seismic Vulnerability of Buildings Based on Damage Survey Data from the 2007 Pisco, Peru Earthquake

Shizuko Matsuzaki*, Nelson Pulido**, Yoshihisa Maruyama*, Miguel Estrada***, Carlos Zavala***, and Fumio Yamazaki*

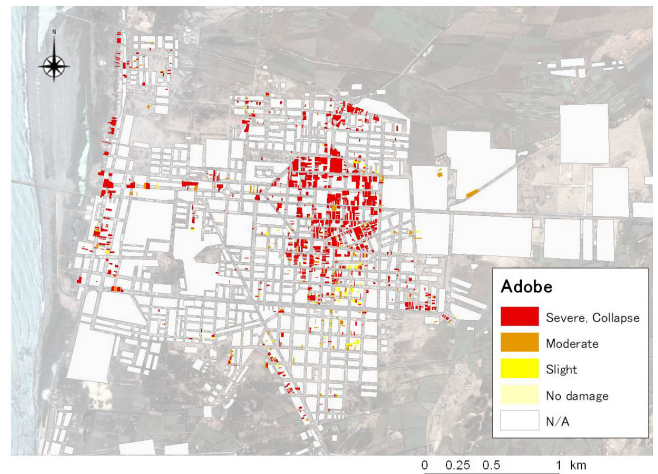
Adobe is quite vulnerable to earthquake damage. In this study, 83% of the adobe structures surveyed had severe damage. Although adobe buildings make up no more than 17% of all buildings in the district, 1,543 of the 2,779 lots (56%) that suffered severe damage were adobe.

Fig. 3. Damage distribution of 1,865 lots of adobe buildings. Adobe buildings were found largely in the old urban area of the Pisco district.

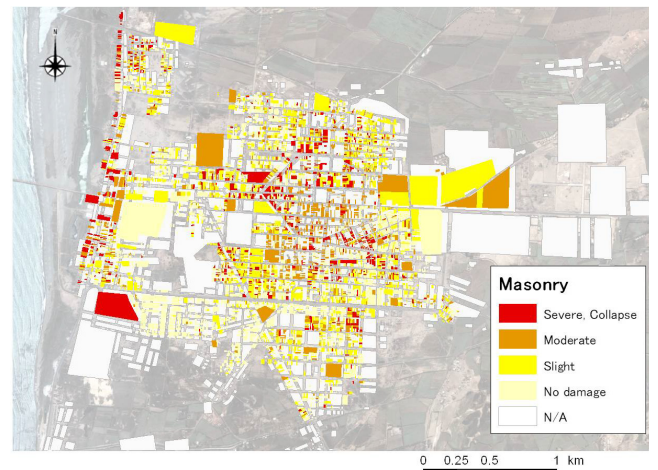
Fig. 4. Damage distribution of 8,298 lots of masonry buildings.

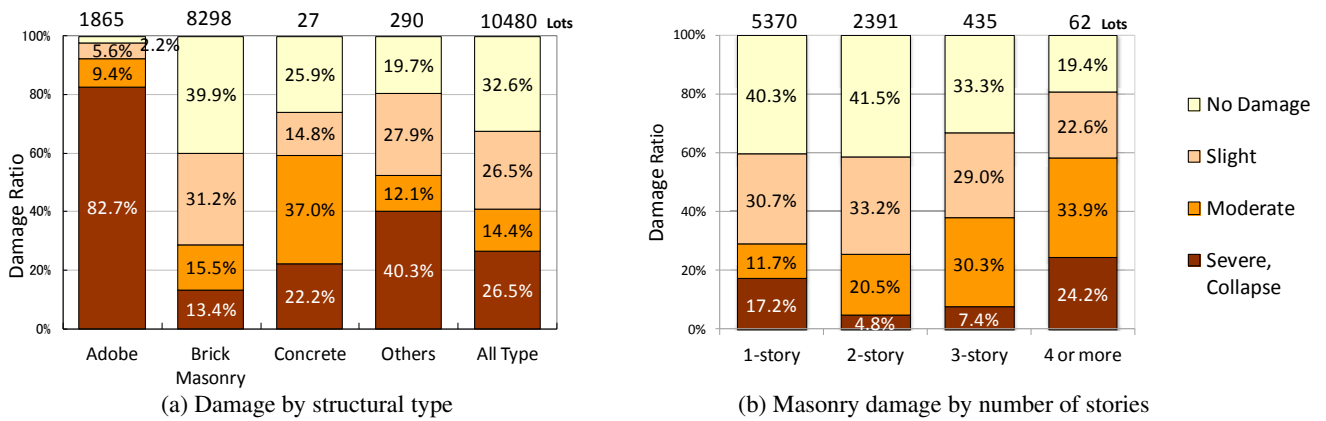
Figure 5(b) and **Table 3** show the damage ratios for masonry buildings with respect to the number of stories. In general, the greater the number of stories was, the heavier the damage was. However, for one-story buildings, the ratio of severe damage was rather high (17.2%) and in fact greater than that for two-story buildings (4.8%). For masonry buildings, the degree of damage observed was not related to the building occupancy (use) or the natural period. With regard to the occupancy, there were no significant differences between one-story and two-story buildings. In the case of one-story buildings, 89% were residential, and 8% were commercial. In the case of two-story buildings, 87% were residential, and 10% were commercial. Assuming that the natural period of a brick masonry building with an RC frame is proportional to the number of stories, with a coefficient of 0.08, the natural period of

Fig. 5. (a) Building damage ratio by structure type and (b) damage ratio of masonry buildings by number of stories.

two-story buildings is around 0.16 s, and that of a one-story building is less than 0.10 s. Because the predominant periods of the acceleration response spectra of the simulated bedrock motion were between 0.2 s and 1.0 s, resonance was not the cause of the damage observed in the one-story buildings.

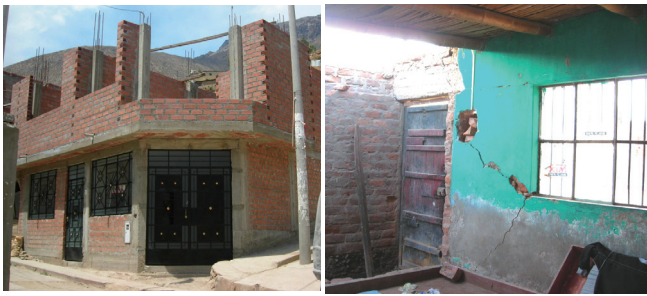
(a) Reinforced brick masonry (RM) (b) Unreinforced brick masonry (URM)

Besides, RC slabs do increase floor rigidity, and hence all the walls of a given story bear the shear force on that story. Consequently, the seismic capacity of the building as a whole is increased. Fig. 6(a) shows the exterior of a reinforced masonry building in Peru for which some columns and an RC slab can be seen. Fig. 6(b) shows an

indoor view of an unreinforced masonry building without RC elements. The walls are made of bricks, but the roof is made of bamboo covered by mud.

Fig. 6. (a) Exterior view of reinforced masonry building with RC frame in Peru and (b) indoor damage state of one-story unreinforced masonry (URM) building without RC elements. The URM building has a roof of bamboo covered by mud.

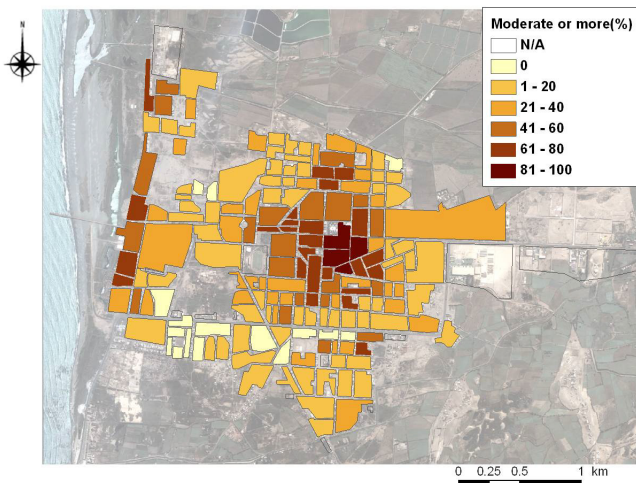
Figure 7 shows the spatial distribution of damage ratios for masonry buildings with moderate or severe damage or collapse, with respect to the city block. The Pisco district was divided into 183 blocks, each of which had at least 30 masonry buildings. Regional differences are evident in the damage ratios: significant damage occurred in the area along the coast and in the old urban area near the main square, as also shown in [21]. The ages of the buildings are unknown; however, masonry buildings do not suffer from degradation over time due to decay or ants, unlike wooden Japanese houses [22]. Differences in ground motion intensity due to soil differences are believed to be among the reasons for the differences observed in the damage distribution.

Fig. 7. Spatial distribution of moderate or greater damage ratio for masonry buildings by city block. Each block was divided to include at least 30 masonry buildings.

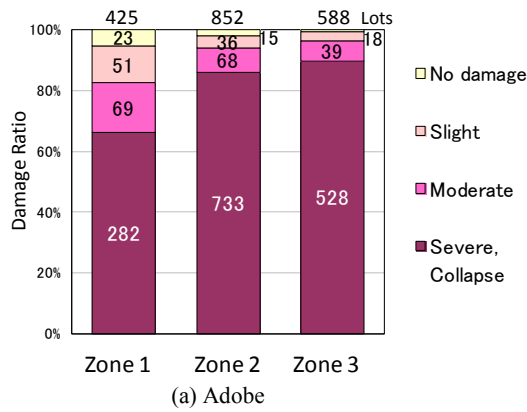
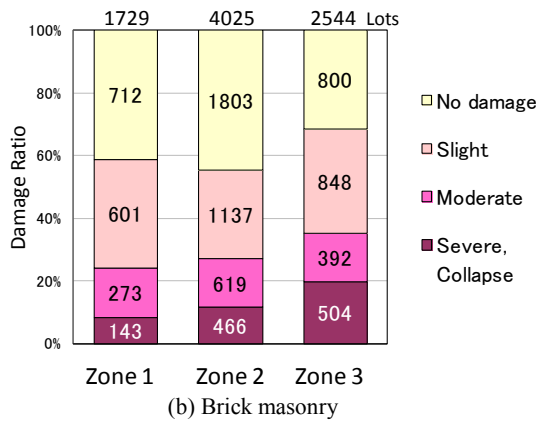
Following the microzoning based on microtremors, the damage ratios shown in **Fig. 9** for adobe and brick masonry buildings were obtained. For 8,298 lots of masonry buildings, the damage ratios for both severe damage and moderate or greater damage were higher for softer soils (from Zone 1 to Zone 3). Similarly, for 1,865 lots of adobe buildings, firmer soils had lower damage ratios for all damage levels. The building damage ratio appears to be related to the soil classification through the peak period of the H/V ratio of microtremors, for both adobe and masonry structures in Pisco.

Fig. 9. Damage ratios by soil zone classification for (a) adobe buildings and (b) brick masonry buildings.
