Evaluation of Tsunami Damage in the Eastern Part of Sri Lanka Due to the 2004 Sumatra Earthquake Using High-Resolution Satellite Images

Hiroiyuki Miura, Anil C. Wijeyewickrema and Shusaku Inoue (Tokyo Institute of Technology)

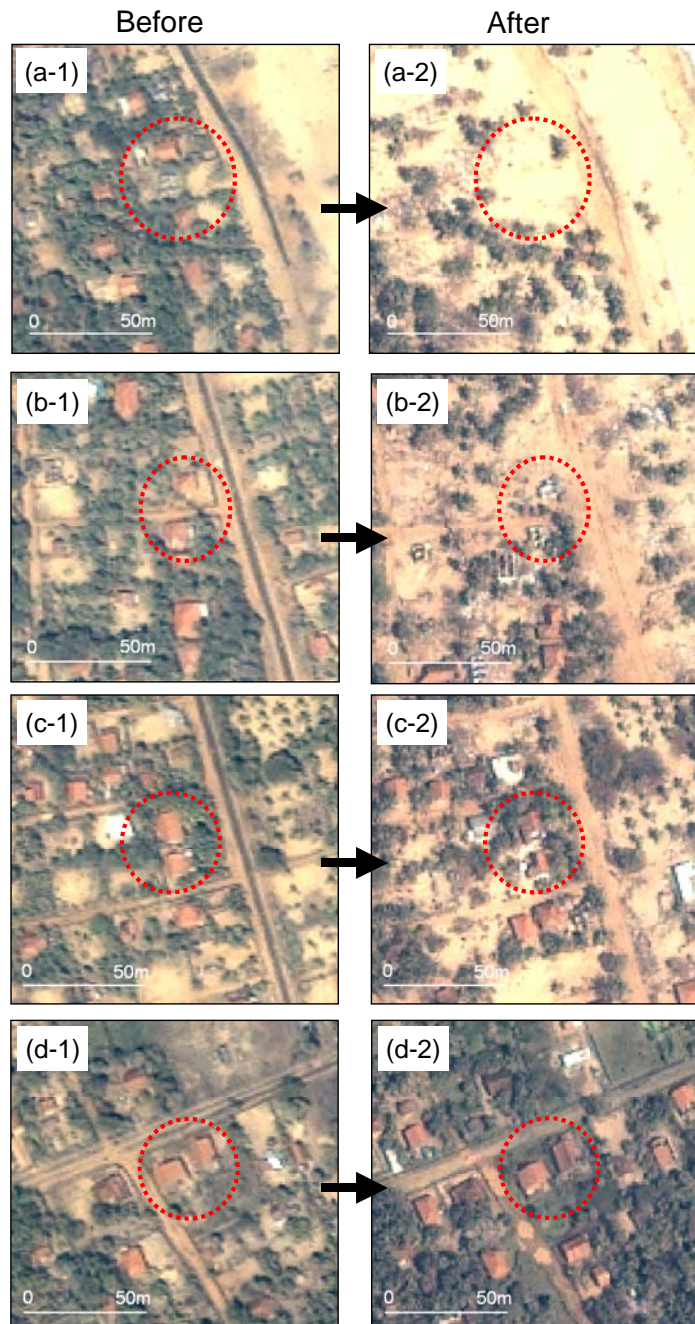
Figure 4 shows the comparison of the images before and after the event. Figure 4 (a-1) and (a-2) represent the buildings washed away by the tsunami. While the buildings indicated by the circle exist in the pre-event image, they are completely washed away with the surrounding vegetation in the post-event image. Figure 4 (b-1) and (b-2) represent the totally collapsed buildings. In the post-event image, the colors of the buildings in the circle turn to white. It indicates that the roof and most of the walls are completely crushed and the basement of the building is exposed. Therefore, those buildings are judged as Grade 5 damage level. Figure 4 (c-1) and (c-2) represent the partially collapsed buildings. The colors of the buildings change little in the appearance. Because some part of the buildings is failed and the debris is remarkably observed in the post-event image, the buildings are judged as Grade 4. Figure 4 (d-1) and (d-2) represent no or slightly damaged buildings. Because

the significant difference of the buildings is not identified between the images, the buildings are judged as Grade 1.

Figure 4. Comparison of images taken before and after the tsunami
(a) Washed away buildings (b) Totally collapsed buildings(Grade 5)
(c) Partially collapsed buildings(Grade 4) (d) No or slightly damaged buildings(Grade 1)

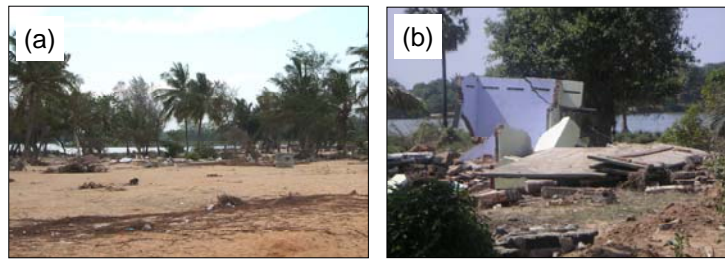
The field survey was conducted to confirm the damage of the area in March 2005. Figure 5 shows the ground photographs of the washed away building and totally collapsed building indicated in Figure 4 (a-2) and (b-2). The damage level of the photographs shows good agreement with the result of the visual inspection. It indicates that the visual interpretation of the building damage is useful to capture the severely damaged area and to identify their damage level.

Figure 5. Ground photographs in Batticaloa. (a) Washed away buildings (b) Totally collapsed buildings

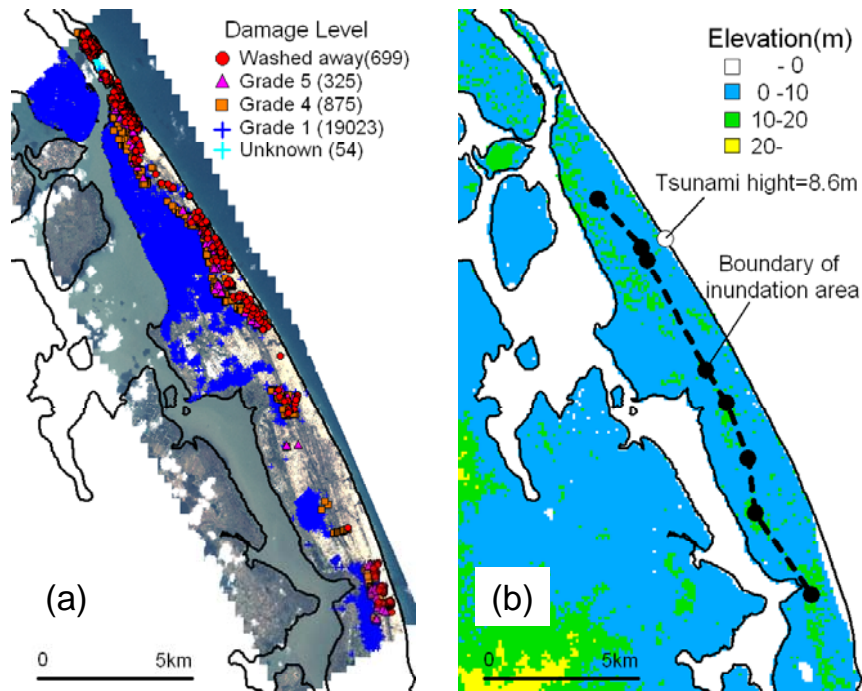
Figure 6 (a) shows the distribution of the classified buildings in Batticaloa. A total of about 20,000 buildings are detected in the area. More than 90% of the buildings are classified into Grade 1. About 10% of the buildings are identified as severely damaged buildings. The damaged buildings are concentrated in the eastern coastal line while no or slightly damaged buildings are distributed in the western area. The severely damaged buildings are distributed in the inland area within 1km distance from the coastal line.

In the field survey, the inundation area due to the tsunami and the tsunami height were investigated using GPS based on the evidence of the local inhabitants. Figure 6 (b) shows the result of the survey with the digital elevation model of SRTM-3 [NASA (2005)]. Solid circles and open circle indicate the location of the survey point for the boundary of the inundation area and the tsunami height, respectively. Broken line shows the estimated boundary of the inundation area. The result shows that the area of 0.8-1.5km distances from the eastern coastal line was inundated. The tsunami whose height is almost 9m hit this region. As shown in Figure 6 (a) and (b), the severely damaged buildings detected by the visual inspection are distributed within the inundation area.

Figure 6. (a) Distribution of classified buildings (b) Survey point of inundation area and tsunami height
