# Airborne and spaceborne images for earthquake damage detection of expressways and buildings

3rd International Workshop on Remote sensing for post disaster response  
September 13, 2005

In this study, visual damage inspection for two recent large earthquakes (2004 Niigata-ken Chuetsu Earthquake and 2005 Fukuoka-ken Seiho-Oki Earthquake) was conducted for expressways and wooden houses.

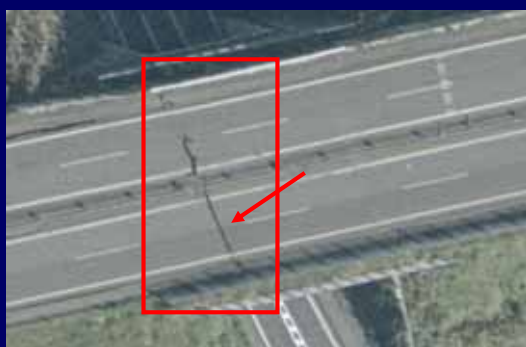
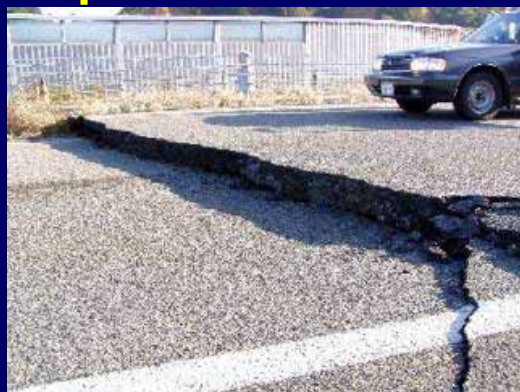
213.7 kp

Gap of road surface (20 cm)

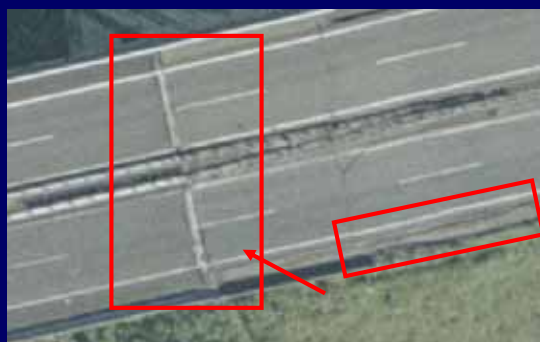
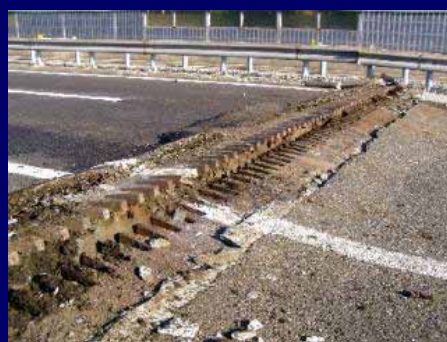
213.9 kp

Gap of bridge joint  
Depression of road shoulder

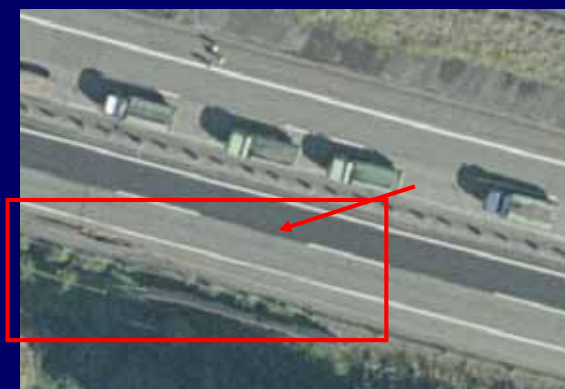
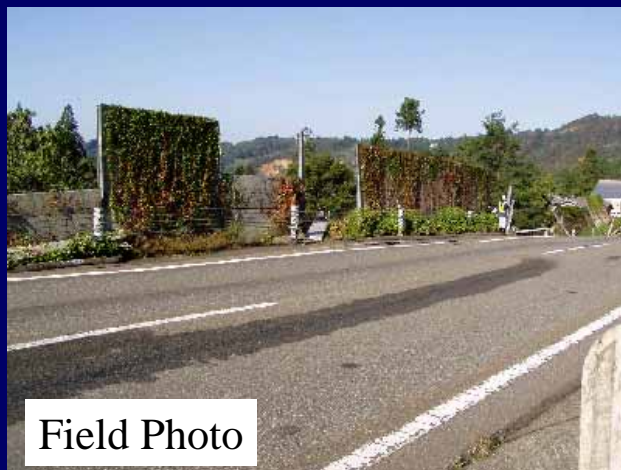
214.9 kp

Depression of road shoulder  
4 panels were fallen down

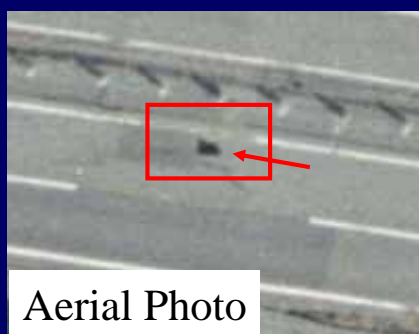
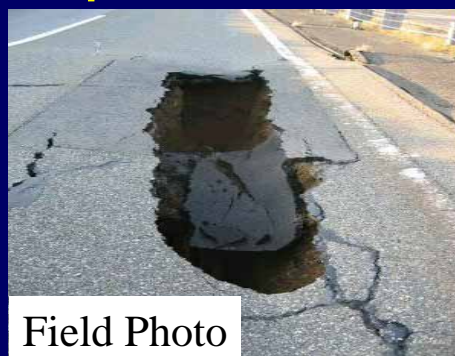
215.2 kp

Depression of road surface

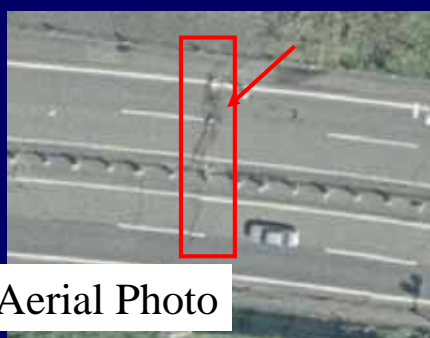
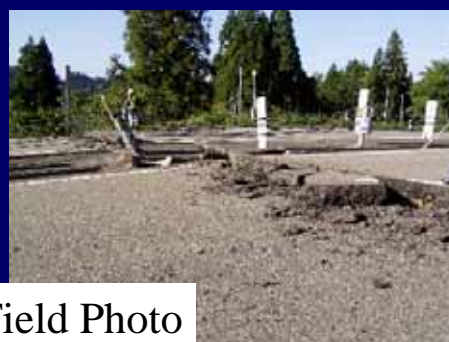
Gap of road surface

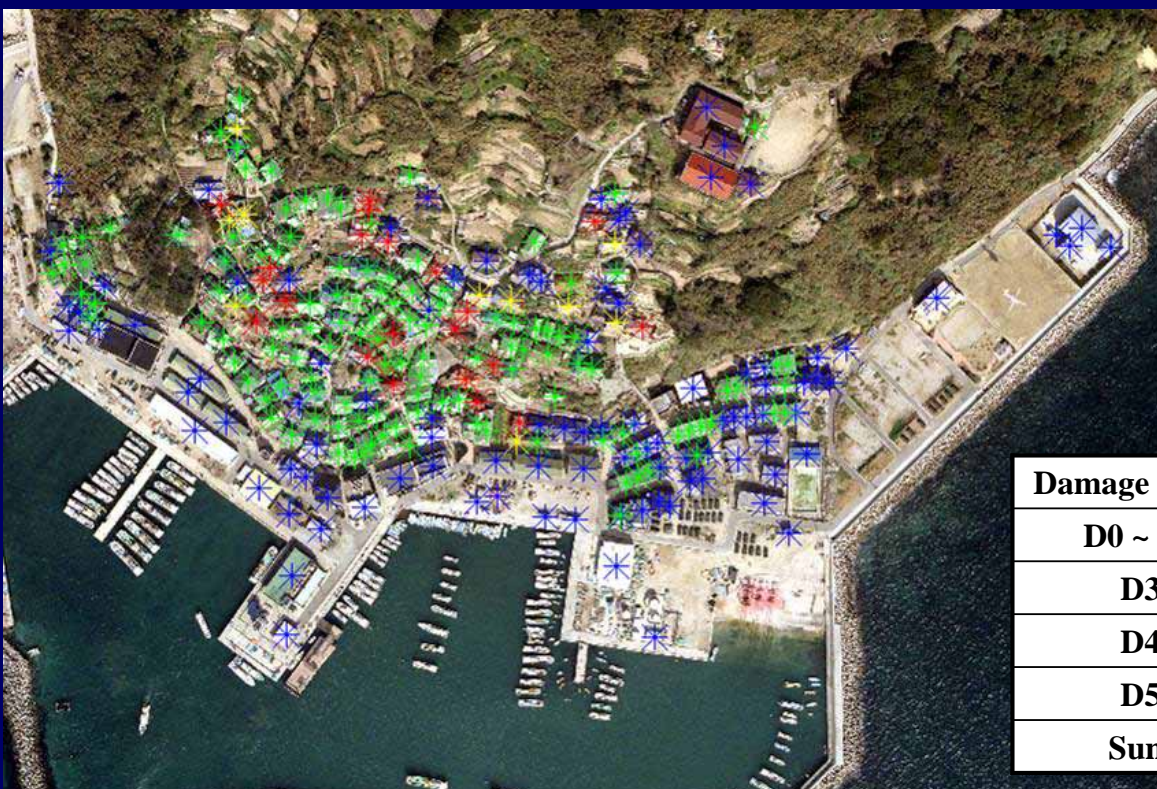
Damage Grade	Number
D0 ~ D2	79
D3	113
D4	8
D5	18
Sum	218
