Evaluation of Tsunami Damage in the Eastern Part of Sri Lanka due to the 2004 Sumatra Earthquake using High-Resolution Satellite Images

Tokyo Institute of Technology

Hiroyuki MIURA, A. Wijeyewickrema and S. Inoue

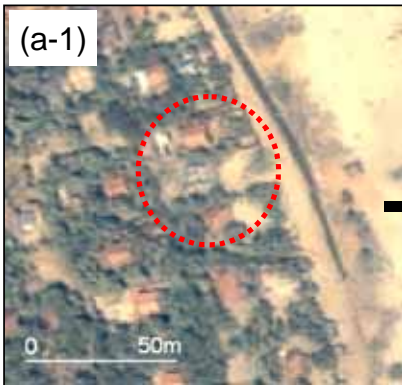
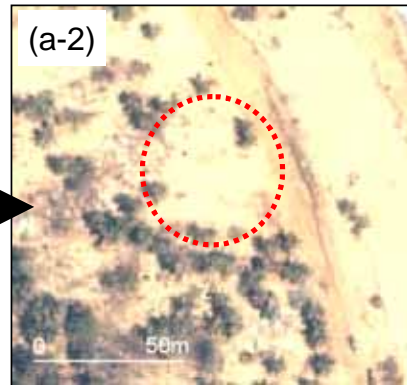
Washed away building

Buildings and vegetation disappear in post-event image.

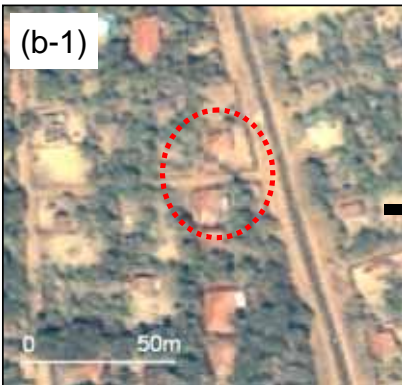
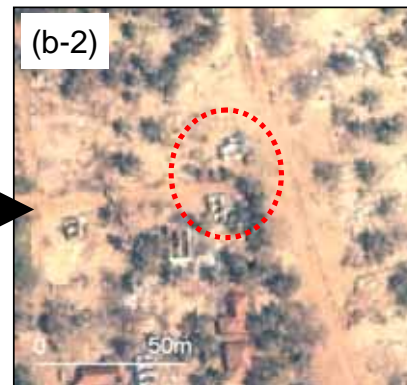
Totally collapsed building
(Grade 5)

Roof and wall are destroyed.
Bottom of buildings is exposed.

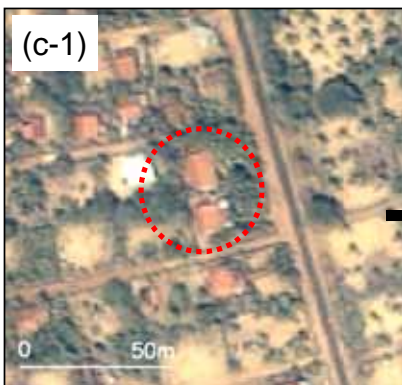
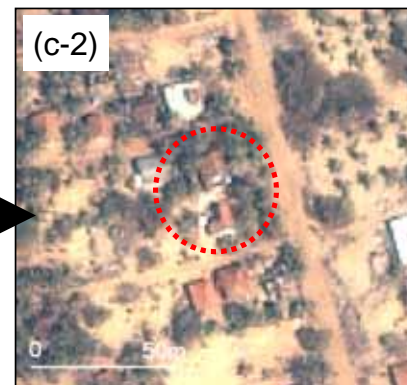
Partially collapsed building
(Grade 4)

Part of building is failed.
Many debris is observed.

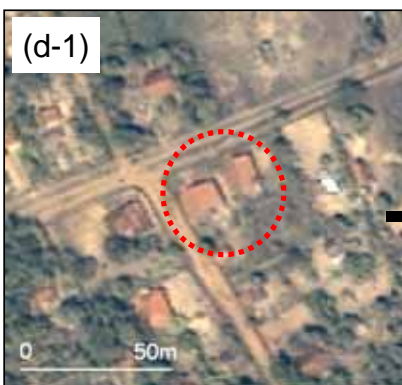
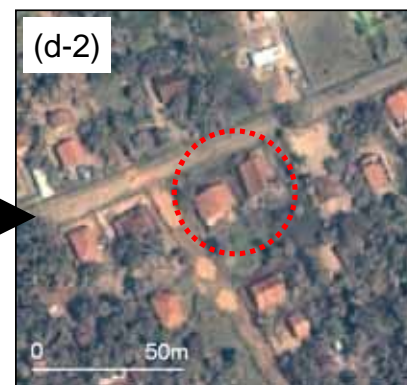
No or slightly damaged building
(Grade 1)

Significant difference is not identified.

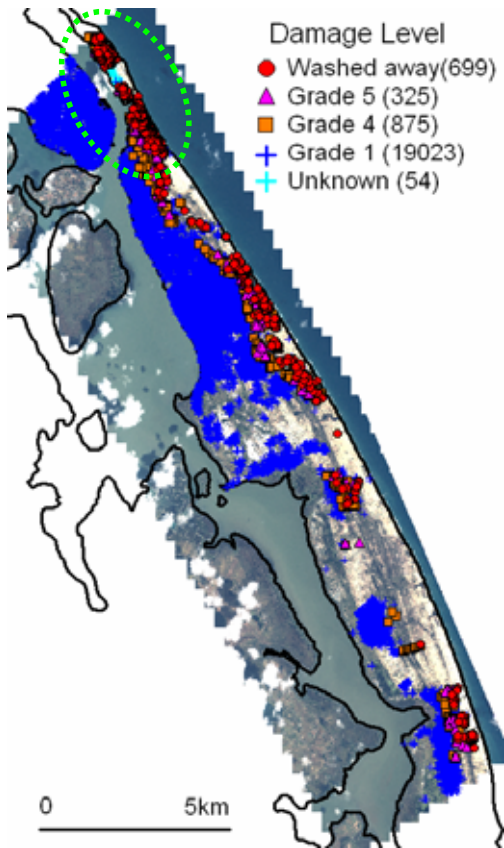
Distribution of Building Damage

- About 10% of buildings are classified into severely damaged buildings.
- Damaged buildings are concentrated in the eastern coastal line.
- The damage is distributed in inland area within 1km distance from coast.
- Severest damage is observed in northern area in which width of land is narrow (dotted circle)

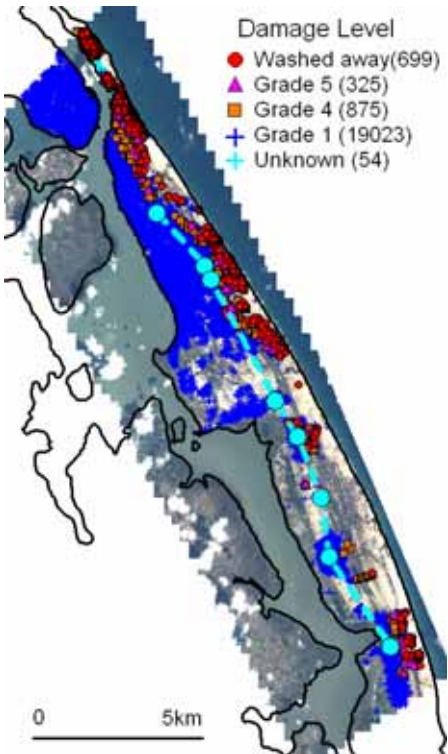
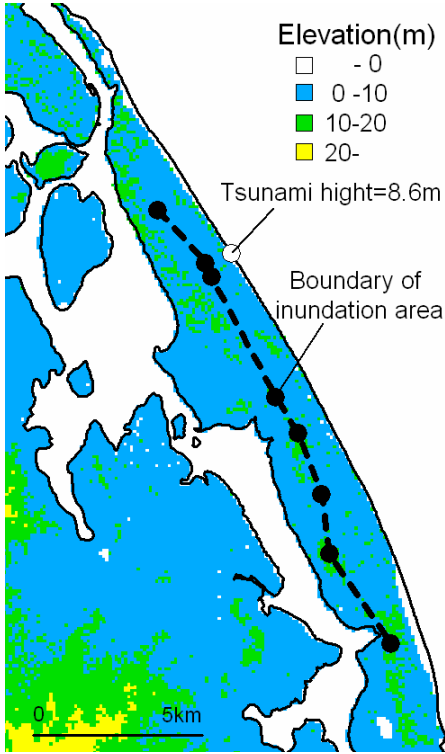
Comparison with Inundation Area

Damaged buildings are distributed in inundation area.
