## Earthquake Damage Detection of Urban Structures using Aerial Photographs

Yoshihisa Maruyama<sup>1</sup>, Fumio Yamazaki<sup>2</sup> and Yoshihisa Yano<sup>3</sup>

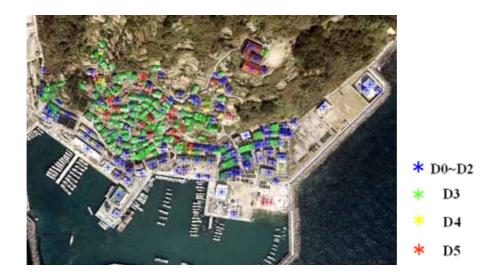
On March 20, 2005, the Fukuoka-ken Seiho-Oki earthquake occurred. An island named Genkai-jima island, which is located near the epicenter, suffered from severe damages, and all inhabitants had to evacuate from the island. The field survey to investigate the damage level of each wooden house was conducted by the authors. The visual damage inspection for wooden houses in this island was conducted using a vertical aerial photograph (Fig. 3). The result of visual damage inspection was verified based on field photos and diagonal aerial photographs (Fig. 4), and our photo interpretation seems to give reasonable accuracy.

Fig. 3 Result of visual damage inspection of Genkai-jima island using a vertical aerial photograph

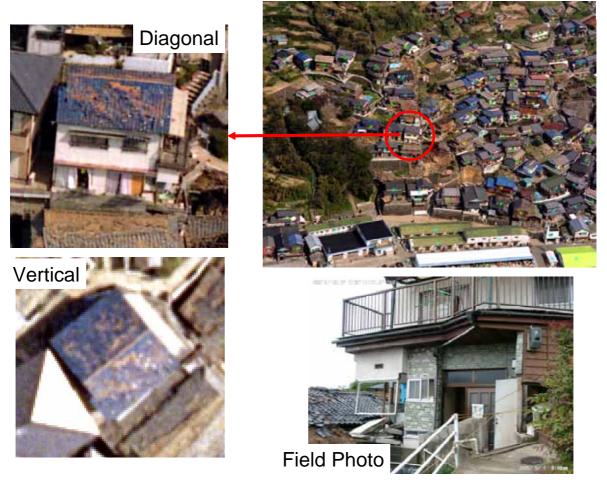
Fig. 4 Verification of visual damage detection using vertical aerial photograph based on diagonal aerial photograph and field photo
