ACCURATE EVALUATION OF BUILDING DAMAGE IN THE 2003 BOUMERDES, ALGERIA EARTHQUAKE FROM QUICKBIRD SATELLITE IMAGES

ABDELGHANI MESLEM*

FUMIO YAMAZAKI and YOSHIHISA MARUYAMA

Accepted 8 October 2010

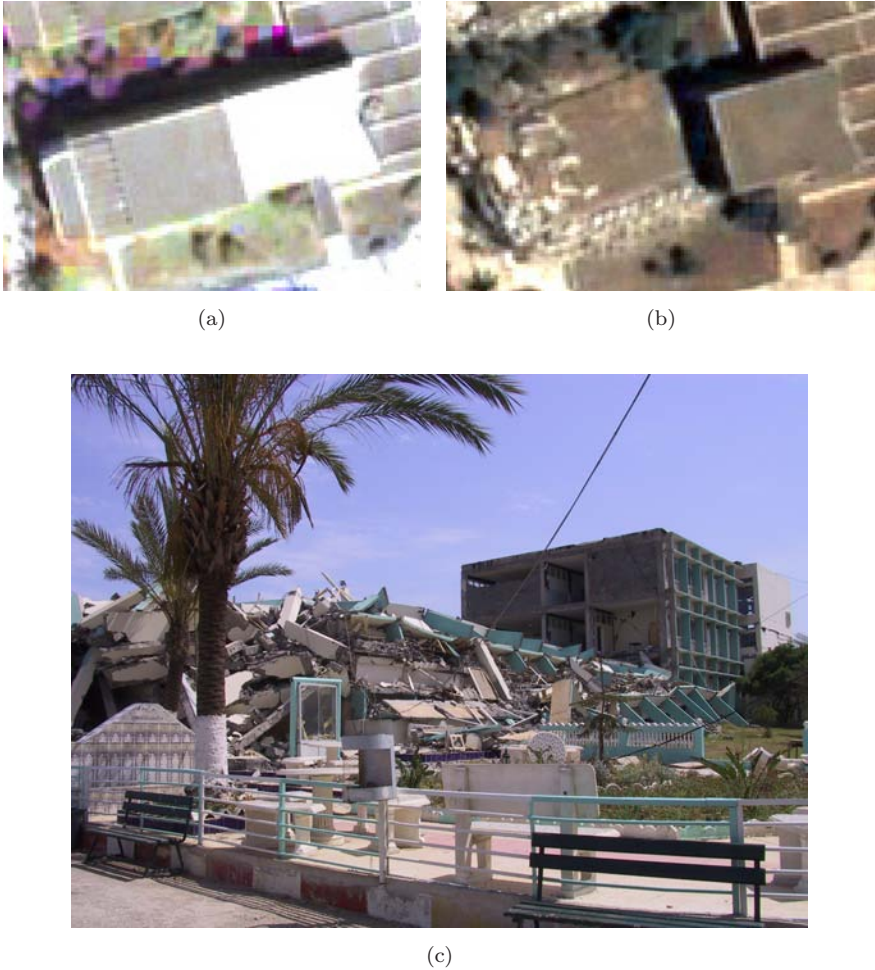
In general, for visual detection from vertical images, the damage can be detected by observing the absence or decrease of shadows, geometric irregularities of contours, and the heterogeneity of the roofs. Accordingly, totally collapsed buildings (Grade 5), partially collapsed buildings (Grade 4), and buildings surrounded by debris (Grade 3) can only be identified from post-event images. An example is shown in Fig. 4, where a building that is totally collapsed and surrounded by debris was easily detected.

Fig. 4. Detection of a totally collapsed building: (a) the preevent QuickBird image, (b) the post-event QuickBird image, and (c) a photograph from the ground.

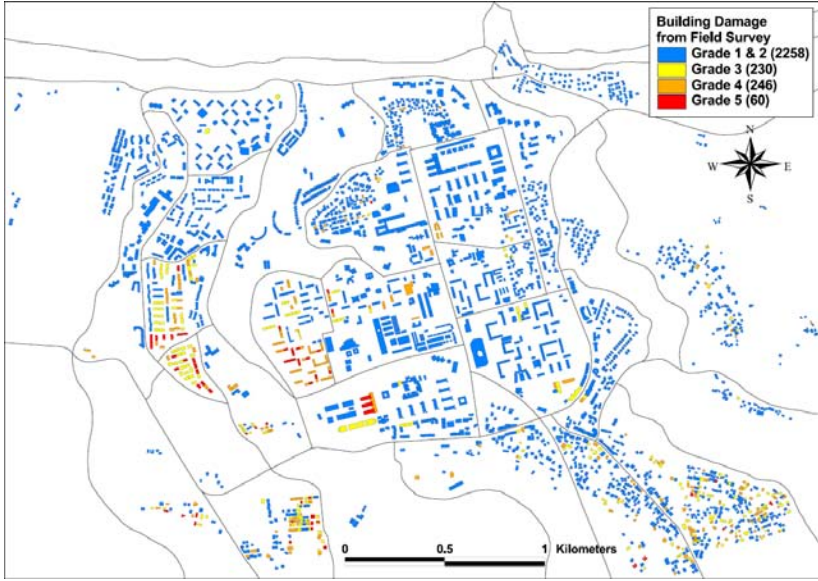
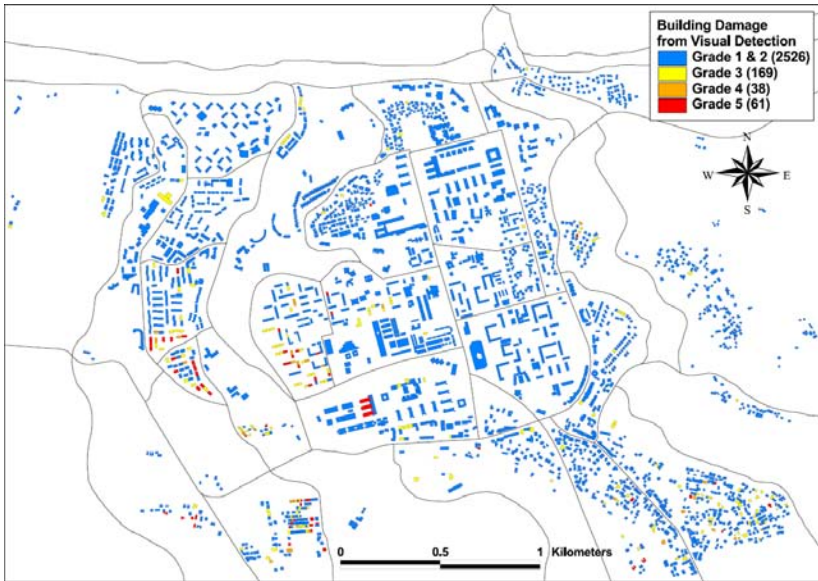
By zone-level mapping, the visual detection results from the QuickBird images are shown to be clearly very close to the ground-truth data from the field survey. In building-level mapping, very heavy damage seems to be localized well from satellite images through visual detection. However, several buildings from the less severe part of Grade 3 were incorrectly judged by visual interpretation, as expected. Figures 6 and 7 show a comparison of damaged building ratios for very heavily damaged and collapsed (Grades 4 and 5) structures between the field survey result and the visual detection result from the satellite images. The damage ratios

Fig. 5. Comparison of GIS damage distribution maps of existing buildings in Boumerdes after the 2003 Algeria earthquake: (a) the map obtained from field survey mission and (b) the map obtained from visual detection using the pre- and post-event QuickBird images.

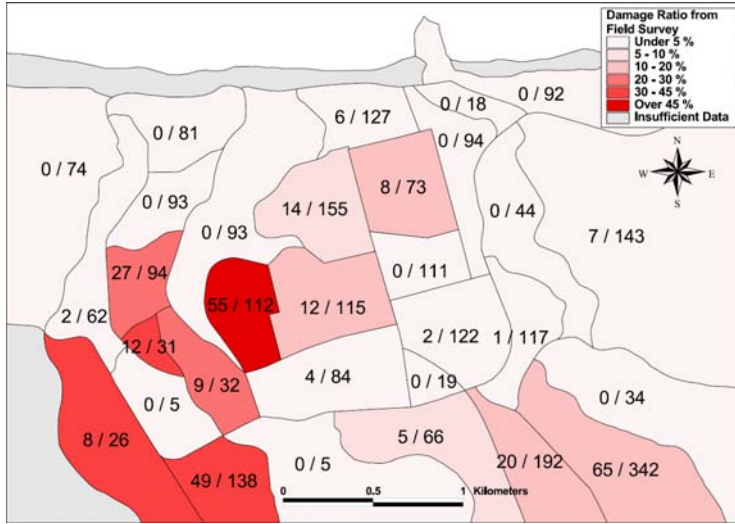
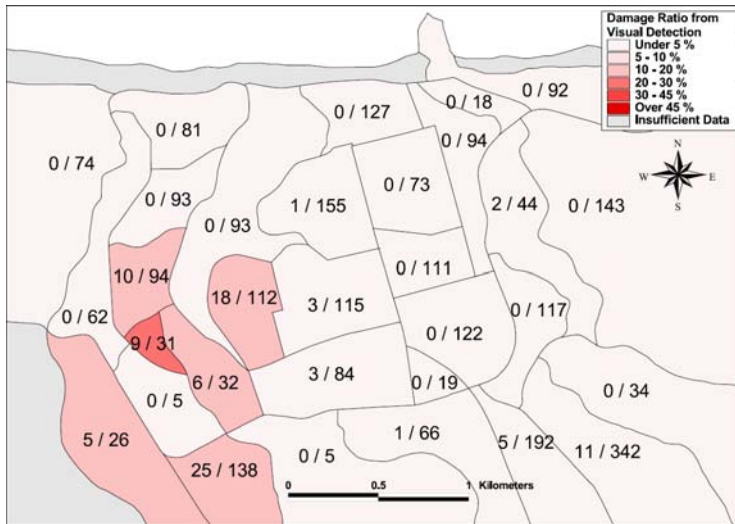
Fig. 6. Building damage ratios of very heavily damaged and collapsed structures (Grades 4–5): (a) field survey results and (b) results of visual detection using the QuickBird images.

based on visual damage detection were underestimated compared with those based on the field survey. This is because some buildings suffering from Grade 4 damage were incorrectly judged by visual detection; this is in contrast to buildings suffering from Grade 5 damage, which generally corresponds to total or partial collapse.

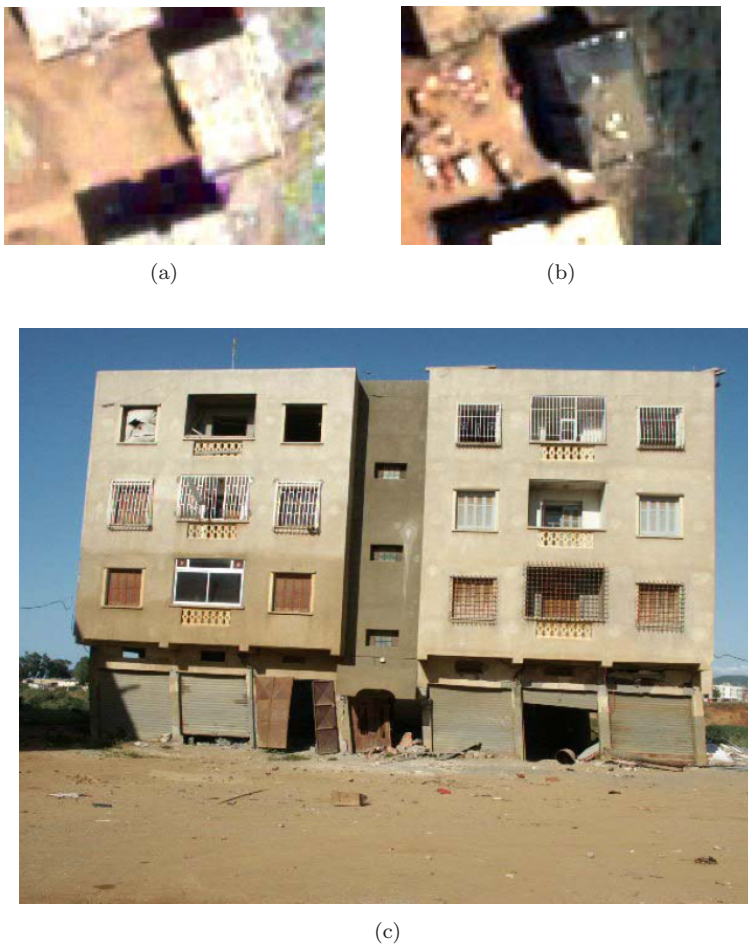
Fig. 9. A 4-story building that suffered from soft-story damage evaluated as Grade 4 from field survey; this structure was incorrectly judged as Grade 1-2 through visual detection from the QuickBird images: (a) the preevent QuickBird image, (b) the post-event QuickBird image, and (c) a photograph from the ground.

Figure 9 shows an example of a 4-story building suffering from soft-story damage classified as Grade 4 by the field survey and incorrectly judged as Grades 1–2 by visual detection.

The presence of soft-story damage due to undersized sections, insufficient longitudinal reinforcement, and weak concrete strength was the most common factor observed for the majority of damaged medium-rise buildings during this earthquake. This type of damage, which was generally judged to be between Grades 3 and 4 in the field survey, is difficult to detect from vertical images, including buildings that suffer from severe internal damage. This observation explains why the percentage of incorrectly judged damage for medium-rise buildings with Grades 3 and 4 is high.

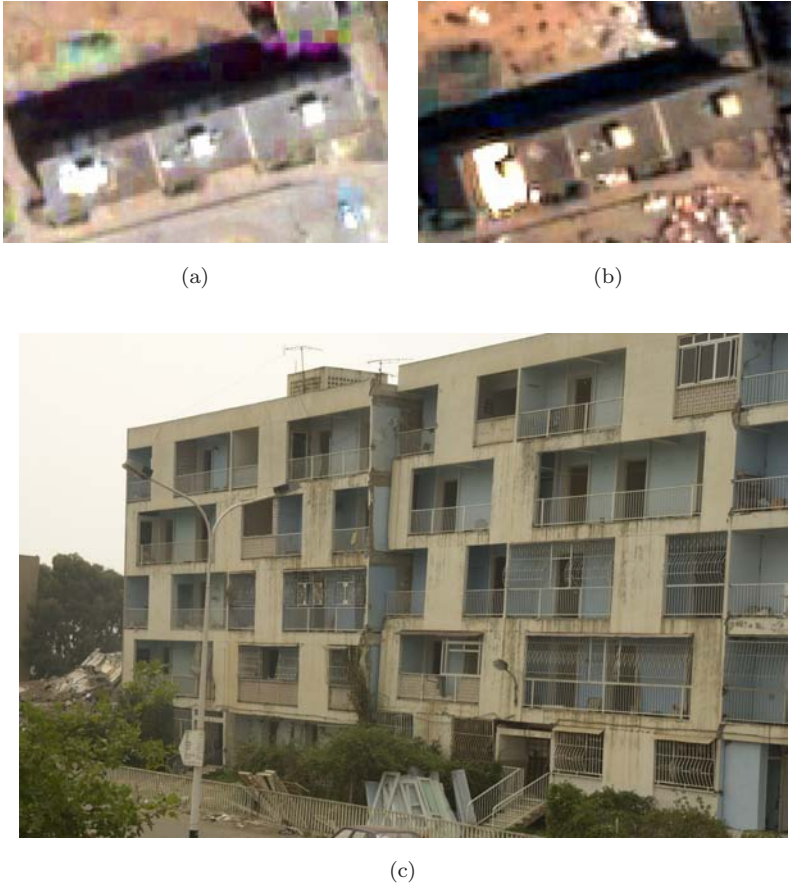
Fig. 10. Damage detection accuracy for a slightly tilted building: (a) the pre-event QuickBird image, (b) the post-event QuickBird image, and (c) a photograph from the ground.

Figure 10 shows another example for a 5-story building that was slightly tilted (Grade 4) by the earthquake, with no surrounding debris; it was incorrectly judged as Grades 1–2 by visual detection even when a preevent image was employed as a reference to judge the damage status. Figure 11 shows the same type of building, but heavily tilted and surrounded by debris; the visual detection accuracy for this structure was good even when only the post-event image was used. However,

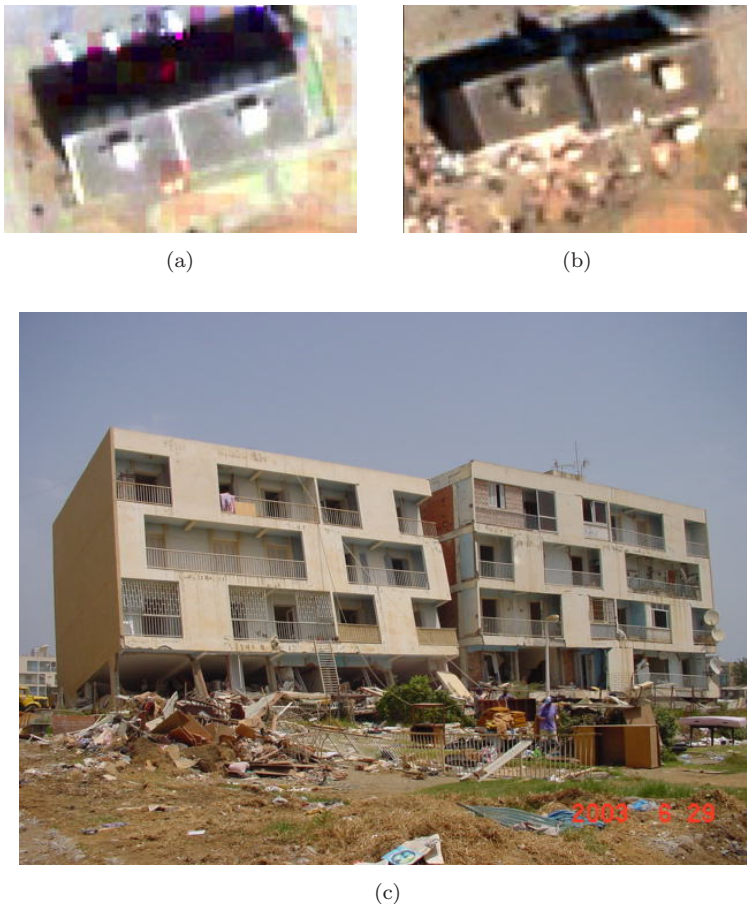
Fig. 11. Damage detection accuracy for a heavily tilted building: (a) the pre-event QuickBird image, (b) the post-event QuickBird image, and (c) a photograph from the ground.

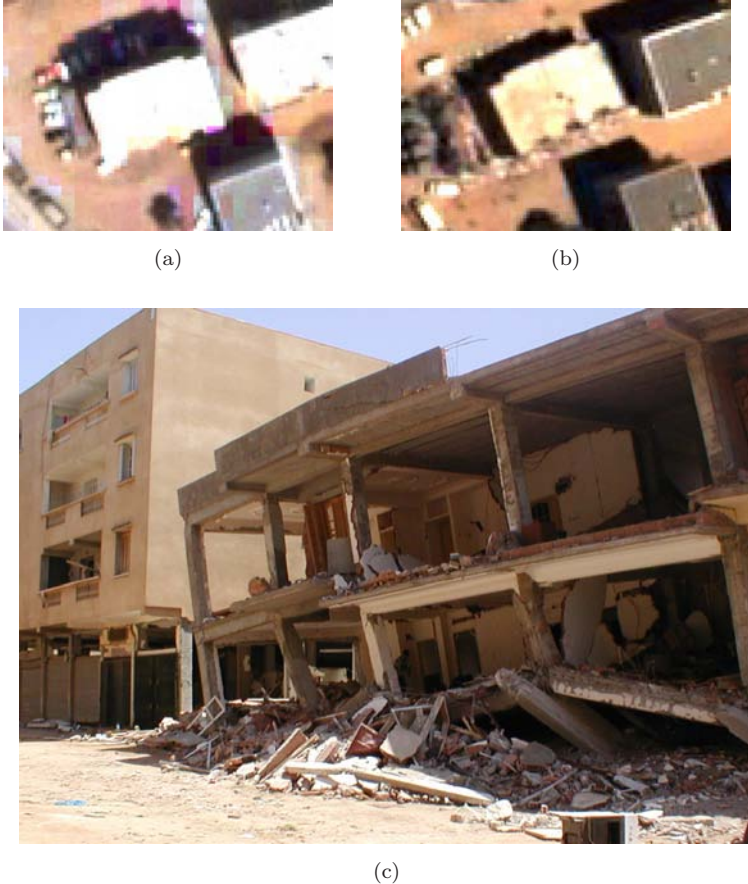
Fig. 12. A case where heavy damage may be difficult to see using only the post-event image; debris surrounding the buildings is hidden by shadow: (a) the preevent QuickBird image, (b) the post-event QuickBird image, and (c) a photograph from the ground.

for some buildings suffering from heavy damage and surrounded by debris, it was difficult to detect damage using only post-event images since the debris was hidden by shadows, as shown in Fig. 12. Studies on the effects of cast-shadows in high-resolution satellite imagery and on the trials to reproduce shadow-free images
