# The Effects of Building Characteristics and Site Conditions on the Damage Distribution in Boumerdès after the 2003 Algeria Earthquake

Abdelghani Meslem,<sup>a)</sup> Fumio Yamazaki,<sup>a)</sup> Yoshihisa Maruyama,<sup>a)</sup> Djillali Benouar,<sup>b)</sup> Abderrahmane Kibboua,<sup>c)</sup> and Youcef Mehani<sup>c)</sup>

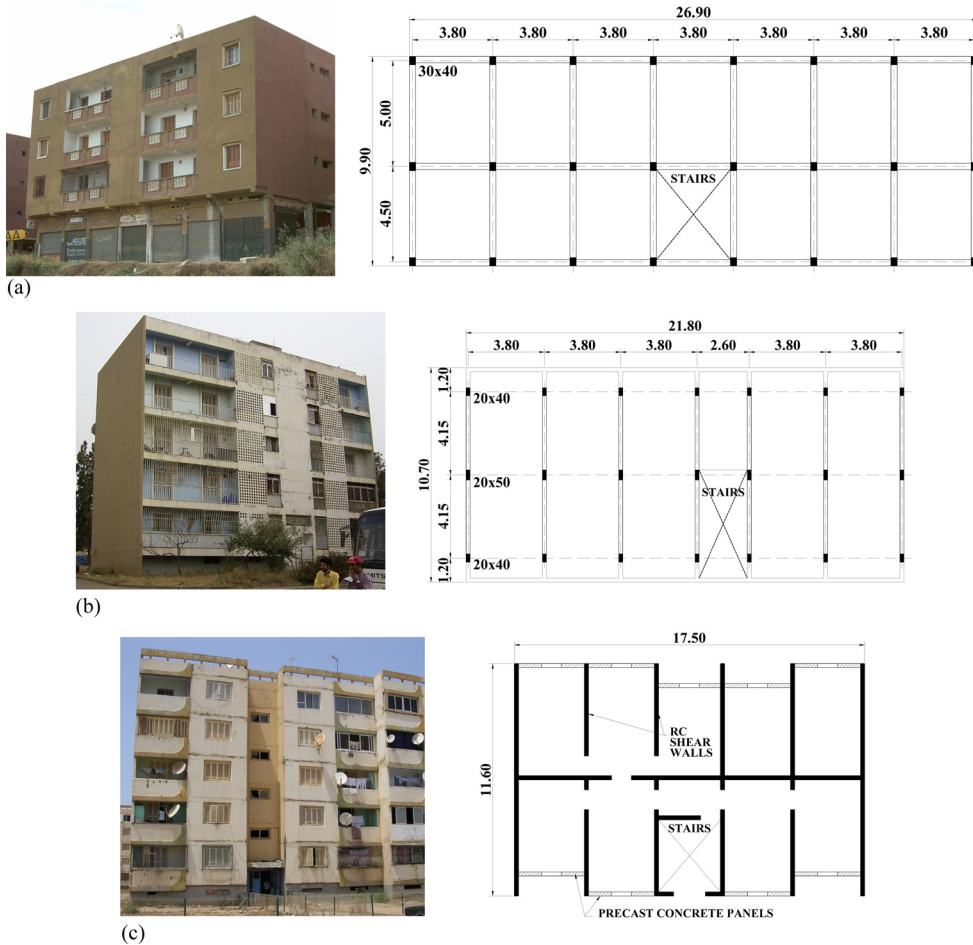
**Figure 4.** Photographs and plan views of reinforced concrete (RC) systems (moment-frame and shear-wall systems) in Boumerdès. (For Zones 1A, 1B, and 2, see Figure 6): (a) RC moment-frame system for a four-story building built in Zone 1A in 1996, (b) RC moment-frame system for a five-story building built in Zone 1B in 1970, and (c) RC shear-wall system for a five-story building built in Zone 2 in 1986.

several mid-rise (four-story) RC moment-frame buildings (Figure 4a shows details of the plan view for this category of buildings in Zones 1A) suffering heavy damage or collapsing. In Zone 1B, the H/V ratios showed smoothed peaks estimated to be in the range of 0.8 to 1.25 s. In this zone, a significant number of mid-rise (five-story) RC moment-frame buildings collapsed and others were heavily damaged (Figure 4b shows details of the plan view for this category of buildings in Zones 1B). The natural period measured for several buildings in this class showed values ranging between 0.28 and 0.35 s (Dunand et al. 2004); these values are quite different to the estimated soil period range. The existing soil conditions report, dated from 1970 (Scandinavian Engineering Corporation 1970), states that in this part of city, which includes Zones 1A and 1B, the geological layers are composed of granulitic mica schist formations (hard soil) as the base, which can be seen on the surface in some locations in Zone 1A. These formations are overlain by preconsolidated lower Pliocene marl (hard-to-stiff soil).

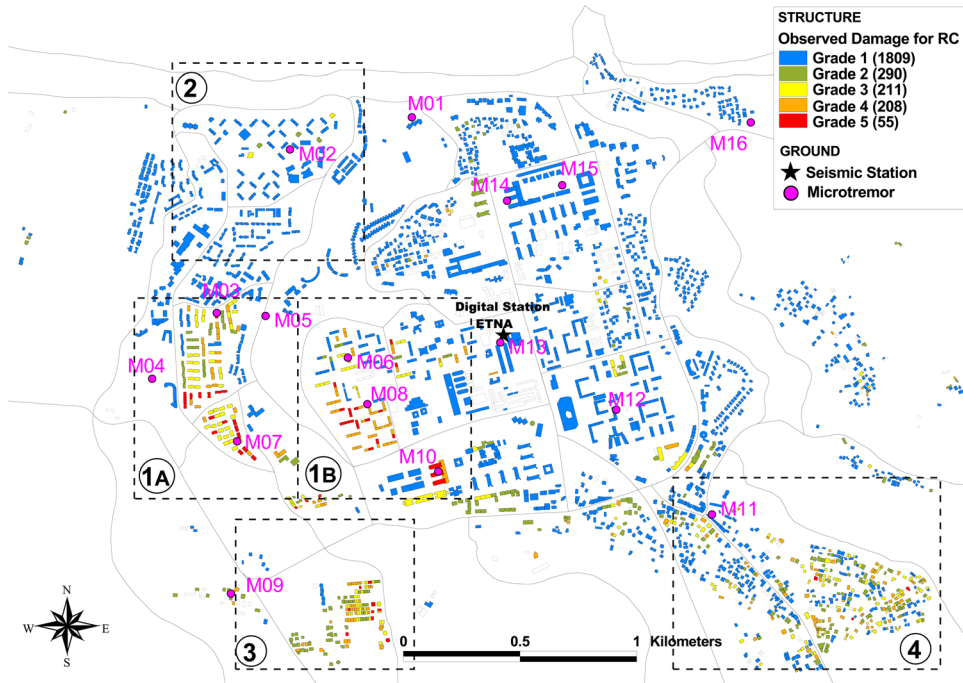
**Figure 6.** GIS damage distribution map of RC structures in Boumerdès after the 2003 Algeria earthquake, including the locations of microtremor measurements on the ground surface. The star indicates the location of the seismic station (digital station ETNA). B1 and B2 are two three-story RC buildings that have the same structural configuration and are located within 1 km of each other (see Figure 11).

The damage distribution (Figure 6) shows that in the southwestern part of the city (Zones 1A and 1B), where most of the buildings were of mid-rise height (Figure 5), the damage was extensive. There were very few low-rise buildings and almost no high-rise buildings in this area. From Figure 8 it can be clearly seen that there was a higher rate of damage for mid-rise buildings as compared to low-rise and high-rise buildings. Furthermore, not far from Zone 1, in Zone 3, in the southwestern part of the city, where the majority of the buildings were newly built three-story houses, the damage was also extensive. In contrast, in Zone 4, in the southeastern part of the urbanized area, where almost all the existing buildings were single, nonengineered, one- to three-story houses (Figure 5), only some

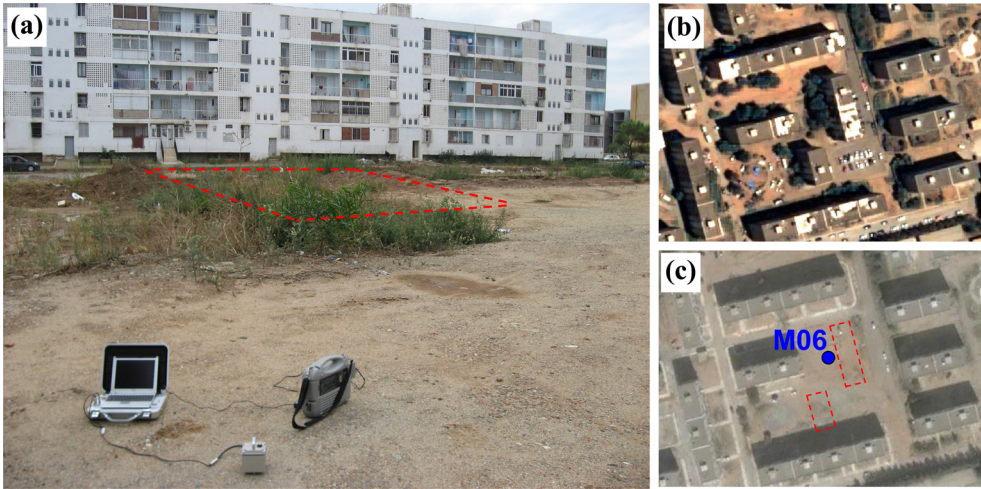
**Figure 7.** Example of microtremor measurement at locations of heavily damaged buildings in the city of Boumerdès: (a) photograph showing location of removed building (red dashed line) and location of portable microtremor equipment (GEODAS and sensor) used for data acquisition at M06, (b) QuickBird image (23 May 2003) showing damaged buildings, and (c) image from Google (20 March 2006) showing removed buildings (red dashed line) and location of microtremor measurements (M06).

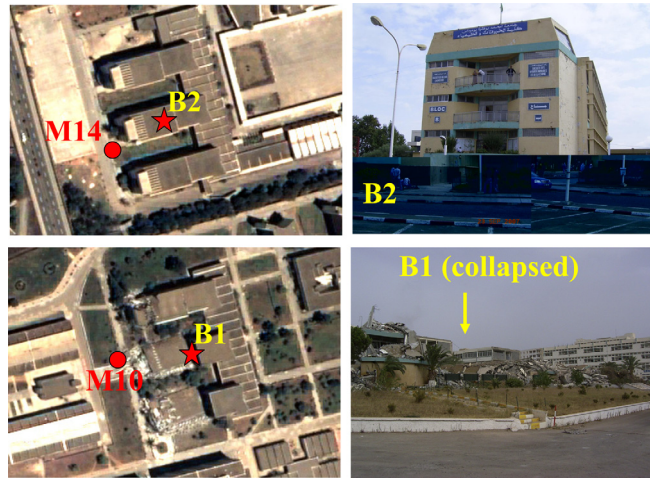
As a case study, we selected two three-story RC buildings, B1 and B2 (Figure 11), that have the same structural configurations but are located on two different campuses of the University of Boumerdès within around 1 km of each other (Figure 6). Building B1, located

on the south campus within Zone 1B, collapsed completely during the earthquake. Building B2, located on the north campus, did not suffer any damage. A comparison of the H/V ratios of microtremor measurements close to Building B1, the one that collapsed, at position M10 (Figure 12a), with those measured close to Building B2, the undamaged building, at position M14 (Figure 12b), shows no clear difference with regard to the effects of

**Figure 11.** Example of two three-story RC buildings with the same structural characteristics located in two different zones in Boumerdès within approximately 1 km of each other (see Figure 6). B1 is located on the south campus of Boumerdès University, whereas B2 is located on the north campus.

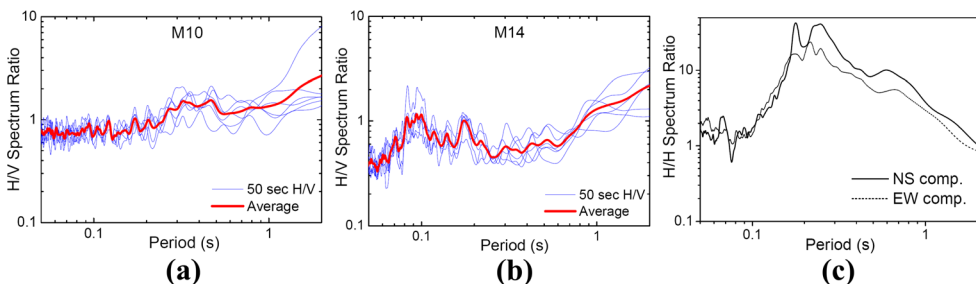
amplification and no clear peaks in the H/V curves. In fact, microtremor measurements between Building B2 and the soil of position M14 were conducted simultaneously to ensure the consistency of the measurements and to identify the natural period of the building and the predominant period of the soil layers. The computed H/H Fourier spectral ratio between Building B2 and the ground surface of M14 (Figure 12c) shows an expected predominant period of around 0.2 s, which is the fundamental period for a three-story building.

**Figure 12.** Analysis of possible amplification effect for three-story RC buildings: (a) measured H/V ratio on the ground surface where B1 collapsed, (b) measured H/V ratio on the ground surface close to B2, and (c) H/H Fourier spectral ratio between building B2 and ground surface M14.

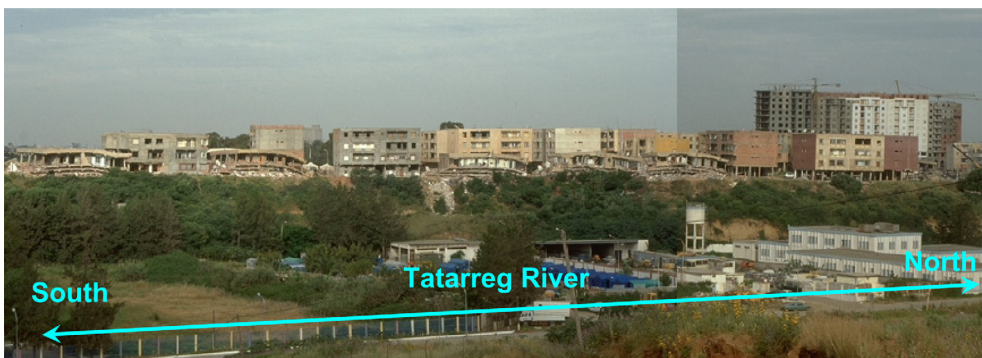
**Figure 16.** Photograph showing the damage to buildings located on hilltops in Zone 1A along Tatarreg River valley (see Figure 15). It can also be seen that the buildings located very close to the scarp edge collapsed totally, while those located some distance away from the scarp edge were only partially collapsed or suffered extensive damage to their structural elements, columns, and beams.

in Boumerdès. In the western part of the city, almost all the buildings that suffered heavy damage were mid-rise RC moment-frame structures, mostly four- to five-story buildings in Zones 1A and 1B and three-story houses in Zone 3, which suggests that these building types had fundamental period values close to each other, and also close to the period of amplification created under the effects of hilltops and steep slopes along the Tatarreg River valley. Figure 4a shows a typical four-story RC moment-frame building in Zone 1A that was built in 1996. Figure 4b shows a typical five-story RC moment-frame building in Zone 1B, which was built by the same contractor in the 1970s.

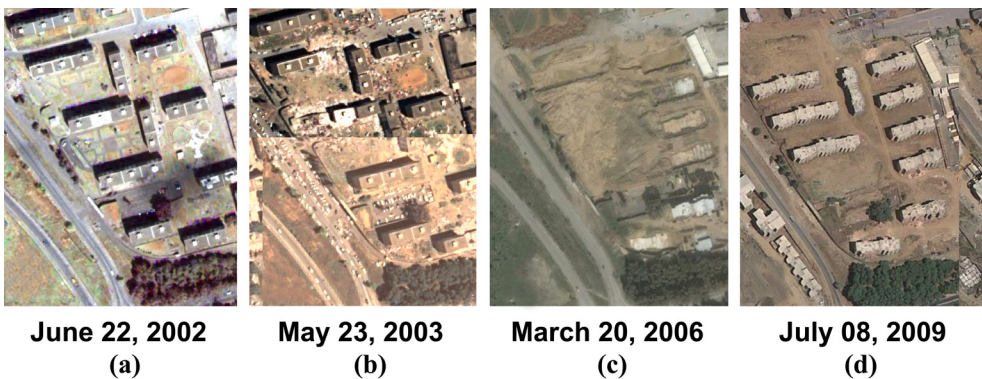
**Figure 20.** New mid-rise RC shear-wall buildings were recently built on the same site as old mid-rise RC moment-frame buildings that collapsed in the earthquake. They are located in Zone 1B on hilltops along Tatarreg River valley (see Figure 15): (a) QuickBird image of the mid-rise RC moment-frame buildings before the earthquake, (b) QuickBird image of the collapsed mid-rise RC moment-frame buildings after the earthquake, (c) Google image of the site of the collapsed mid-rise RC moment-frame buildings after they were removed, and (d) Google image of the new mid-rise RC shear-wall buildings built at the same location.
