## **SPATIAL DISTRIBUTION OF DAMAGES TO BURIED PIPES FOLLOWING THE 2007 NIIGATA-KEN CHUETSU-OKI, JAPAN, EARTHQUAKE**

K. Kimishima<sup>1</sup>, Y. Maruyama<sup>2</sup> and F. Yamazaki<sup>3</sup>

### **ABSTRACT**

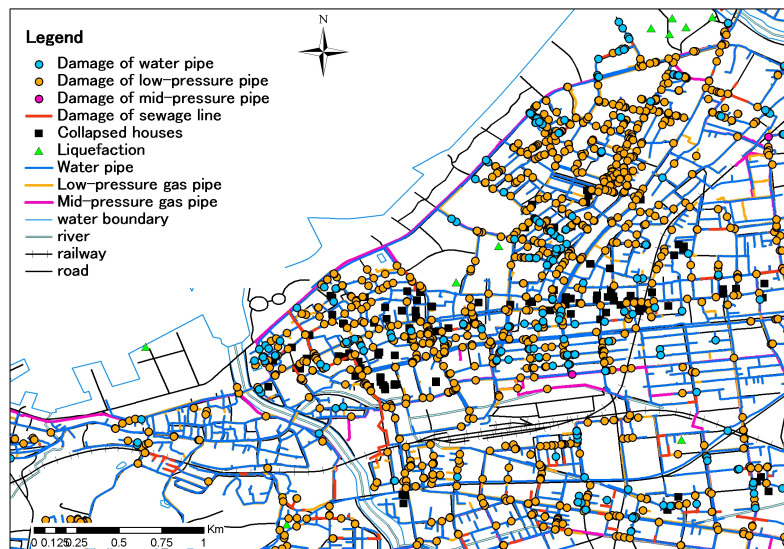
Figure 1. Damage datasets due to the 2007 Niigata-ken Chuetsu-oki earthquake

Damage datasets used in this study are shown in Table 1. The datasets include the locations of breaks/leaks of water, gas, and sewage lines, and those of collapsed houses. Liquefaction occurrences were also detected by visual inspection using aerial images from Pasco Co., Ltd. The Digital Map 2500 (Spatial Data Framework), developed by the Geographical Survey Institute of Japan (2002), was used as a base map. The various datasets integrated on GIS are shown in Fig. 1.

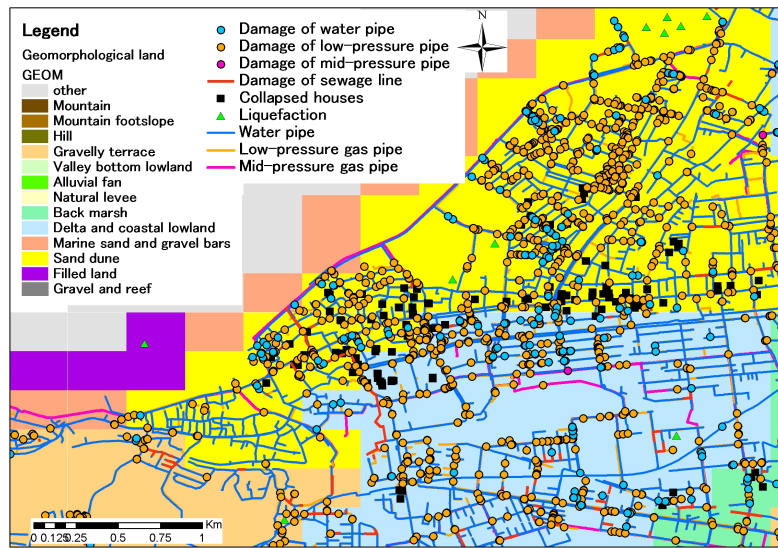
Fig. 2 shows the distribution of damages to lifeline systems plotted on the geomorphological land classification. The geomorphological land classification dataset used in this study is a nationwide digital map constructed by Wakamatsu *et al.* (2006). According to this classification map, the central part of Kashiwazaki City is mainly classified as *sand dune*, *delta and coastal lowland*, and *back marsh*. The damage ratios of water, low-pressure gas, and mid-pressure gas pipes with respect to the geographical land classification are shown in Fig. 3(a). The damage ratio of the sewage system is plotted in Fig. 3(b).

Figure 2. Damages to lifeline systems in Kashiwazaki and geographical land classifications.

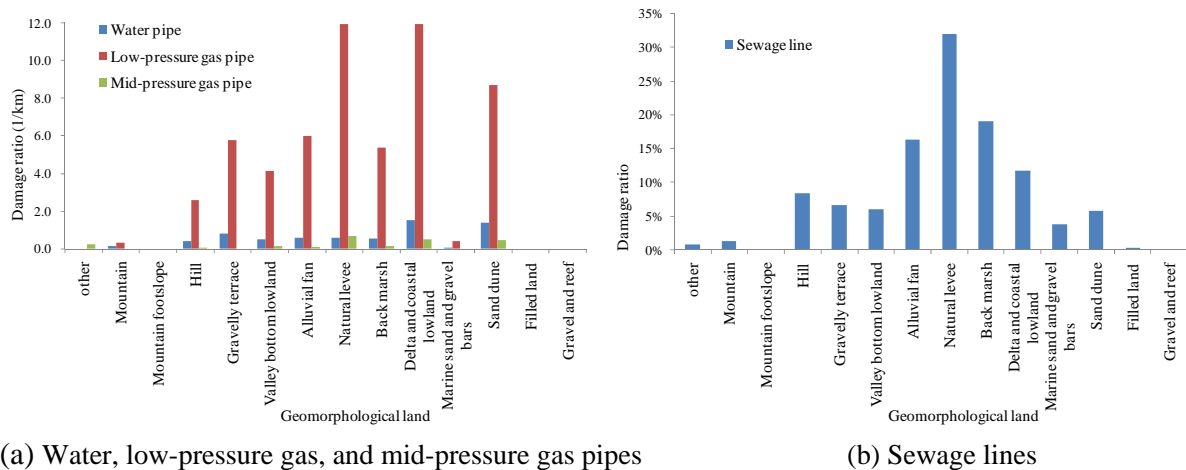
The damage ratio of water distribution pipes is the highest in *delta and coastal lowland* areas (1.48), followed by *sand dune* (1.35). Similarly, the damage ratio of low-pressure gas pipes

Figure 3. Damage ratios of lifelines with respect to geographical land classifications.

is the highest in *delta and coastal lowland* (11.93), followed by *natural levee* (11.92). As for the water and low-pressure gas pipes, the damage ratios are high for the geographical classes, which mainly consist of soft soil. The damage ratio of mid-pressure gas pipes is the highest in *natural levee* (0.65) and the second highest in *delta and coastal lowland* (0.47). The damage ratio of sewage lines is the highest in *natural levee* (32%) while it is 19% in *delta and coastal lowland*. As for the mid-pressure gas pipes and sewage lines, the damage ratios are high in *natural levee* and *delta and coastal lowland*.

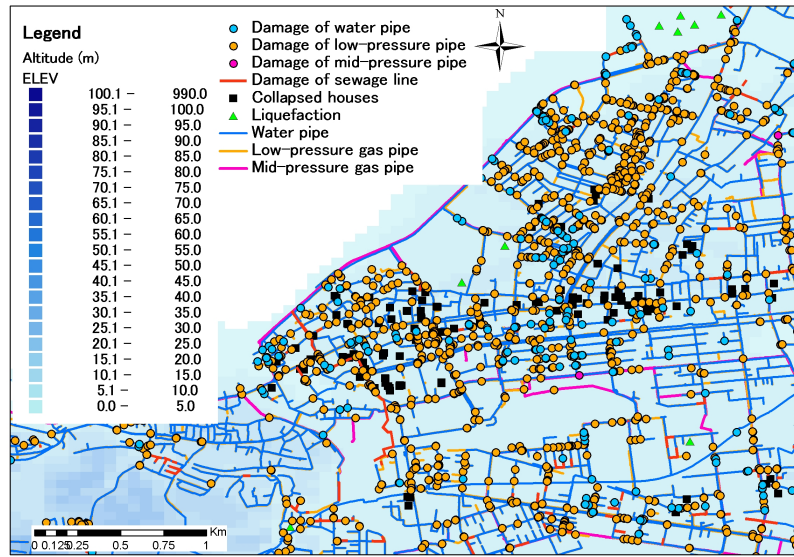
Fig. 4 shows the location of damage incidents (breaks/leaks) of lifeline systems and the altitude model, which was developed by the Geographical Survey Institute of Japan (2001). The altitude is shown in 50 x 50 m<sup>2</sup> grid cells. The damage ratios of water, low-pressure gas and mid-

Figure 4. Relationship between the altitude class and lifeline damage

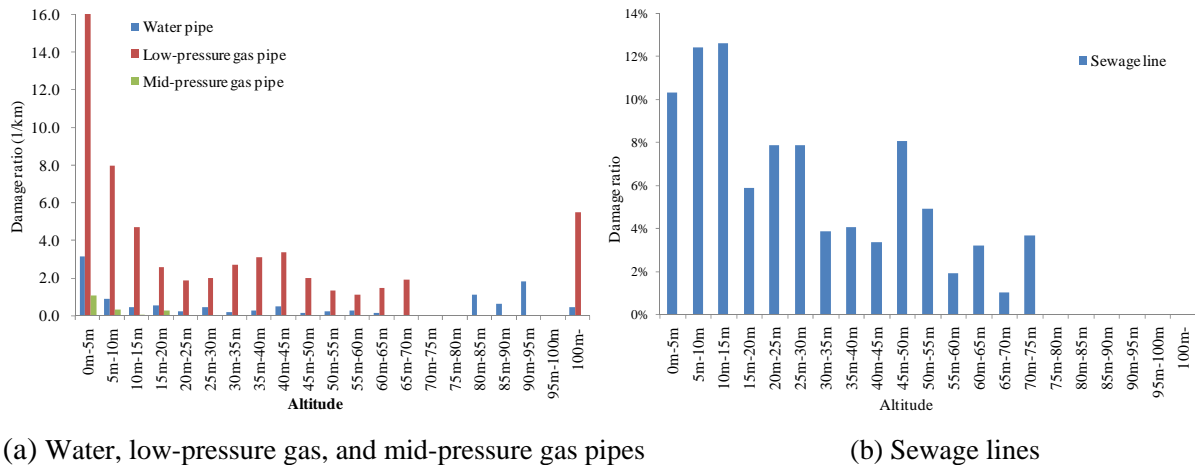
(a) Water, low-pressure gas, and mid-pressure gas pipes

(b) Sewage lines

Figure 5. Damage ratios of lifelines with respect to the altitude class

pressure gas pipes with respect to the altitude are shown in Fig. 5(a) and that of sewage lines is shown in Fig. 5(b).

The damage ratios of water, low-pressure gas and mid-pressure gas pipes are the highest for altitude class 0-5 m. The damage ratio of sewage lines is the highest when the altitude is 10-15 m. The damage ratio is still in high values for the altitude 0-10 m. As for water, low-pressure gas, and mid-pressure gas pipes, no notable difference is seen in the trend of the damage ratios of the three buried pipes.
