FIELD SURVEY OF THE 2010 TSUNAMI IN CHILE

Abstract: We conducted the field survey of the tsunami generated by the M8.8 great earthquake in Chile triggered on 27 February 2010 (UTC). The survey focused on the measurements of tsunami inundation/run-up height, flow depth, extent of inundation zone, structural damage inspection, and collecting eyewitness accounts. In total, tsunami heights and flow depths at approximately 155 points were measured along the coast of Biobio region, Chile, to understand the tsunami features during this event.

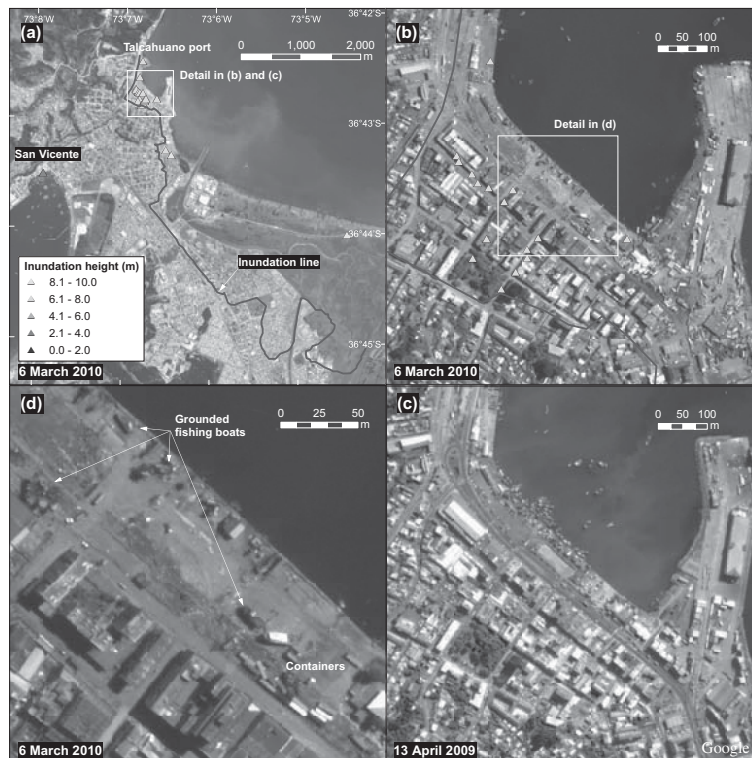
Figure. 5 represents the result of tsunami inundation height measurement in Talcahuano. The tsunami penetrated approximately 300 m inland in the port-town area and more than 1 km in the southern coastal marsh. Tsunami inundation reached to 6-8 m in port-town area and 10 m in the coastal marsh. This figure also shows the comparison of pre and post event satellite images in Talcahuano port (Figures. 5(b), (c)). Significant amount of containers and fishing boats were left as tsunami debris, which caused long duration of failure of port and harbor facilities. While the tsunami left considerable damage to the town of Talcahuano (eastern bottom of the bay), no damage was found in the western port area (San Vicente). The measured tsunami run-up height in San Vicente was 3.4 m (Figure. 5(a)).

According to the interview with eyewitness, the tsunami slightly overtopped the dock of the harbor but did not inundate out of the port. Possible causes of this discrepancy may be local effect of tsunami source mechanisms and the condition of harbor oscillation related to the size and shape of the bay.

Figure 5 (a) Result of tsunami height measurement in Talcahuano. The red line indicates the extent of inundation zone which was obtained by the interview with CATOE (Centro de Alertamiento Temprano y Oficina de Emergencia). (b) Damage in Talcahuano found in the post-event satellite image (WorldView-2). (c) Satellite image of Talcahuano before the tsunami attack (13 April 2009, from Google) (d) Close-up view of port of Talcahuano. Grounded fishing boats and drifted containers were seen.

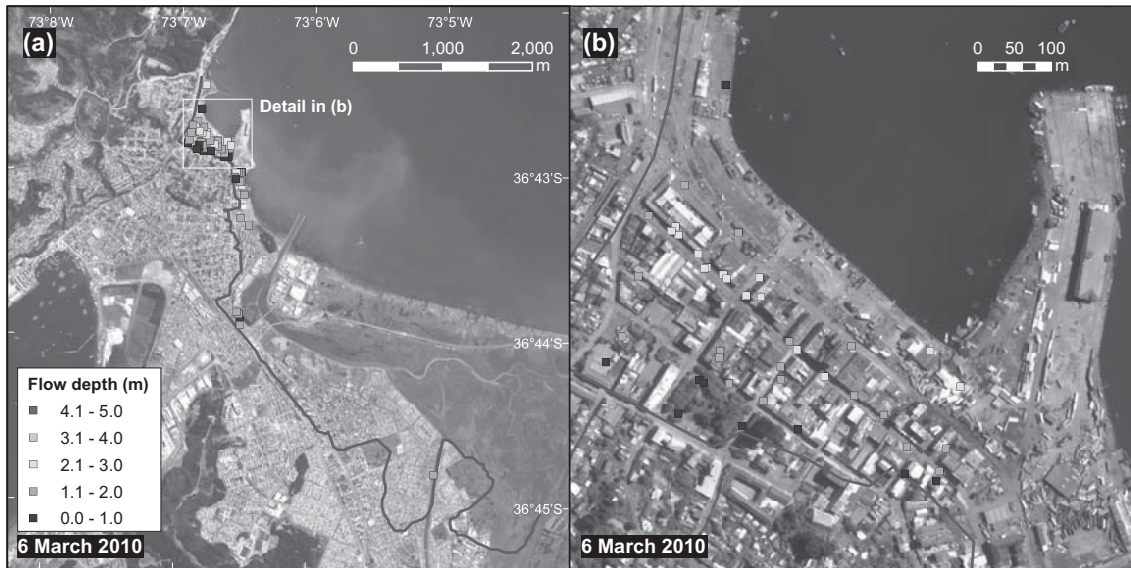
In the town of Talcahuano, the tsunami penetrated with up to 2-3 m of flow depth (Figure. 6). After inspecting the structural damage in the town, some washed-away structures were found, but it was limited within the port facilities (north-west) and industrial area (south-west). Most of the structural damage in the town was likely to be caused by ground shaking, but minor damage, e.g. bending shutters of commercial buildings and broken windows.

Figure 6 Result of tsunami flow depth measurement in the town of Talcahuano. The tsunami penetrated approximately 100 m inland with the flow depth of up to 2-3 m.

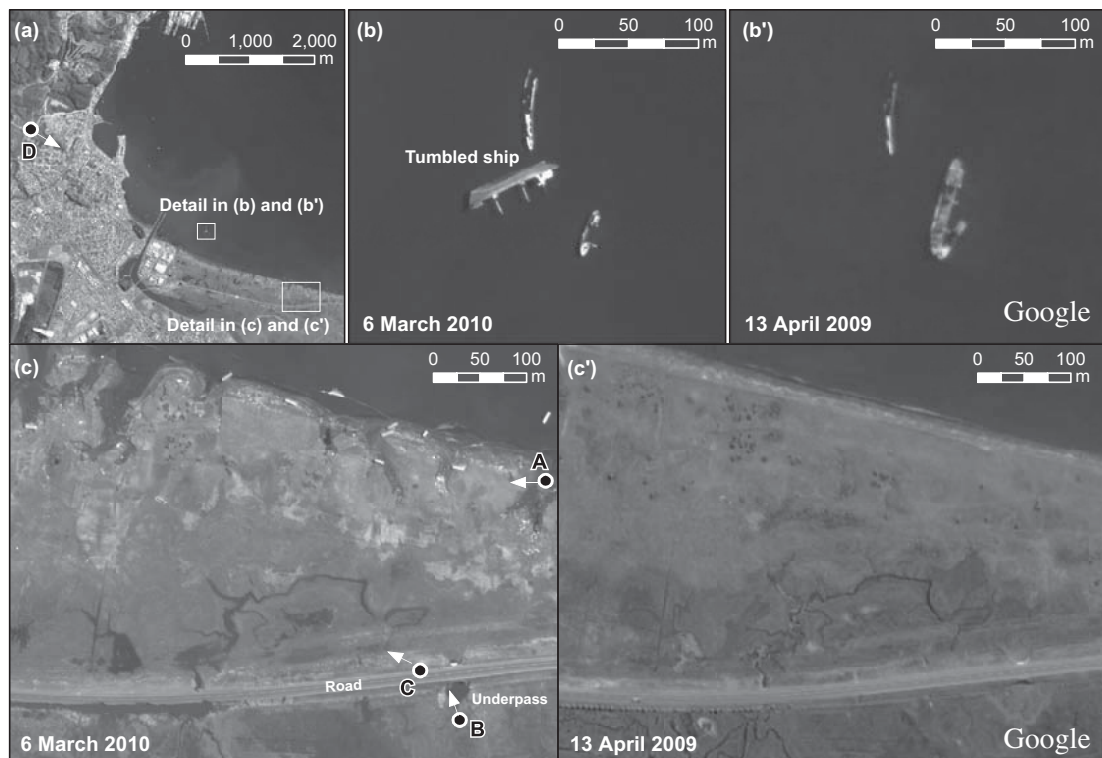
Inspecting pre and post event satellite images and ground photos helps to understand multi aspects of tsunami disaster. Figure. 7 is the comparison of pre and post event satellite images in Talcahuano. We acquired the pre-tsunami image from GoogleEarth (QuickBird image taken on 13 April, 2009), and used WorldView-2 pan-sharpened composite image as post-tsunami image. From post-tsunami image and field survey, we found the tumbled ship at the west of waterway in Talcahuano bay that has been stably stood in the bay (even though it was not in use). In the coastal marsh, considerable changes of shoreline and tsunami debris are seen in the satellite images, and it was found from the ground photos (Figure. 8) that the coastal

Figure 7 Pre and post event satellite images in Talcahuano. Points A to D represent the position of ground photos taken by the authors (Figure 8). White arrow is approximate direction of the camera focus. (a) Overview of Talcahuano port. (b) and (b') A 70m-long tumbled ship found the east of waterway. (c) and (c') Considerable change of coastline and drifted containers in the coastal marsh.

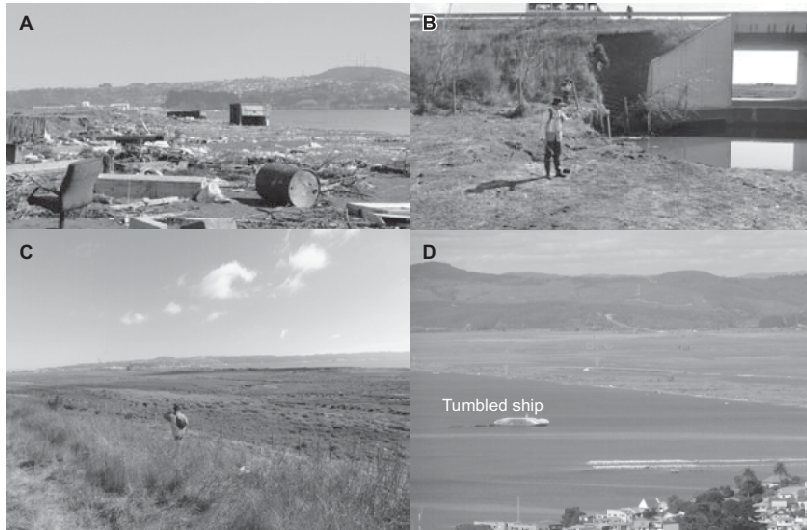
sand were eroded by inland penetration of tsunami.

Figure 8 Ground photos in Talcahuano taken by the authors. Each point is identified in Figure 7. A : Tsunami debris and drifted containers in the coastal marsh. B : Erosion by the tsunami inundation found at the underpass. C : Overview of the coastal marsh inundated by the tsunami. D : Panoramic view of the coastal marsh from the hill.

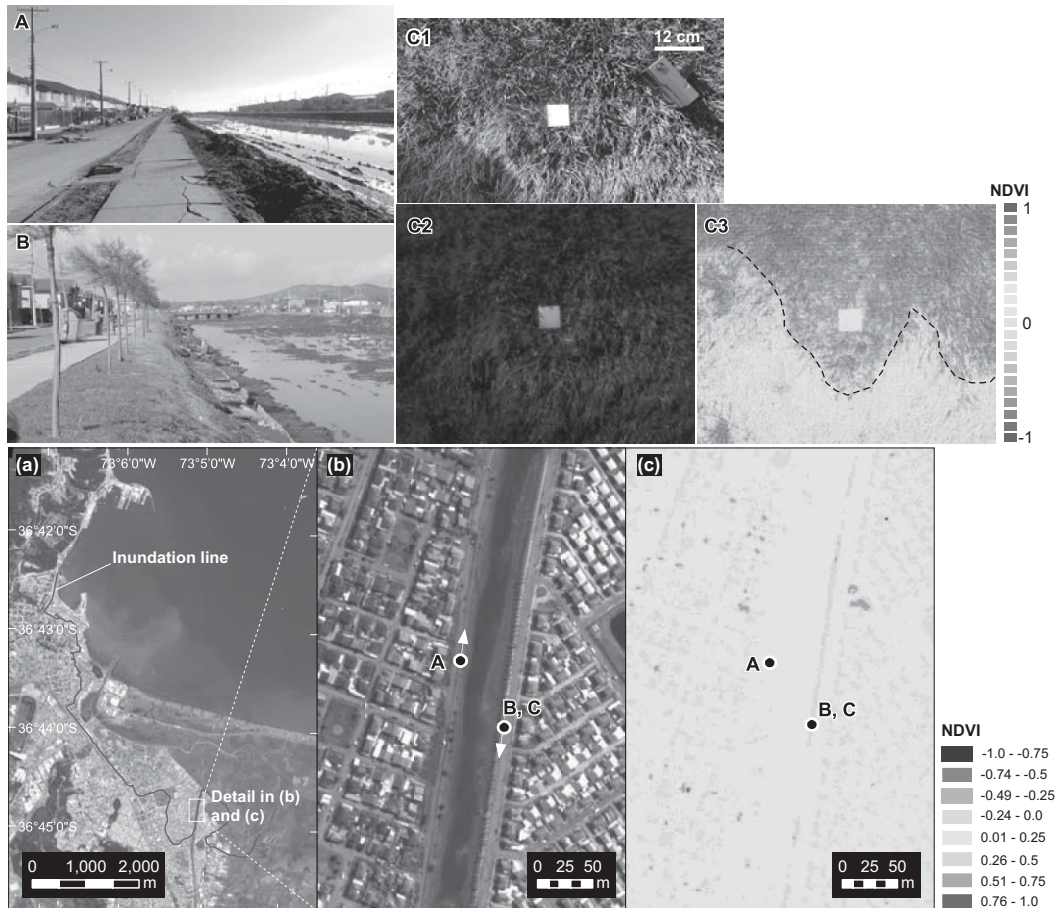
Here, we focused on the eastern bank of the canal in Talcahuano. Figure. 9 indicates the area of investigation and illustrates the result of detecting tsunami penetration by the analysis of WorldView-2 pan-sharpened multi-spectral image and the multi spectral camera (Tetracam ADC3). As shown in the ground photos (Figures. 9 A and B), considerable inundation was found on the western bank of the canal while the eyewitness testified that the tsunami slightly overtopped the eastern bank (no inundation in houses). Using the multi spectral camera that takes visible red, green and near infrared bands, we first calculated NDVI at the top of the bank where the tsunami did not overtop (Figure. 9B). As a result, we found that NDVI of the dead vegetation becomes less than 0.3. Using the threshold value determined by the spectral camera, we discuss the salt-water penetration on the eastern bank of the canal. Figure. 9 (c) shows the distribution of NDVI calculated from the post-tsunami WorldView-2 image (pan-sharpened). NDVI indicates lower value on the western bank (inundated) while relatively higher value on eastern bank (not inundated), and these features are quite consistent with the ground photos A and B.

Figure 9 (a) Inspection area of saltwater penetration, (b) Pan-sharpened multi-spectral image of WorldView-2 acquired on 6 March 2010. A, B and C is the point of ground photos, White arrow is approximate direction of camera focus. (c) Spatial distribution of NDVI Western. A and B : Ground photos taken on the western and eastern bank of the canal respectively. C1 is the ground photo for inspecting vegetation activity (Same position as B). C2 and C3 : False color composite image and NDVI taken by the multi spectral camera (Tetracam ADC3). White plate is the reflector used for calibration.

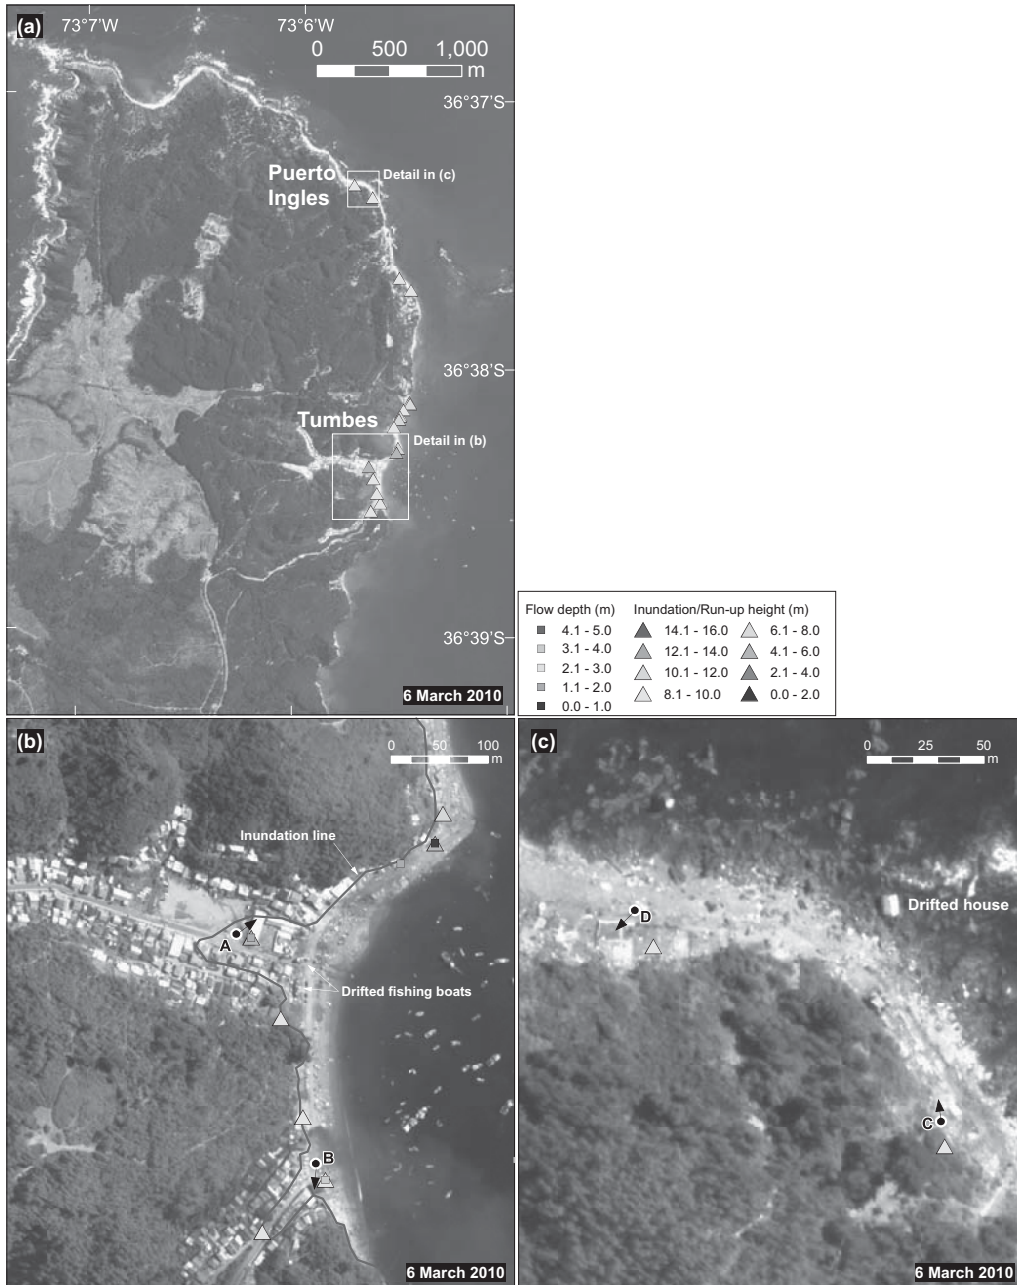
Tumbes locates and Puerto Ingles are the coastal communities, which were isolated by the limited road access. Figure.10 represents the overview of tsunami height measurements. Tsunami attacked these communities with up to 11 m height and caused significant damage. Along the coast from Tumbes to Puerto Ingles, the tsunami was particularly devastating to demolish the houses of isolated villages (Figure.11). Some survivors mentioned that the first wave was withdrawal and the 2nd wave was the largest. Having the experience and lessons from the 1960 Chilean tsunami, most of the village people evacuated to the hill immediately after the ground shaking. They mentioned that the tsunami in 1960 was witnessed only as receded sea and did not cause inundation.

Figure 10 (a) Overview of tsunami measurements (inundation and run-up heights) in Tumbes and Puerto Ingles. (b) Detailed features of the measurements and the damage in Tumbes. (c) Devastated damage in Puerto Ingles. Point A to D is the position of ground photos in Figure 11 respectively with the arrow of focus direction.

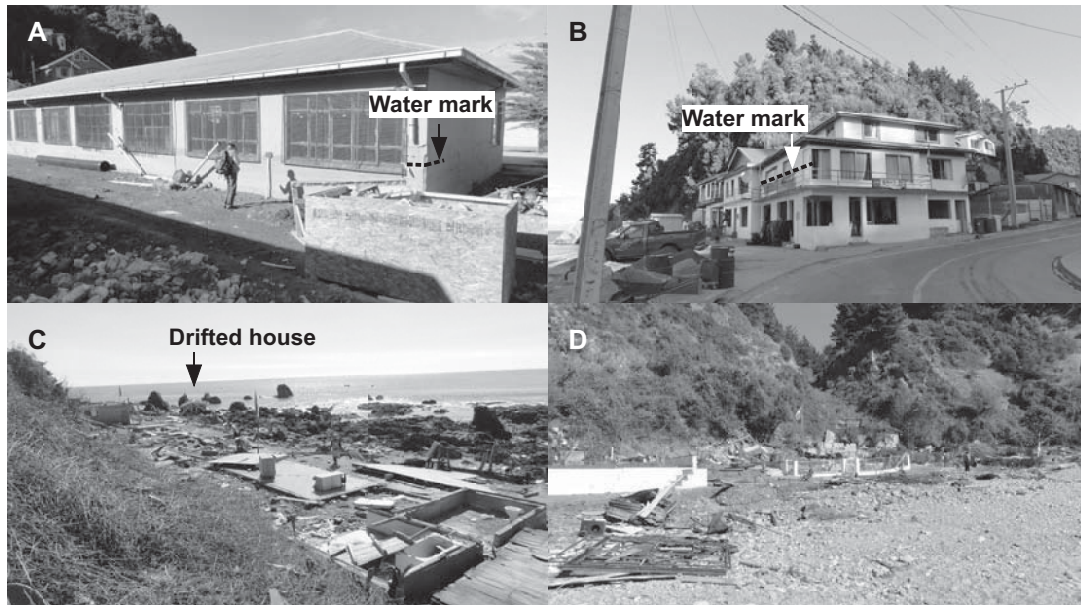
Figure 11 Ground photos from Tumbes (A, B) and from Puerto Ingles (C, D). A : Watermark on school building. B : Watermark on the house of Tumbes, C and D : Completely devastated village of Puerto Ingles.

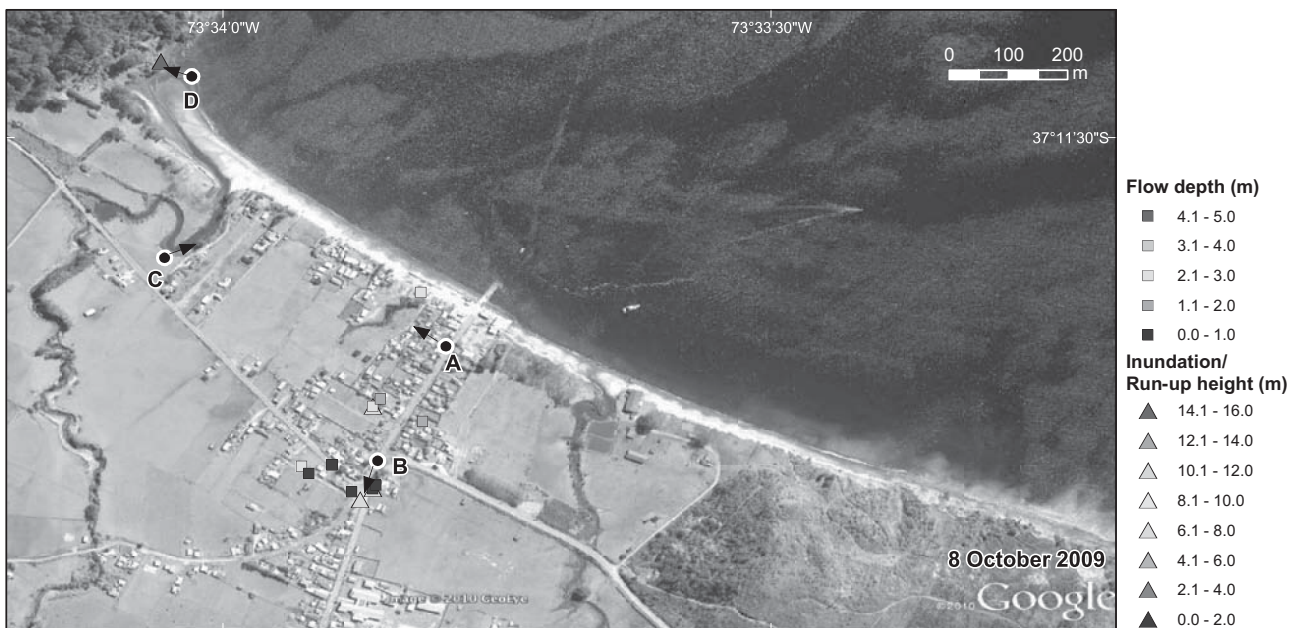
Figure 12. Result of tsunami height measurement in Llico. Point A to D are the position of ground photos with the arrow of focus direction shown in Figure 13.

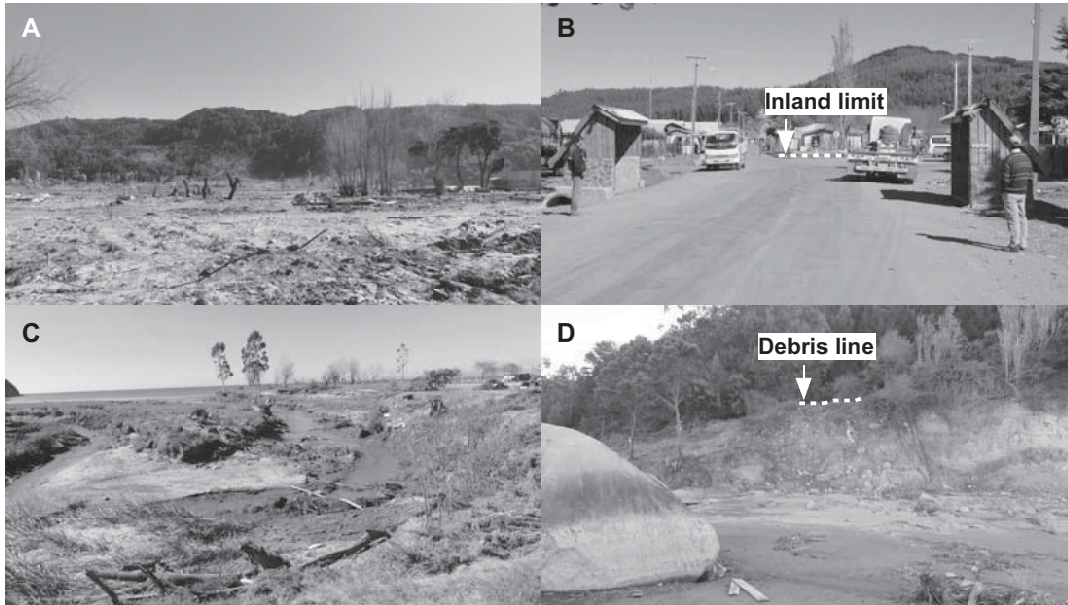
Figure 13 Ground photos from Llico. A : Completely devastated village. In the village, there were around 60 houses before tsunami. Almost all the houses were washed-away. B : Inland limit of tsunami inundation that is approximately 400 m from the shoreline. C : Tsunami run-up along the river. D : Tsunami debris line above 14.8 m pre-tsunami sea level.

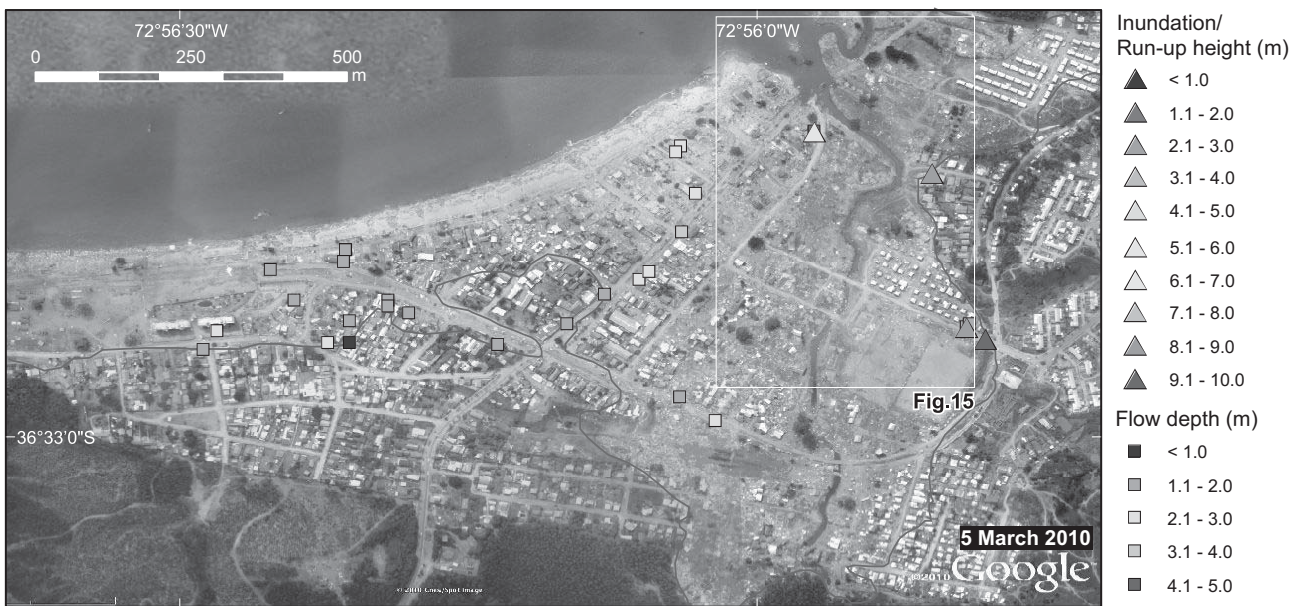
devastated towns. According to Dichato-Tome Emergency office, 405 families living in camps, and 1223 families were affected on their properties. Figure. 14 represents the measured tsunami run-up height and flow depths. The tsunami penetrated approximately 800 m inland to 10 m altitude. Figures. 15 and 16 illustrates the devastating damage in Dichato. In this area, most of the houses were washed away and the tsunami left considerable amount of debris. According to the eyewitness who watched the tsunami from 8-story building, the first wave of tsunami hit at 5:00 (AM) after most of the people evacuated. In addition, he said that the tsunami attack was at least 3 times and the 3rd wave was the largest. The other eyewitness said that the tsunami did not come first from the sea, but from the backside with not so much power (first wave).

Figure 14 Tsunami height, flow depth and extent of inundation in Dichato.

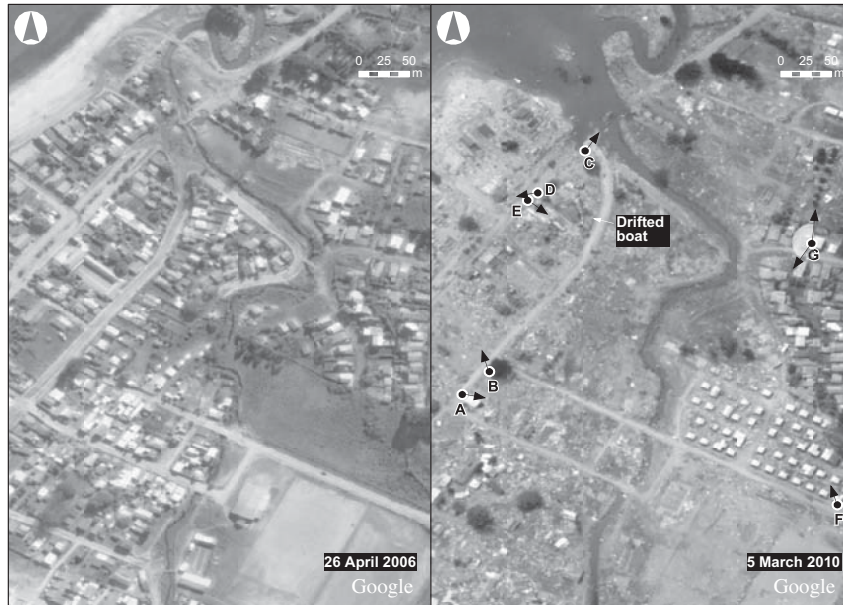
Figure 15 Pre and post event satellite images of the most devastated area in Dichato. Points A to G represent the position of ground photos taken by the authors (Figure 16). White arrow is approximate direction of the camera focus.

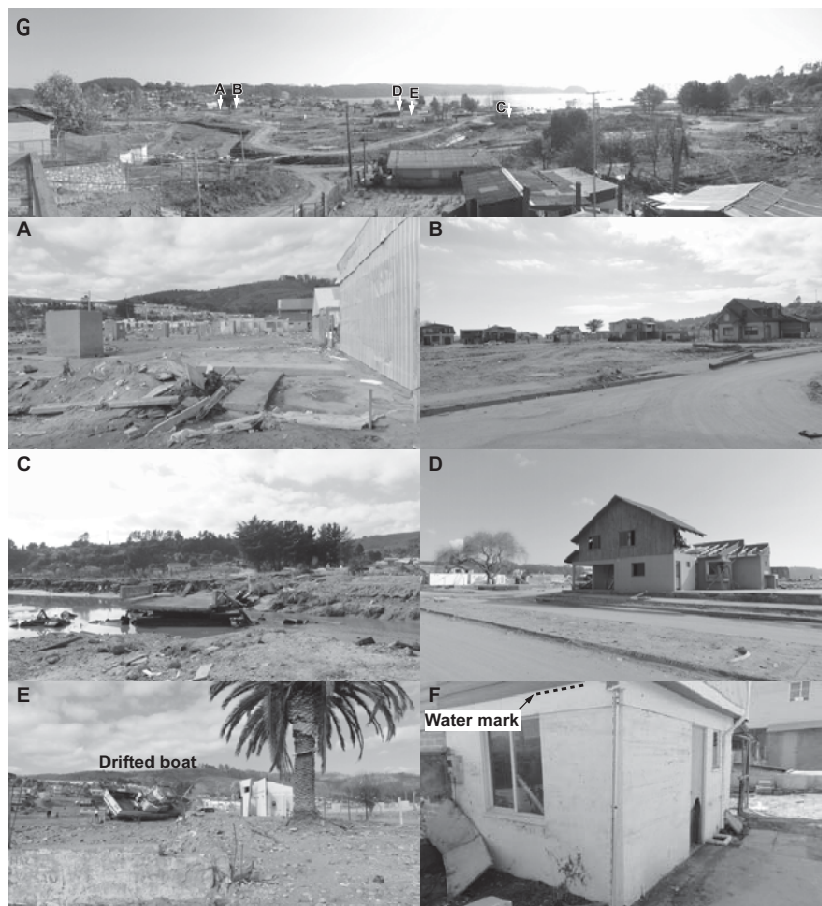
Figure 16 Ground photos from Dichato. A and B : Most devastated area. Only the unit of bathroom is remained. C : Damage on a bridge and erosion by tsunami inundation. D: Withstanding house, but significant damage. E : Drifted boat. F : Watermark on the house (approximately 2 m of flow depth). G : Panoramic view of the town of Dichato.
