BUILDING DAMAGE AND TSUNAMI INUNDATION GIS DATASETS AFTER THE 2010 CHILE EARTHQUAKE

Abstract: This paper presents the results of a field survey conducted by the authors after the 2010 Chile earthquake. The authors visited the affected area about a month after the earthquake. The GIS datasets for the damage levels of buildings in Talca and the tsunami-inundated areas in Talcahuano, Dichato, and Constitución are constructed in this study, and a series of fundamental analyses are performed using a digital elevation model (DEM). Further, the usefulness of satellite images captured after the earthquake to detect damaged buildings in Talca is discussed using the GIS datasets constructed in this study.

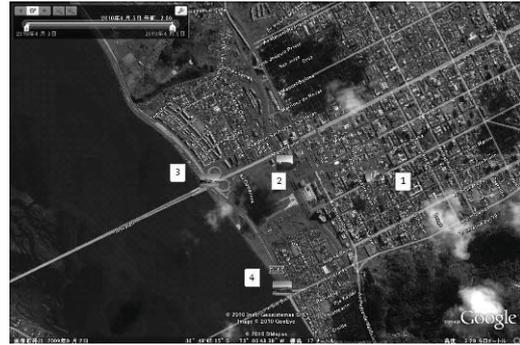
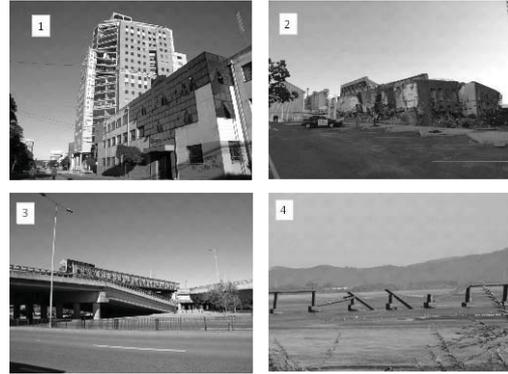
Figure 3 Survey route and field photos in Concepción—April 4, 2010

Figure 3 shows the survey route in Concepción. An RC

building with the damaged middle floor was found at the site numbered 1. An RC building with 15 stories had collapsed completely at the site numbered 2. The road bridges collapsed at sites 3 and 4. The temporary bridge girder was constructed two days after the earthquake at site 3. Although the photos are not shown in this paper, the adobe and unreinforced masonry constructions were severely damaged in the urban area.

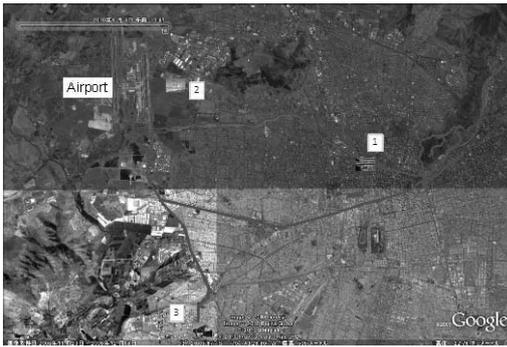
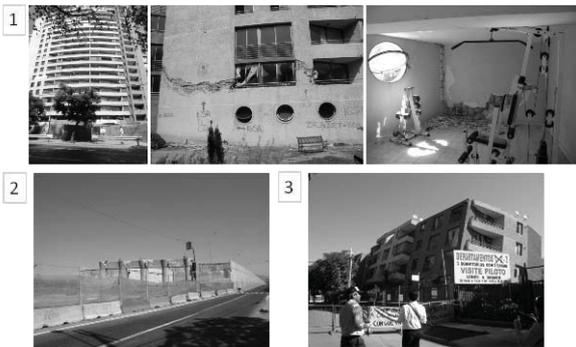
Figure 2 Survey route and field photos in Santiago—April 2, 2010

and some field photographs. The route was recorded by a portable GPS device during the survey and the location of the photo shooting could be identified as the location data were embedded in the Exchangeable Image File Format (EXIF). An RC building with 20 stories constructed in 2003 suffered from shear failures in columns and walls at the first and the second stories. A collapsed highway bridge and an

RC building with the collapsed first floor were found. The locations of these sites are also shown in the survey route in Fig. 2.

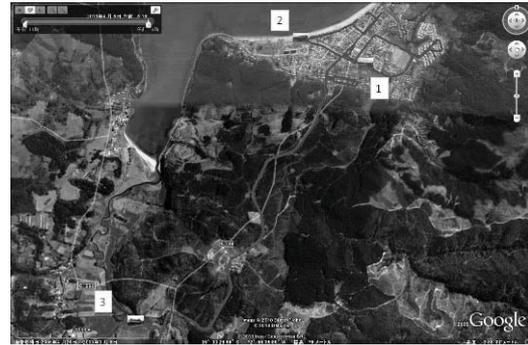
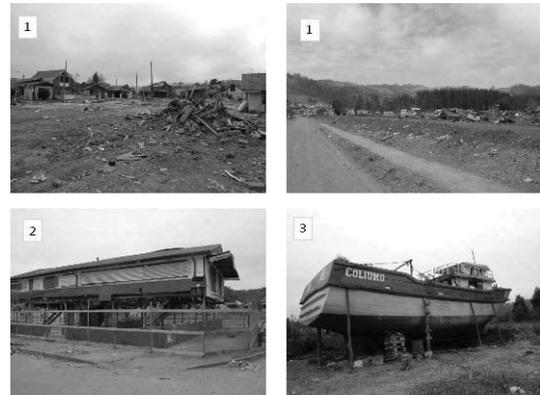
Figure 4 Survey route and field photos in Dichato—April 5, 2010

Figure 4 shows the survey route in Dichato. It is reported that more than 80% of the built-up area in Dichato suffered from tsunami (Humboldt State University Preliminary Tsunami Survey Team, 2010). As shown in the field photos, the buildings collapsed because of the tsunami waves. A ship was conveyed against the river flow because of the tsunami and eventually found at site 3.

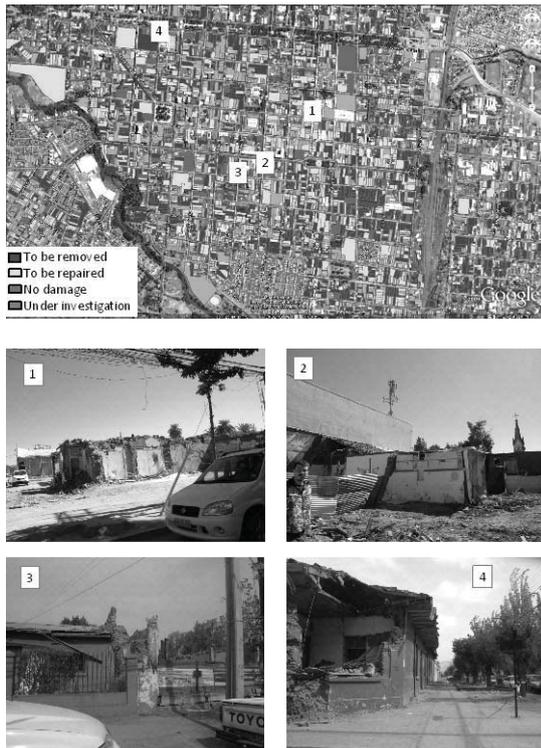
Figure 5 GIS file to show the damage levels of buildings in Talca and locations of field photos

In all, 5617 polygons were projected to the map coordinate system. 1559 (27.8%), 1872 (33.3%), and 1864 (33.2%) buildings were classified as to be removed, to be repaired, and no damage, respectively. The typical construction types in Talca are adobe and unreinforced masonry buildings, which are primarily used for older constructions with 2–4 stories (dating back to before the 1960s–70s). Modern buildings that were designed according to the current codes suffered minor, repairable damage, while a large number of adobe and unreinforced masonry constructions suffered significant damage (MCEER, 2010).

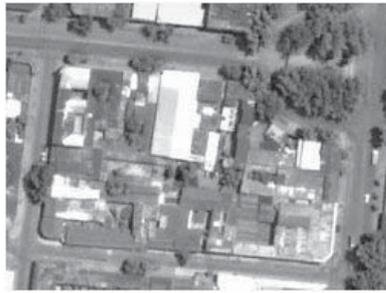
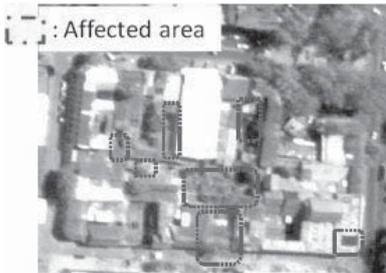
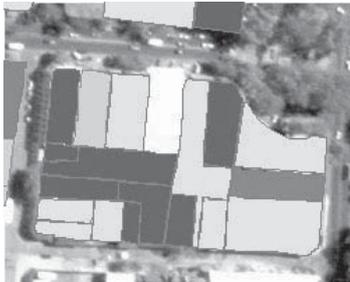
Figure 7 Comparison between pre- and post-event satellite images to detect affected buildings

post-event high-resolution optical satellite images with the GIS dataset shown in Fig. 5. As for the pre- and post-event images, the image captured by QuickBird on January 1, 2008, which is presented in Google Earth, and that captured by WorldView-2 on March 10, 2010, are employed in this study. A comparison of the pre- and post-event images revealed that some of the affected buildings could be visually detected, but not all the damaged ones could be identified appropriately. Since the post-event image was captured with the large off-Nadia angle (40.3°), the quality of image is not sufficient for visual damage inspection. Moreover, the number of affected buildings whose roofs had completely collapsed is small in Talca. Hence, it can be concluded that the damaged buildings in Talca are difficult to be detected through visual damage inspection using satellite images.

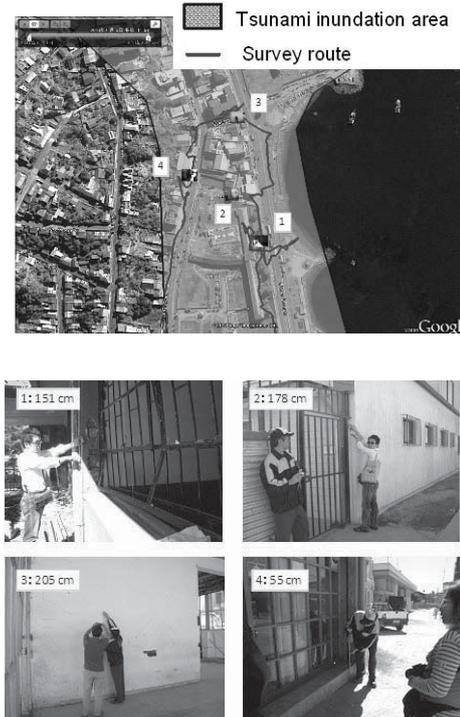
Figure 10 Measurement of tsunami inundation depth in Talcahuano

As shown in Fig. 10, the inundation depth was measured at several sites in the three cities. The inundation depth along the beachfront street in Talcahuano was larger than 150 cm, but a depth of 55 cm was observed in its bystreet (site 4). Figure 11 summarizes the measurements in the three cities. The inundation depth is presented with
