# DAMAGE DETECTION OF THE MAY 6, 2012 TORNADO IN TSUKUBA, JAPAN USING AERIAL THERMAL INFRARED IMAGES

Daiki HANADA<sup>\*1</sup>, Kentaro SUZUKI<sup>1</sup> and Fumio YAMAZAKI<sup>2</sup>

**KEY WORDS:** Tornado, Aerial Thermal Infrared Image, Temperature Distribution, Damage Detection, GIS

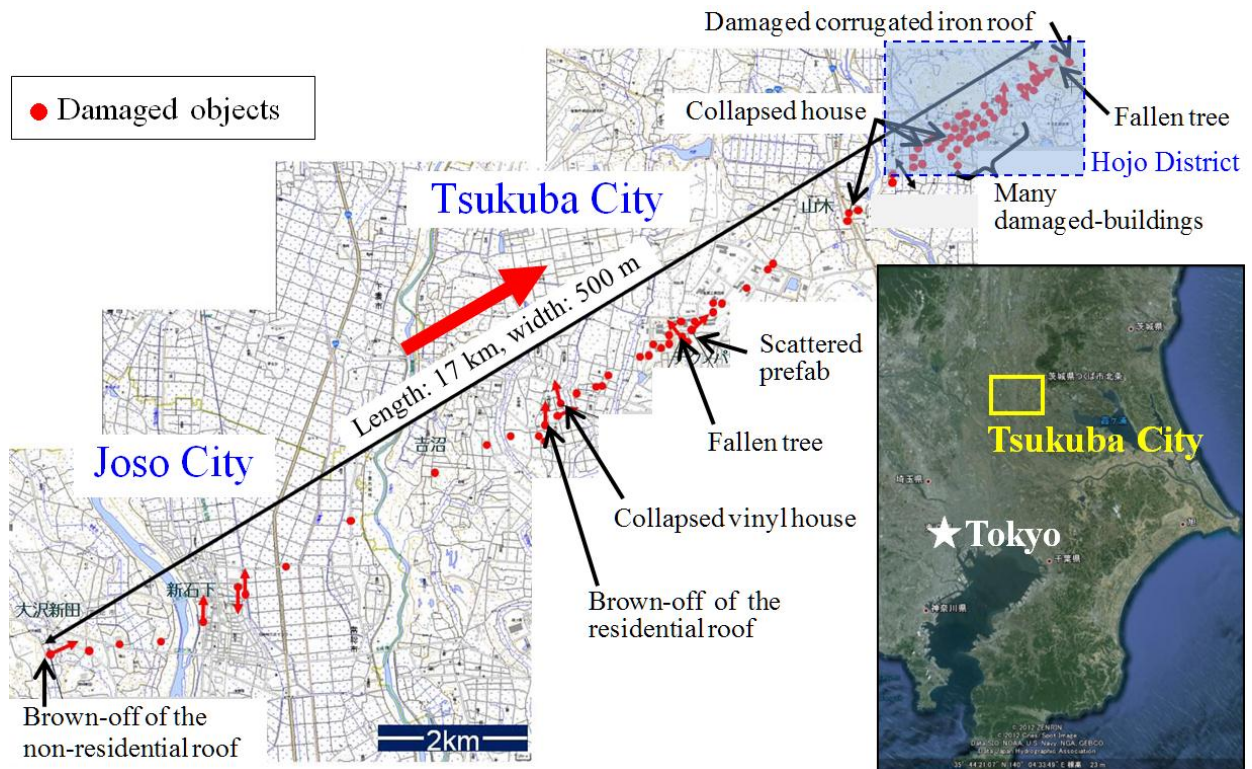
A strong tornado was generated in Joso City, Ibaraki Prefecture on May 6, 2012 at 12:35. It caused significant damages along its path with 17 km in length and 500 m in width, until its end at Tsukuba City (Figure 1). The moving speed of the tornado was about 60 km/h (passing 17 km in 18 min) based on the analysis of meteorological Radar by Japan Meteorological Agency (JMA, 2012). JMA judged the Fujita scale of the tornado as F2 (the average wind speed

Figure 1 Detail map of the tornado's path and resultant damages, modified from JMA (2012).

of 50–69 m/s in 7 s) based on their field survey after it passed by. However, it was changed to F3 (the average wind speed of 70–92 m/s in 5 s) in June 8 because the resultant damages were found to be so severe; for example, one wood-frame house was overturned upside-down with its concrete base.

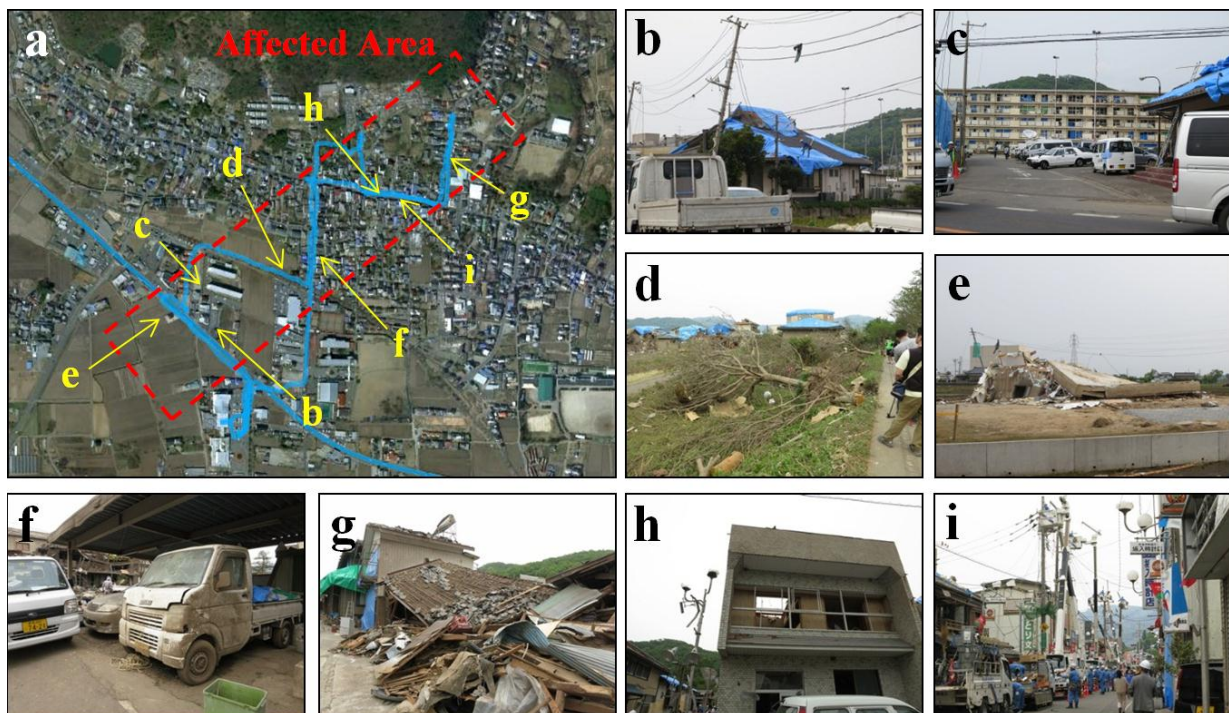
We also conducted a field survey of Hojo district, Tsukuba City to obtain ground truth data from 14:00 to 16:00 on May 8, 2012, almost at the same time of the daytime's aerial image acquisition. Typical damages by the tornado were blown-off of buildings' roofs, broken windows, and falling-down of trees and electric poles. Since these types of damages, other than the damage to building walls, can generally be observed from vertical imagery, we thought this is a good opportunity to test the capability of aerial TIR imagery for building damage assessment as well as that of optical imagery. We surveyed the hard-hit area and look ground photos of severely damaged buildings with their GPS location data.

Typical damage scenes are shown in Figures 3b to 3i. Many buildings were collapsed or brown off their roofs, and these were covered by blue sheet (Figure 3b, 2h). Trees were uprooted, and a wooden house was overturned upside-down with its concrete base (Figure 3e). The Fujita scale was changed to F3 by this damage. Many objects were covered with mud because the tornado hit the area with rain (Figure 3f). This might affect the surface temperature. Debris and mud on roads were mostly cleaned up already at the time of our field survey although some still remained. Recovery efforts were very fast because the tornado damage was localized. Restoration of electric poles and cables were going on with many trucks and workers (Figure 3i).

Figure 3 (a) The area of field survey in Hojo district of Tsukuba City and photo shooting locations, (b) Blue-sheet on the roof, (c) Damage on the side wall of the apartment building, (d) Fallen trees along the street, (e) Overturned wooden house with its concrete base, (f) Cars stained with tornado's mud water, (g) Buildings that reduced to debris, (h) Brown-off of the roof (the sky is seen from the window), (i) Restoration work of electric poles and cables.

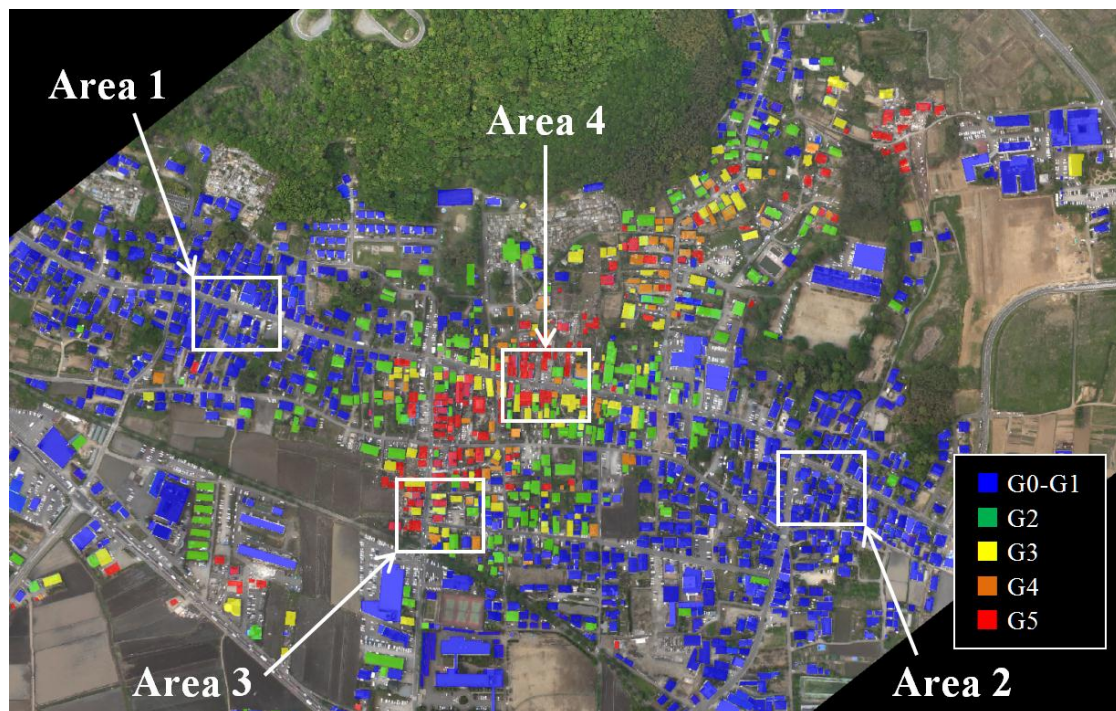
Figure 4 shows the result of our visual damage inspection from the daytime aerial visible image based on the criteria in Table 1. It is seen that the grades G3-G5 buildings were located along the path of the tornado. In this step, some buildings were judged as no damage although some damages on their side surfaces, like the apartment building in Figure 3c, because the damage was judged only from the roof condition. This might be the reason of the difference between our inspection result with the damage assessment result by Tsukuba City, as shown in Table 2. In this study, however, our inspection result was used as the reference data for the aerial TIR images since the both data were acquired from the same vertical view angle, where only the damage condition or the temperature of the roof was seen.

Figure 4 Damage classification result by our visual inspection of the daytime aerial visible image

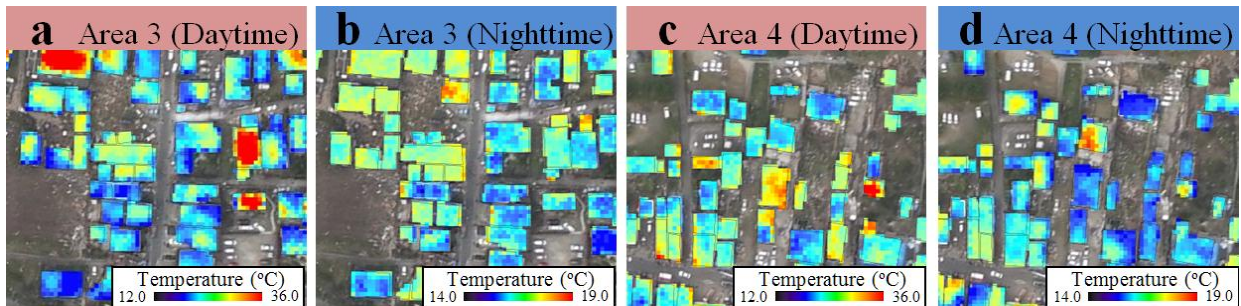
Next the characteristics of the TIR images at heavily-damaged areas were discussed. Figure 8 show the locations of two target heavily-damaged areas in Figure 4. Figure 9 shows the surface temperature within the building footprints from the daytime and nighttime TIR images, superimposed on the visible image. From the daytime roof temperature distributions in Figures 9a and 9c, damaged roofs mostly show low temperature because they were covered by blue sheet or reduced to debris. The nighttime roof temperature distributions in Figure 9b and 9d also exhibit low values. The temperature distributions for heavily-damaged buildings are seen to be somewhat different from those of non-damaged ones both at daytime and nighttime, but this observation is highly affected by the material, color and orientation of the roof, shadow and surrounding conditions.

Figure 9 Temperature within building footprints for heavy-damage areas, **a, c**: Daytime, **b, d**: Nighttime.

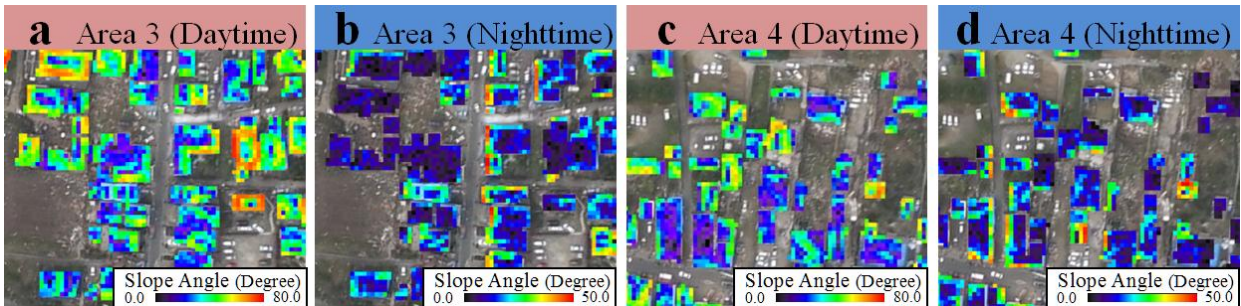
Figure 10 shows the slope angle of the surface temperature within the footprints. In the daytime slope angles in Figures 10a and 10c, many buildings show small values as in purple to blue colors. It is also observed that the pixels with large angles are few probably because buildings were reduced debris and it spread in and outside of the original building footprints. Many materials were mixed up by building collapse and thus many objects became a mixed-pixel (mixel) condition for the low resolution TIR images (1.54m). This characteristic is remarkable especially for the upper left building group in Figure 10b. Most footprint areas show small changes as in dark blue color. It can be seen in the visible image of Area 3 that the spread debris in the area became the similar condition as soil. This kind of debris spread was also observed in our field survey, and hence there is possibility to use this more uniform temperature distribution with the surroundings in early damage detection from TIR images.

Figure 10 Slope angle of the temperature within building footprints in Figure 9, **a, c**: Daytime, **b, d**: Nighttime.

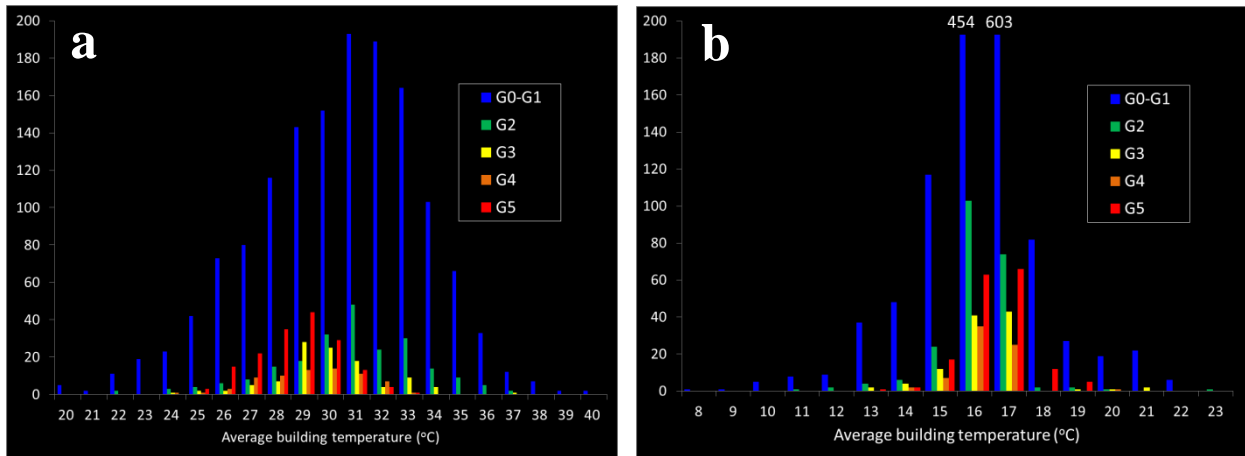
From the daytime histogram in Figure 11a, the average roof temperatures for non-damaged buildings are seen to be widely distributed in the range from 20 to 40 °C. On the contrary, those for damaged buildings are displayed in a narrower range from 24 to 35 °C and the range gets small as the damage level gets higher. For collapsed buildings (G5), the average temperature becomes in the range from 25 to 33 °C. This is because that the roofs were lost and the footprint areas were covered by the mixture of various materials like debris and mud. If we can use a much higher-resolution TIR image, a wider temperature distribution can be seen in more detail. But at this time, the resolution of our TIR images are 1.54 m, and thus most debris became in a mixel condition and the temperature distributions became flat. The histogram for damaged buildings at daytime tends to be in a narrow range and the average values were decreased for 2 or 3 °C.

From the nighttime histogram in Figure 11b, the average temperatures for most buildings are seen in narrower ranges, around 17 °C, compared with the daytime histograms, as typically observed for collapsed buildings (G5). The histograms for damaged buildings at nighttime also tend to be in narrower ranges, the same as the daytime case. This kind of temperature characteristics in aerial TIR images may be used in early damage detection in the future although more examples for various conditions should be tested.

Figure 11 Histogram of average temperature within footprint for each damage level, a: Daytime, b: Nighttime.
