USE OF AIRBORNE OPTICAL AND THERMAL IMAGERY FOR THE DETECTION OF BUILDING DAMAGE DUE TO THE 2012 TSUKUBA TORNADO

Fumio Yamazaki¹⁾, Daiki Hanada²⁾ and Kentaro Suzuki²⁾

1) Professor, Department of Urban Environment System, Chiba University, Japan

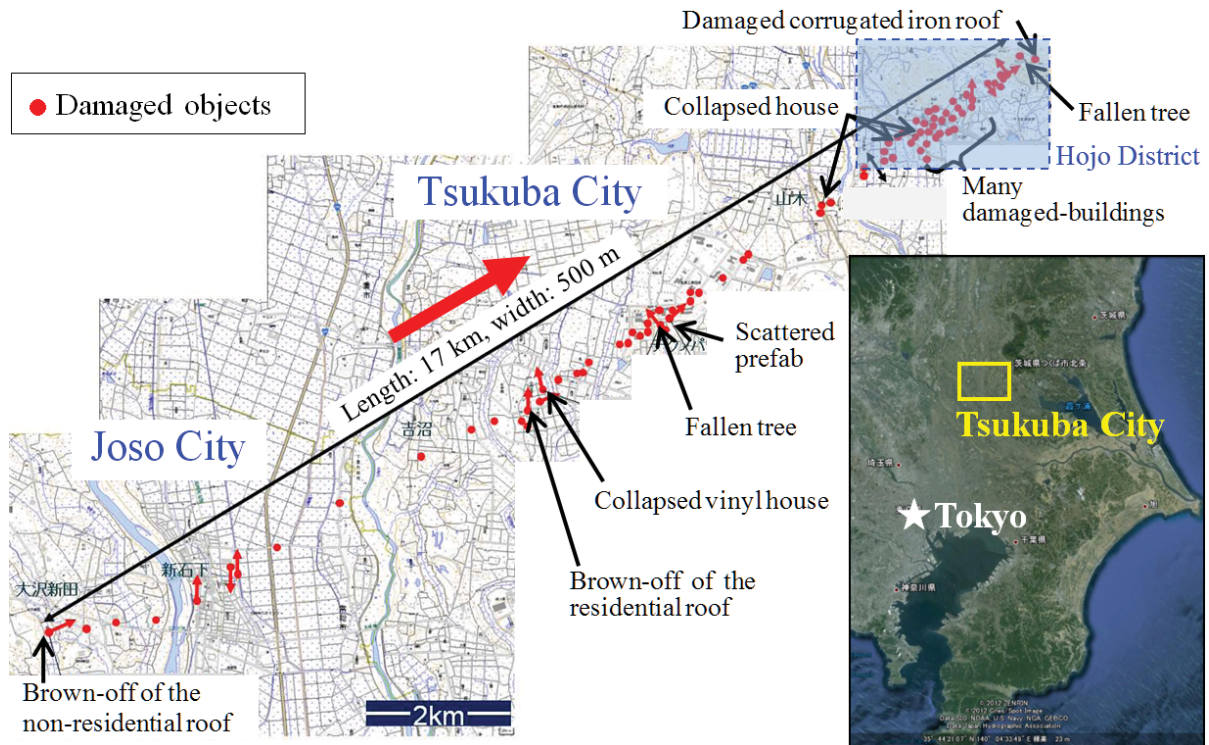
A strong tornado was generated in Joso City, Ibaraki Prefecture, on May 6, 2012 at 12:35. It caused significant damages along its path with 17 km in length and 500 m in width until its end at Tsukuba City (**Figure 1**). The moving speed of the tornado was about 60 km/h (passing 17 km in 18 min) based on the analysis of meteorological Radar by Japan Meteorological Agency (JMA, 2012). JMA judged the Fujita scale of the tornado as F2 (the average wind speed of 50-69 m/s in 7 s) based on their field survey after it passed

Figure 1 Detail map of the tornado's path and resultant damages, modified from JMA (2012).

by. However, it was changed to F3 (the average wind speed of 70-92 m/s in 5 s) in June 8, 2012 because the resultant damages were found to be so severe; for example, one wood-frame house was overturned upside-down with its concrete base.

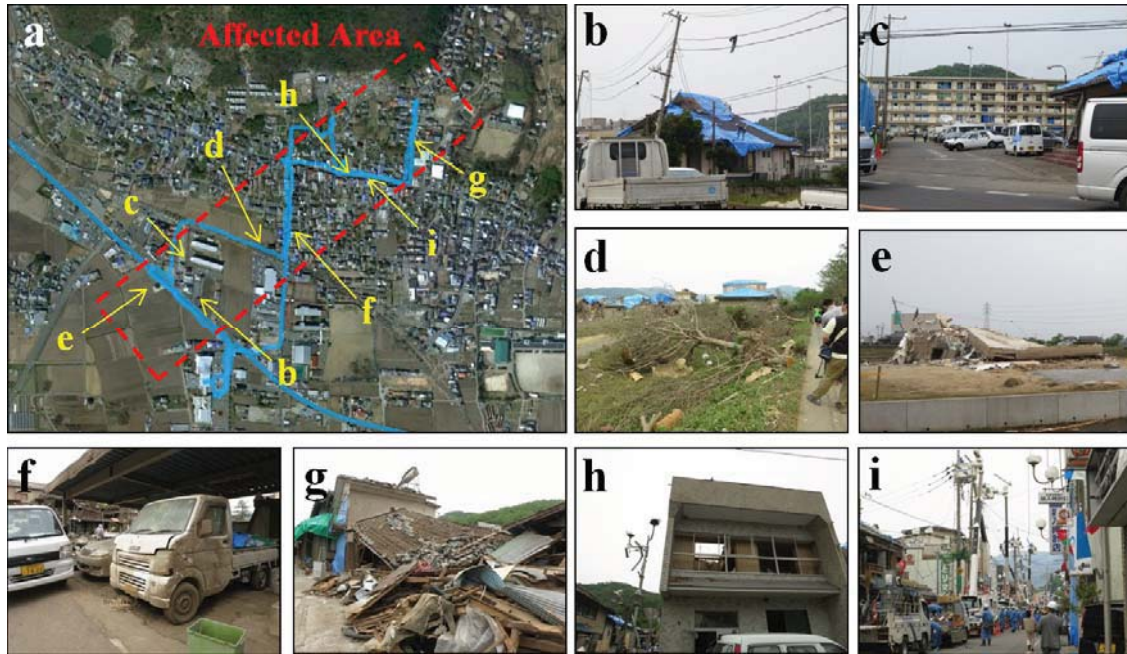
The route of our field survey in Hojo district on May 8, 2012 was shown by the blue line in **Figure 2a**. We walked around the hard-hit area with digital cameras and hand-held GPSs. The weather condition of the day was cloudy with the maximum air temperature 24.8 °C, and minimum air temperature 13.4 °C.

Typical damage scenes are shown in **Figure 2 (b-i)**. Many buildings were collapsed or brown off their roofs, and these were covered by blue sheet (**b**). Trees were uprooted, and a wooden house was overturned upside-down with its concrete base (**e**). The Fujita scale was changed to F3 by this damage. Many objects were covered with mud because the tornado hit the area with rain (**f**). This might affect the surface temperature. Debris and mud on roads were mostly cleaned up already at the time of our field survey although some still remained. Recovery efforts were very fast because the tornado damage was localized. Restoration of electric poles and cables were going on with many trucks and workers (**i**).

Figure 2 (a) The area of field survey in Hojo district, Tsukuba City and photo shooting locations, (b) Blue-sheet on the roof, (c) Damage on the side wall of an apartment building, (d) Fallen trees along street, (e) Overturned wooden house with its concrete base, (f) Cars stained with tornado's mud water, (g) Buildings that reduced to debris, (h) Brown-off of the roof (the sky is seen from the window), (i) Restoration work of electric poles and cables.

In our visual damage inspection, some buildings were judged as no damage although some damages on their side surfaces were seen in our field survey, i.e. the apartment building in **Figure 2c**, because the damage was judged only from the roof condition of the vertical visible image. This might be the reason of the difference between our inspection result with the damage assessment result by Tsukuba Fire Department from the ground, as shown in **Table 2**. The damage assessment in their field survey was conducted by looking from outside, and thus damages to side walls and facade could mostly be seen. G3 and G4 were grouped as one class because their results did not distinguish these two.

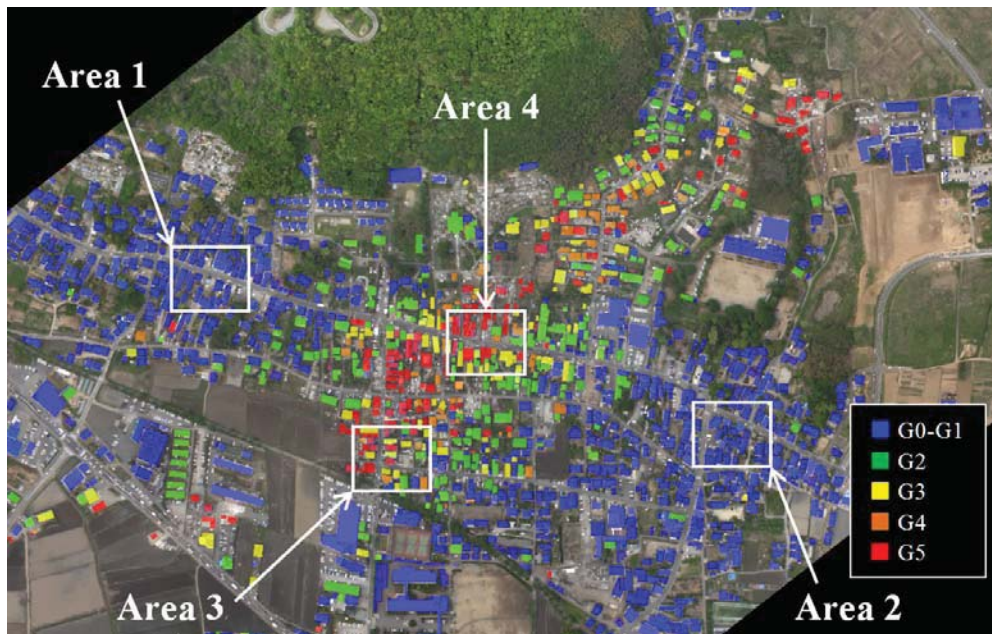
Figure 4 shows the result of our visual damage inspection from the daytime aerial visible image. It is seen that the grades G3-G5 buildings were located along the path of the tornado. The path of the tornado was clearly seen from the visible image, and the center line was drawn as shown in **Figure 5**. The parallel lines were also drawn up to 200 m from the center line to the both sides in 20 m interval. The damage ratio for each distance class was calculated and shown also in **Figure 5**. It is observed that the collapsed

Damage Level	G2	G3	G4	G5
Roof damage ratio				
$R = \frac{\text{Damaged Roof}}{\text{Roof}}$	$0\% < R \leq 20\%$	$20\% \leq R < 50\%$	$50\% \leq R < 70\%$	$R \geq 70\%$

Figure 4 Damage classification result by our visual inspection for the daytime aerial visible image.

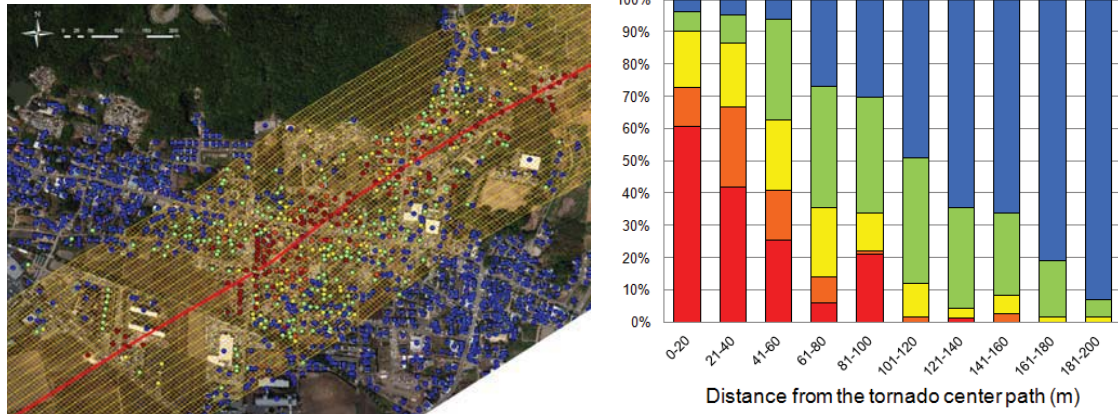
Figure 5 The center path of the tornado detected from our visual inspection and its parallel lines within 200 m (left) and the damage ratio of buildings for 20 m interval from the center path (right)

buildings (G5) were located mostly within 60 m from the center path of the tornado. No collapsed building was found outside of the 100 m lines from the center path. Almost no damaged buildings were seen outside of the 200 m lines from the center path. The damage due to the tornado was concentrated in a narrow range although tornado paths are unpredictable.

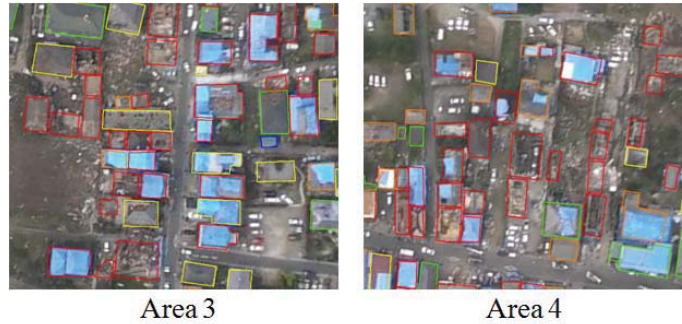
Next the characteristics of the TIR images at heavily-damaged areas were discussed. Figure 9 show the locations of two target heavily-damaged areas in Figure 4.

Figure 9 Target areas of heavy-damage in Figure 4

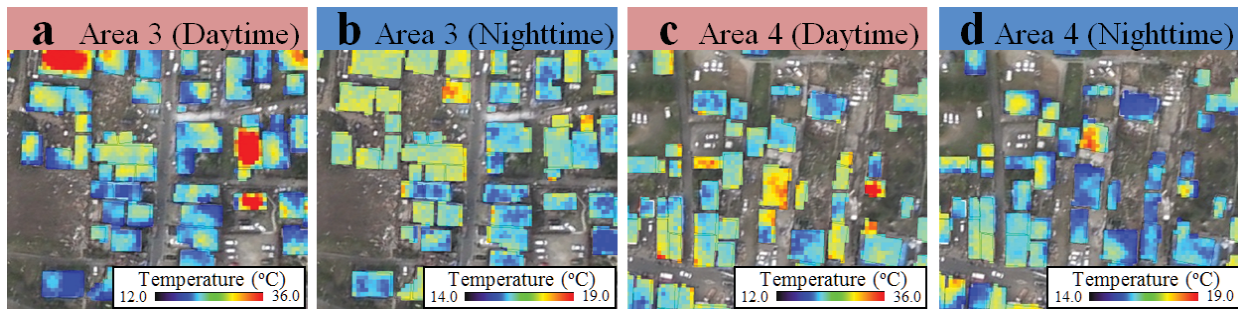
Figure 10 shows the surface temperature within the building footprints from the daytime and nighttime TIR images, superimposed on the visible image. From the daytime roof temperature distributions in Figure 9 (a, c), damaged roofs mostly show low temperature because they were covered by blue sheet or reduced to debris. The nighttime roof temperature distributions in Figure 9 (b, d) also exhibit low values. The temperature distributions for heavily-damaged buildings are seen to be somewhat different from those of non-damaged ones both at daytime and nighttime, but this observation is highly affected by the material, color and orientation of the roof, shadow and surrounding conditions.

Figure 10 Temperature within building footprints for heavy-damage areas, a, c: Daytime, b, d: Nighttime

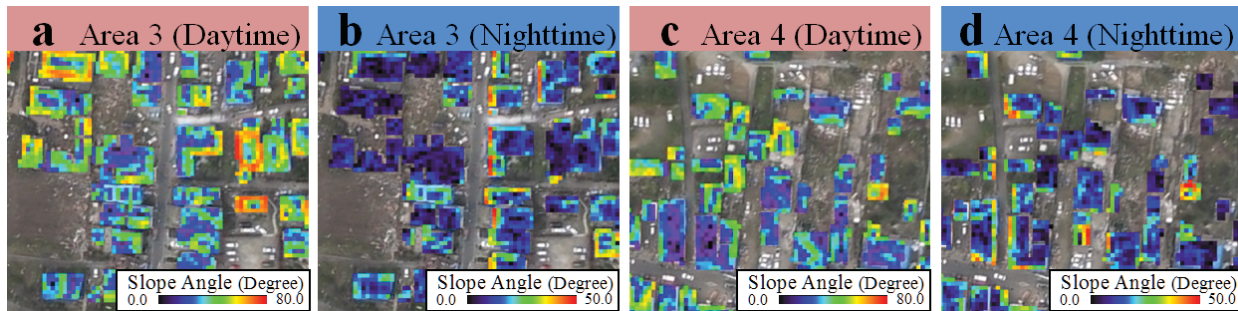
Figure 11 shows the slope angle of the surface temperature within the footprints. In the daytime slope angles in Figure 11 (a, c), many buildings show small values as in purple to blue colors. It is also observed that the pixels with large angles are few probably because buildings were reduced debris and it spread in and outside of the original building footprints. Many materials were mixed up by building collapse and thus many objects became a

Figure 11 Slope angle of the temperature within building footprints in Figure 10, a, c: Daytime, b, d: Nighttime

mixed-pixel (mixel) condition for the low resolution TIR images (1.54 m). This characteristic is remarkable especially for the upper left building group in **Figure 11b**. Most footprint areas show small changes as in dark blue color. It can be seen in the visible image of Area 3 that the spread debris in the area became the similar condition as soil. This kind of debris spread was also observed in our field survey, and hence there is possibility to use this more uniform temperature distribution with the surroundings in early damage detection from TIR images.

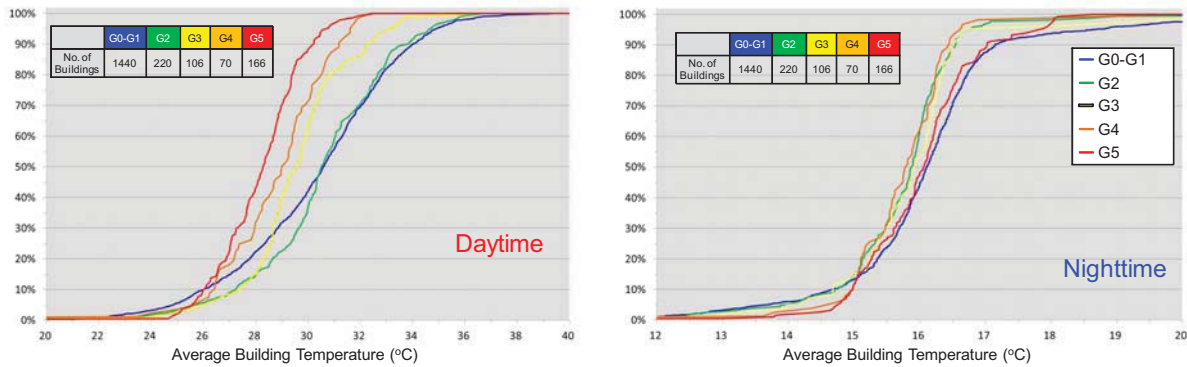
Figure 12 shows the cumulative distributions of the average temperature within building footprints for each damage level. Here, buildings other than in Hojo district were also counted. From the daytime graph, the average roof temperatures for non-damaged buildings are seen to be widely distributed in the range from 20 to 40 °C. On the

contrary, those for damaged buildings are displayed in a narrower range from 24 to 35 °C and the range gets small as the damage level gets higher. For collapsed buildings (G5), the average temperature becomes in the range from 25 to 33 °C. This is because that the roofs were lost and the footprint areas were covered by the mixture of various materials like debris and mud. If we can use a much higher-resolution TIR image, a wider temperature distribution can be seen in more detail. But at this time, the resolution of our TIR images are 1.54 m, and thus most debris became in a mixel condition and the temperature distributions became flat. The histogram for damaged buildings at daytime tends to be in a narrow range and the average values were decreased for 2 or 3 °C.

From the nighttime graph, the average temperatures for most buildings are seen in narrower ranges, around 17 °C, compared with the daytime graph, as typically observed for collapsed buildings (G5). The cumulative distributions for damaged buildings at nighttime also tend to be in narrower ranges, the same as the daytime case. This kind of temperature characteristics in aerial TIR images may be used

Figure 12 Cumulative distributions of average temperature within footprint for each damage level
