MONITORING OF URBAN RECONSTRUCTION: A STUDY OF RECOVERY PROCESS IN BAM AFTER THE 2003 EARTHQUAKE

Seyed Omid HASHEMI PARAST¹, Fumio YAMAZAKI²

Key Words: Monitoring, Reconstruction, The 2003 Bam Earthquake, Satellite Image

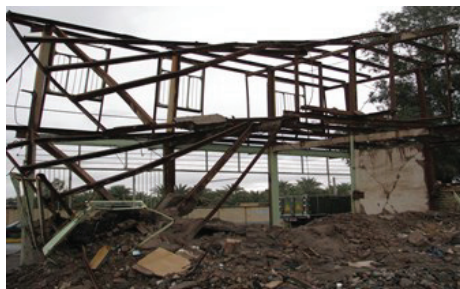
1. The debris could still be seen in some damaged areas (Fig.1a). In addition in some regions, especially in the center and northern part of the city, debris had been removed, but construction has not been taken place and there are still bare lands. (Fig.1b)
2. Except for a few cases, almost all of the important public buildings, mosques, banks and other governmental offices were reconstructed (Fig. 2).

Fig.1 (a) Desolate building in the northeast of Bam and (b) bare land in the center of Bam

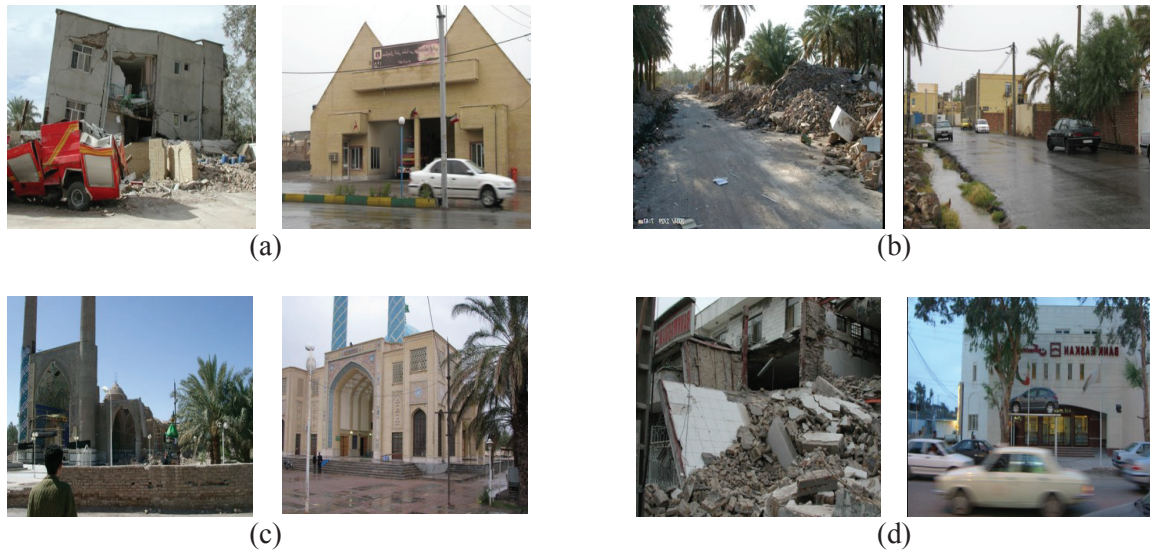
Fig. 2 Comparison of some reconstructed buildings after the earthquake and in 2014. (a) Fire station of Bam in January 2004 (left) and March 2014 (right). (b) An alley near the Madani Street in the north of Bam in January 2004 (left) and March 2014 (right). (c) ZEYD Mosque in January 2004 (left) and March 2014 (right). (d) MASKAN Bank in January 2004 (left) and March 2007 (right).

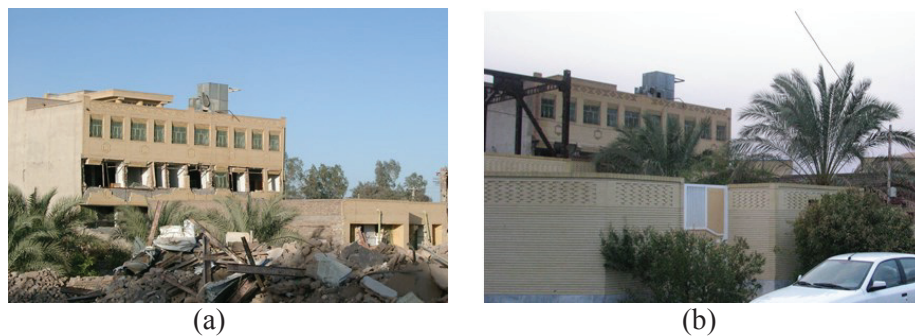
3. Some of the buildings that have been highly damaged but not destroyed, have been renewed and reused with the existing conditions (Fig. 3).
4. New buildings that not exist before the earthquake as a sport stadium, medical university, commercial-administrative complex, library and cultural center, and also a new residential region in the east and southeast of the city. (Fig. 4)

Fig. 3 A building in south of the city was severely damaged but was still used as in photos taken in (a) January 2004 and (b) March 2014

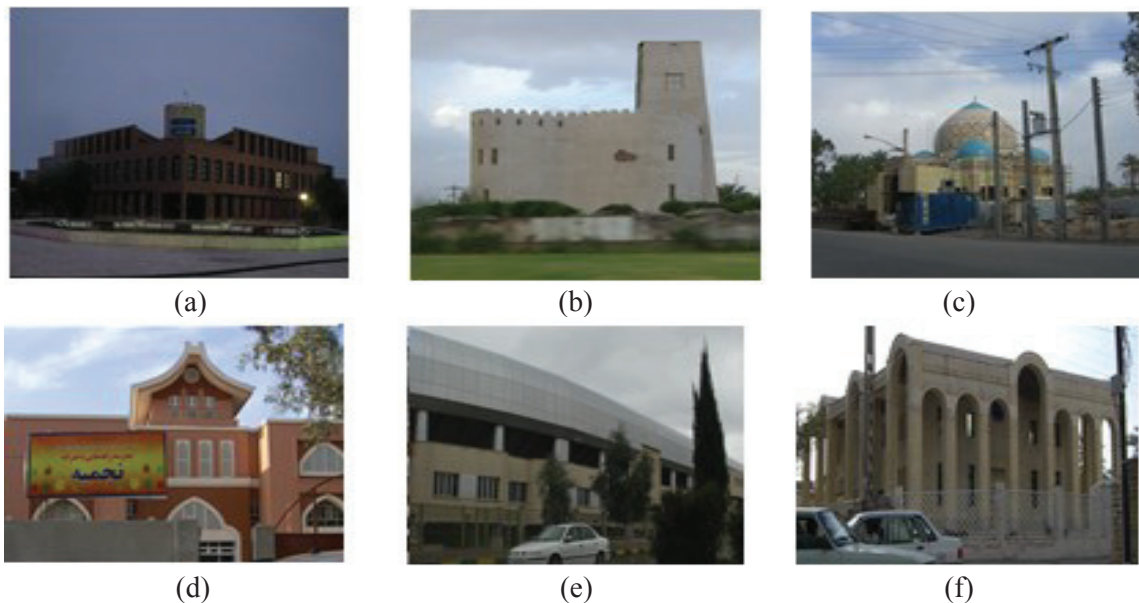
Fig. 4 New set of buildings consisting of (a) medical university in 2014 (b) City hall in 2007 (c) mosque in 2007 (d) a primary school in 2007 (e) sport stadium in 2014 (f) library in 2007 have been constructed in Bam, which did not exist before the earthquake.

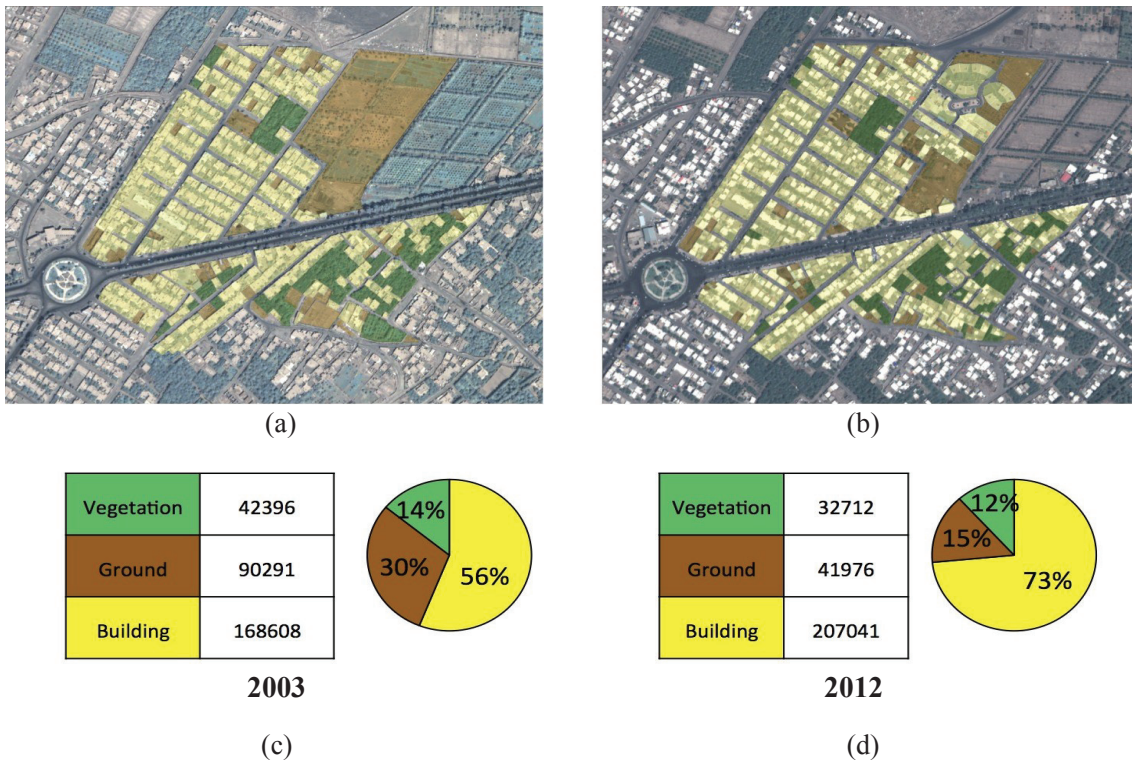
Figure 6 shows the satellite images covering the station 1 in 2003 and 2012. The area and percentage for the three land-covers are presented under each image. A clear increase in the percentage of buildings and a decrease of ground in 2012 can be observed.

Fig. 6 (a) Satellite image and land-covers at the station 1 in 2003 and (b) those in 2012. The area (m²) and percentage of *buildings*, *vegetation* and *ground* in (c) 2003 and (d) 2012.

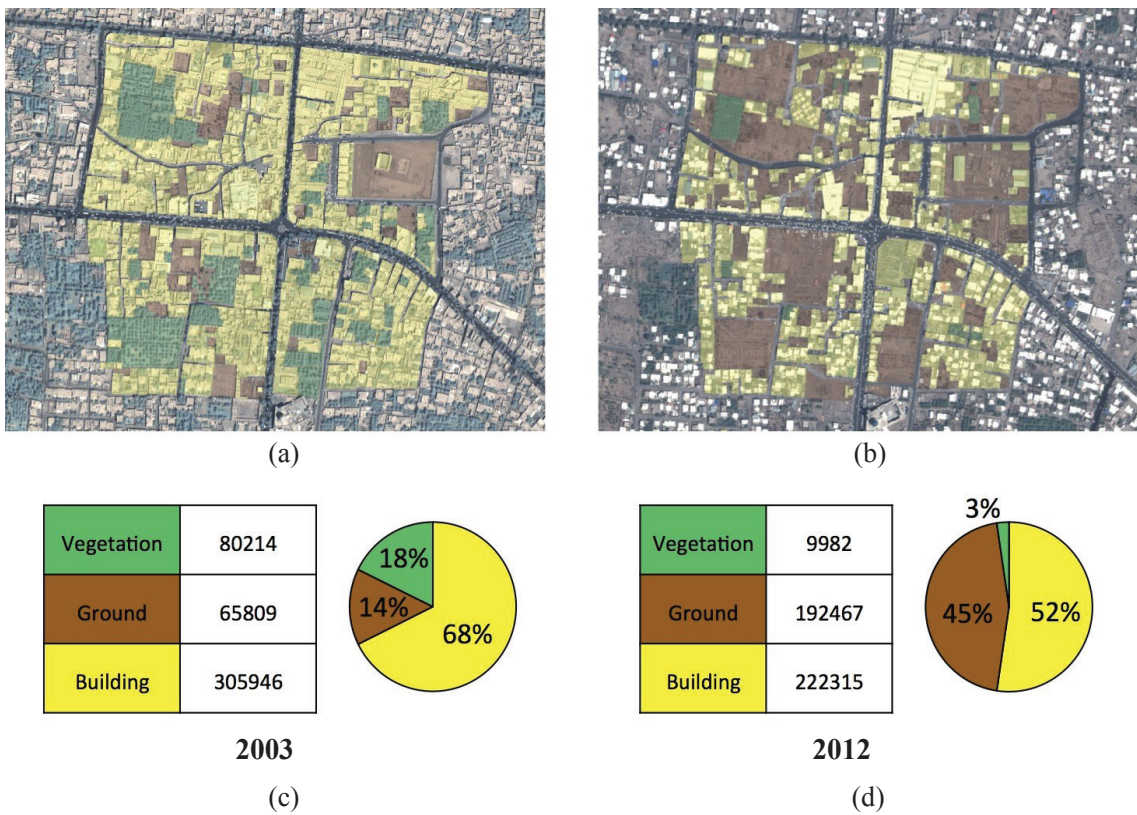
Similarly, the changes in land-covers around the station 2 are depicted in Fig. 7. In this area, which was extensively destroyed after the earthquake, the land-covers for buildings and vegetation were decreased and those for ground increased significantly. In this area, located in the north part of the city, the amounts of empty lands are quite large, in other words, reconstruction is slow. Although

debris had been removed and the lands were smoothed, reconstruction has not yet started.

Fig. 7 (a) Satellite image and land-covers at the station 2 in 2003 and (b) those in 2012. The area (m²) and percentage of *buildings*, *vegetation* and *ground* in (c) 2003 and (d) 2012.

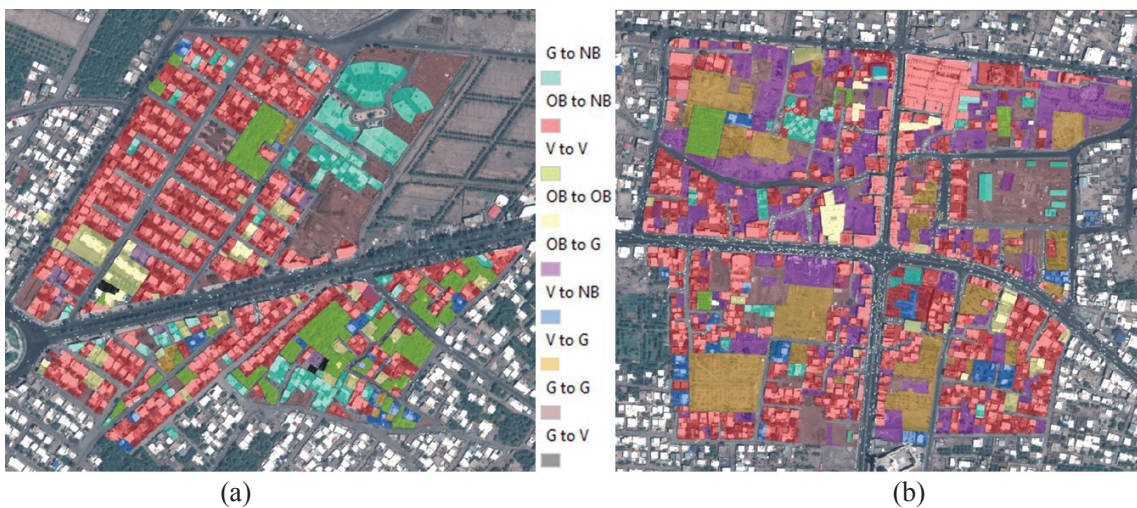
Figure 8 shows the changes in land-cover before and after the earthquake in the two study areas. The total areas associated with each of these changes are tabulated in Table 3. The considerable changes of old buildings and ground into new buildings were again confirmed around the station 1. On the other hand, around the station 2, the large amount of land-cover changes from old buildings and vegetation into ground were recognized.

Fig. 8 Changes in land-cover from *old building*, *vegetation*, *ground* in 2003 into *new buildings*, *old buildings*, *vegetation* and *ground* in 2012 are shown in colors at two locations: around (a) the station 1 and (b) the station 2.

Furthermore, although parts of vegetation have converted into new buildings (Fig. 8b), the amount of this change is not to that extent to be concerned about. The more concerning issue is the considerable amount of vegetation land that has become empty ground after the earthquake. With regard to the value of farms and gardens and the profits that could be made from these areas, and also considering the fact that most of the destroyed gardens are located in the largely-damaged areas such as (G4+G5) > 70% in Hisada et al. (2004), we can say that probably the owners of these lands were killed in the earthquake and thus nobody can restore and maintain the conditions of these gardens.
