CHARACTERISTICS OF THE JULY 1990 PHILIPPINE EARTHQUAKE AND RELATED DAMAGES

Gilbert L. MOLAS
Graduate Student
Institute of Industrial Science
The University of Tokyo
7-22-1 Roppongi, Minato-ku, Tokyo
106, JAPAN

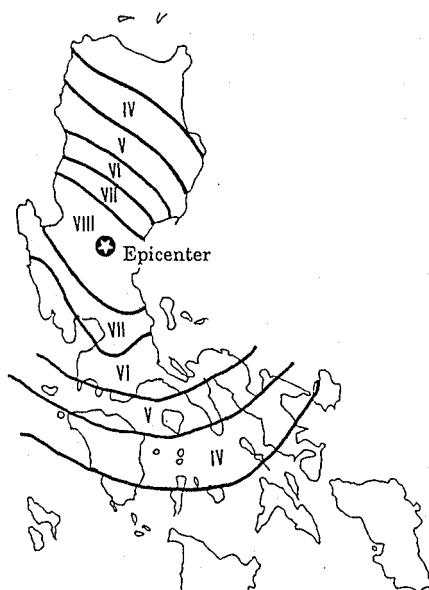
Figure 3 Isoseismal map of the 16 July 1990 Philippine Earthquake (Rossi-Forel Intensity Scale)

As in past destructive earthquakes, the Philippine Atmospheric Geophysical and Astronomical Services Administration (PAGASA) generated an isoseismal map (Figure 3) for this earthquake [2].

Figure 4 shows the plot of Acharya's intensity attenuation law. Comparing it with the observed isoseismals in Figure 3, it can be said that Acharya's attenuation law is in agreement with the observed isoseismals for the intensities south of the epicenter and within 100 kilometers north of the epicenter. The attenuation law underestimates the intensity for the rest of northern Luzon.

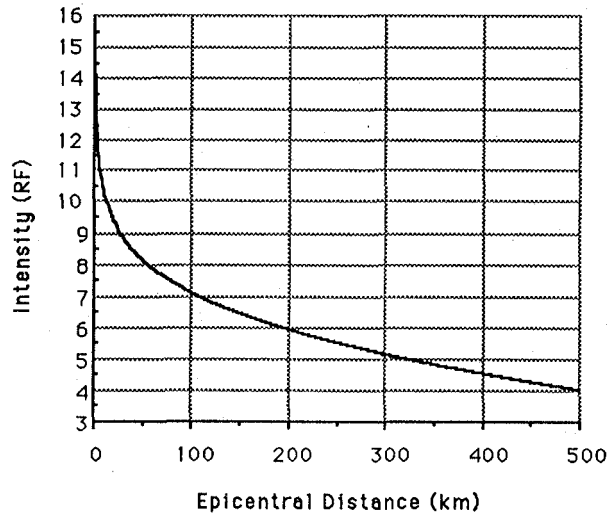
Figure 4 Plot of Acharya's Intensity Attenuation Law

The underestimated region is characterized by mountain ranges as compared to the generally flat plains of the other affected areas.

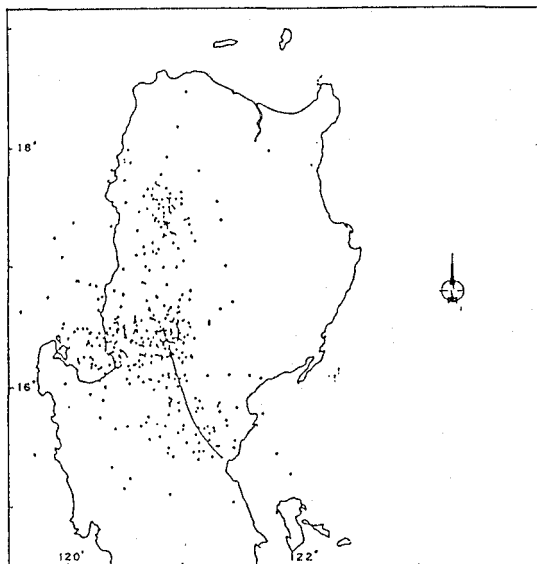
Figure 5 Distribution of aftershock epicenters [1]

A joint team from the U.S. Geological Survey (USGS) and PHILVOCS were able to get digital records of aftershocks of this earthquake [5]. Figure 5 shows the distribution of epicenters of the aftershocks. From this figure, it can be observed that there was clustering of aftershocks on 4 regions, namely: (1) along the surface rupture, (2) near the northern tip of the rupture, (3) west side of the surface rupture near Baguio and La Union, and (4) north of the surface rupture. The largest aftershock, with a magnitude of 6.6, was recorded on July 17, 1990 near the northern tip of the surface rupture [1]. This pattern of aftershock distribution was attributed to: a) presence of still unreleased stress along the rupture trace, b) subsurface crustal readjustment near the termination of the rupture trace to accommodate the large horizontal slip, and c) possible reactivation of other faults or splays of the PFZ in the region but did not result in surface rupture [1].

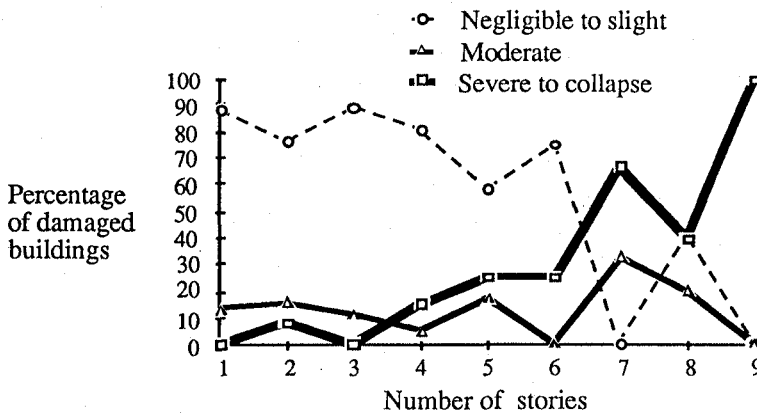
Figure 6 Relation of number of stories to percentage of damage (After Molas and Yamazaki [6])

Several buildings in Baguio collapsed or were severely damaged. From Molas and Yamazaki [6], it was observed that most of these buildings were built on sloping ground and/or have a special configuration that includes large overhangs, abrupt change in storey stiffness, large dissymmetry of torsional rigidity, etc. It was also observed that buildings 5 stories or higher are more susceptible to severe damage, more so for buildings higher than 7 stories. This suggests that the dominant frequency of the earthquake ground motion is near the natural frequen-

cy of these buildings. Figure 6 shows the number of stories to percentage of damaged buildings.

Based on the Philippine seismic design code, the natural period of a reinforced concrete building falling under the category of "Ductile Moment Resisting Space Frame" can be estimated by $0.1 N$ (secs.), where N is the no. of stories. Then 7, 8, and 9 stories would correspond to 0.7, 0.8, and 0.9 secs., respectively. Buildings with elements for resisting lateral forces would be stiffer and thus have a shorter natural period. If resonance played an important factor on the severity of damage in these buildings then it can be deduced that the predominant period of the ground motion may be within or close to this range.

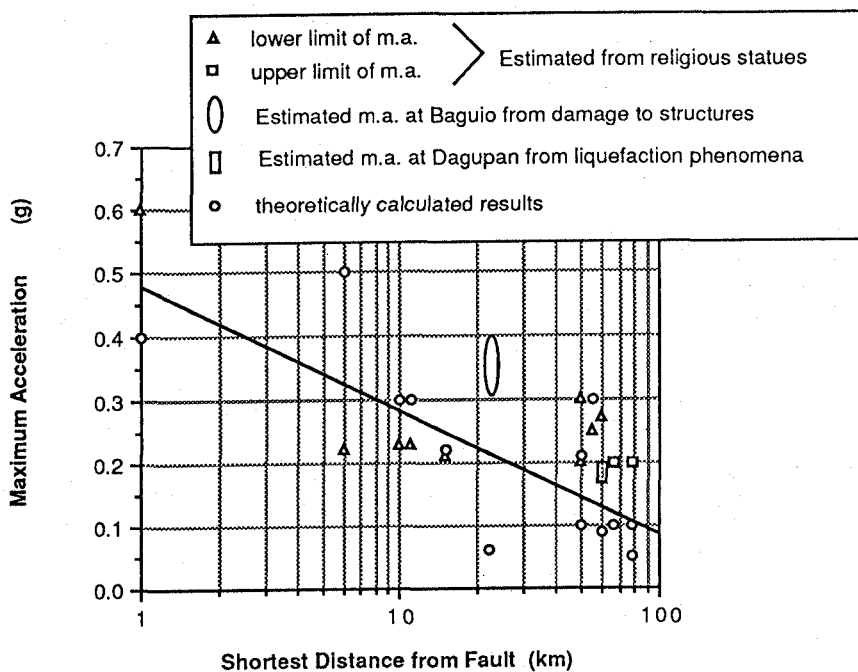
Figure 7 Plot of estimated maximum accelerations during field survey and theoretically calculated results by Sato [7] (Regression line considers theoretical results only, plot was redrawn from [8])

One method that is popular in Japan is to measure the tombstones that were toppled and those that were not. Based on the aspect ratio of the tombstone, an estimate of the PGA can be calculated. Fallen tombstones represent the lower bound of the PGA while the unfallen tombstones represent the upper bound of the PGA. This method is oversimplified but very useful in obtaining rough estimates.

In the Philippines, however, the method of burial is different from Japan and tombstones are not generally used. Therefore, the group searched for similar objects from which to gather data. The objects used were gateposts, furnitures and religious statues. The data interpretation of the group is given in Figure 7.

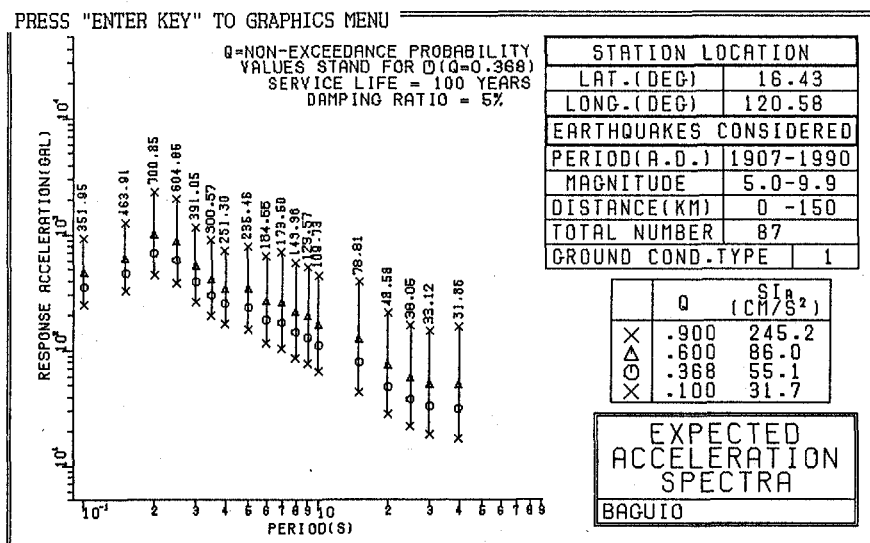
Figure 8 Expected acceleration response spectra for Baguio City

ERISA-P is an acronym for Earthquake Risk Analysis-Personal Computers. The program uses earthquake history data and given attenuation law to compute for parameters relevant to earthquake risk assessment for a given site [9,10]. These parameters are then displayed in several graphs for better readability. One of these parameters is the expected acceleration spectra for a site (Figure 8). For this analysis, a catalogue of Philippine earthquakes provided by PHILVOCS and McGuire's attenuation law (Eqn. 2) for western United States was used [11].

Earthquakes whose epicenters were within 150 kilometers from Baguio City and with magnitudes greater than 5 were used in the analysis.
