# Development of Building Damage and Tsunami Inundation GIS Dataset following the 2010 Chile Earthquake

## Summary

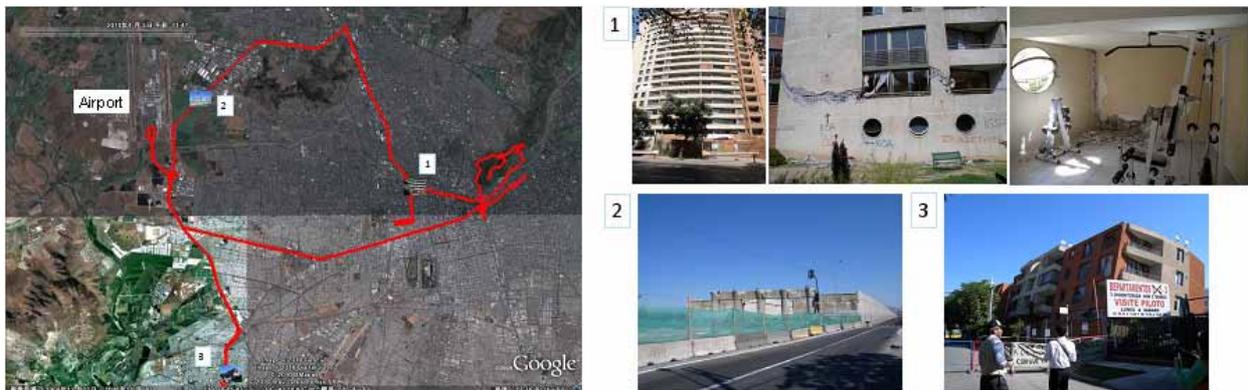
Fig. 2: Survey route and field photos in Santiago—April 2, 2010

Figure 2 shows the route of our field survey in Santiago and some field photographs. The route was recorded by a portable GPS device during the survey and the location of the photo shooting could be identified as the location data were embedded in the Exchangeable Image File Format (EXIF). An RC building with 20 stories constructed in 2003 suffered from shear failures in columns and walls at the first and the second stories. A collapsed highway bridge and an RC building with the collapsed first floor were found. The locations of these sites are also shown in the survey route in Fig. 2.

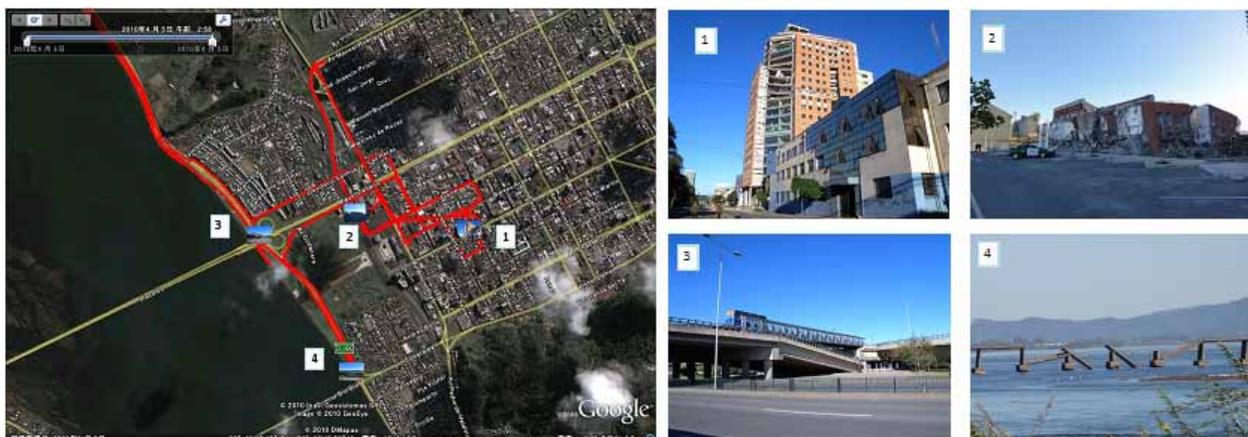
Fig. 3: Survey route and field photos in Concepción—April 4, 2010

Figure 3 shows the survey route in Concepción. An RC building with the damaged middle floor was found at the site numbered 1. An RC

building with 15 stories had collapsed completely at the site numbered 2. The road bridges collapsed at sites 3 and 4. The temporary bridge girder was constructed two days after the earthquake at site 3. Although the photos are not shown in this paper, the adobe and unreinforced masonry constructions were severely damaged in the urban area.

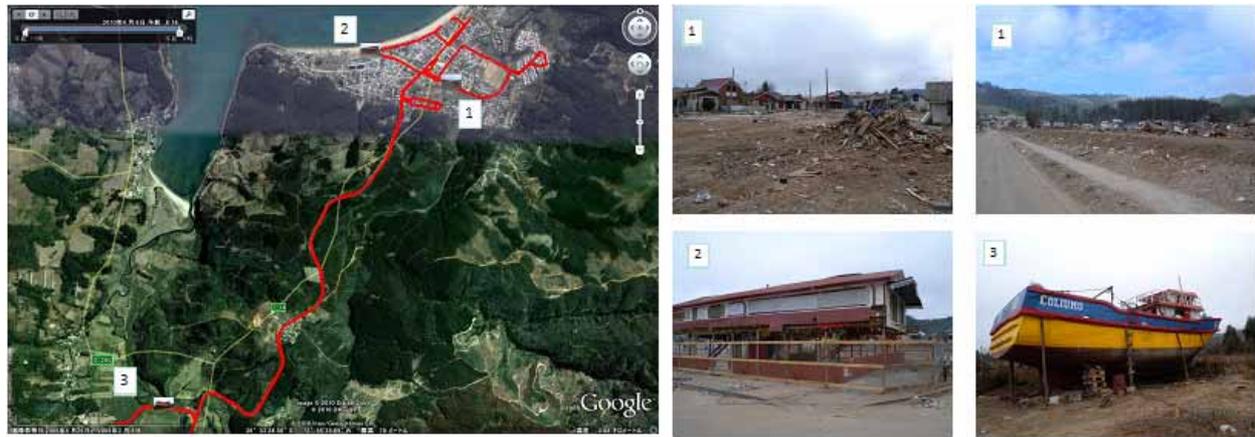
Fig. 4: Survey route and field photos in Dichato—April 5, 2010

Figure 4 shows the survey route in Dichato. It is reported that more than 80% of the built-up area in Dichato suffered from tsunami [5]. As shown in the field photos, the buildings collapsed because of the tsunami waves. A ship was conveyed against the river flow because of the tsunami and eventually found at site 3.

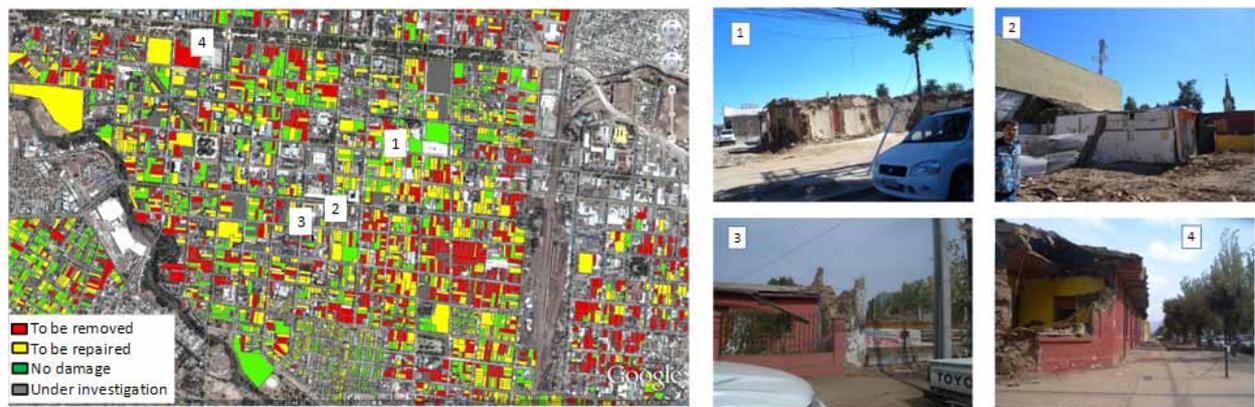
Fig. 5: GIS file to show the damage levels of buildings in Talca and locations of field photos

In this study, the location of the image file was established in terms of map projections. The satellite image and road data presented in Google Earth were employed as a base map to georeference the image file. Then, the image file was converted to a GIS file with polygons to identify the damage levels of buildings. Figure 5 shows the developed GIS file presented by Google Earth and some

field photos to show the examples of damaged buildings.

In all, 5617 polygons were projected to the map coordinate system. 1559 (27.8%), 1872 (33.3%), and 1864 (33.2%) buildings were classified as to be removed, to be repaired, and no damage, respectively. The typical construction types in Talca are adobe and unreinforced masonry buildings, which are primarily used for older constructions with 2–4 stories (dating back to before the 1960s–70s). Modern buildings that were designed according to the current codes suffered minor, repairable damage, while a large number of adobe and unreinforced masonry constructions suffered significant damage [6].

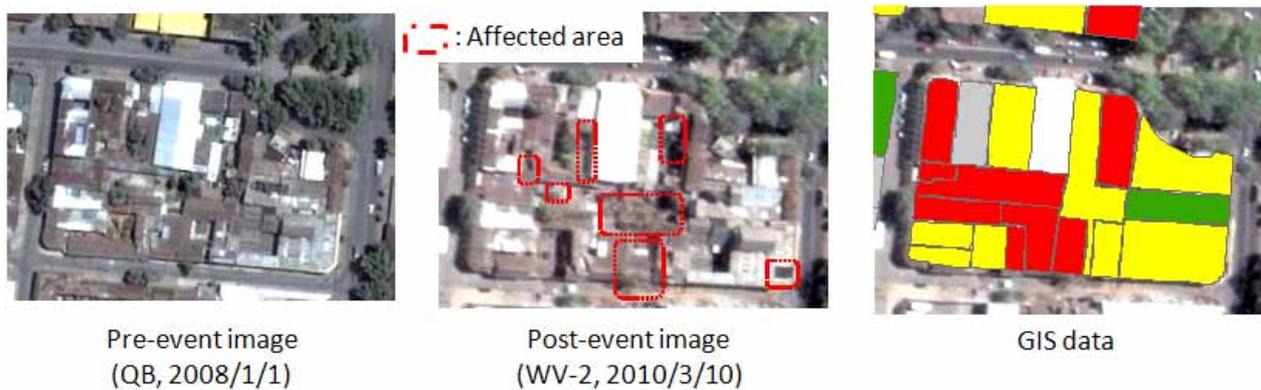
Fig. 7: Comparison between pre- and post-event satellite images to detect affected buildings

Recent advancements in remote sensing technologies and their applications have made it possible to use remotely sensed imagery for estimating the damage distribution due to natural disasters. Among them, high-resolution optical satellite imagery, which has become available in the last decade, has made satellite remote sensing more useful in disaster management since even the damage status of individual buildings can be identified [7–8]. Figure 7 compares the pre- and post-event high-resolution optical satellite images with the GIS dataset shown in Fig. 5. As for the pre- and post-event images, the image captured by QuickBird [9] on January 1, 2008, which is presented in Google Earth, and that captured by WorldView-2 [10] on March 10, 2010, are employed in this study. A comparison of the pre- and post-event images revealed that some of the affected buildings could be visually detected, but not all the damaged ones could be identified appropriately. Since the

post-event image was captured with the large off-Nadia angle ( $40.3^\circ$ ), the quality of image is not sufficient for visual damage inspection. Moreover, the number of affected buildings whose roofs had completely collapsed is small in Talca. Hence, it can be concluded that the damaged buildings in Talca are difficult to be detected through visual damage inspection using satellite images.

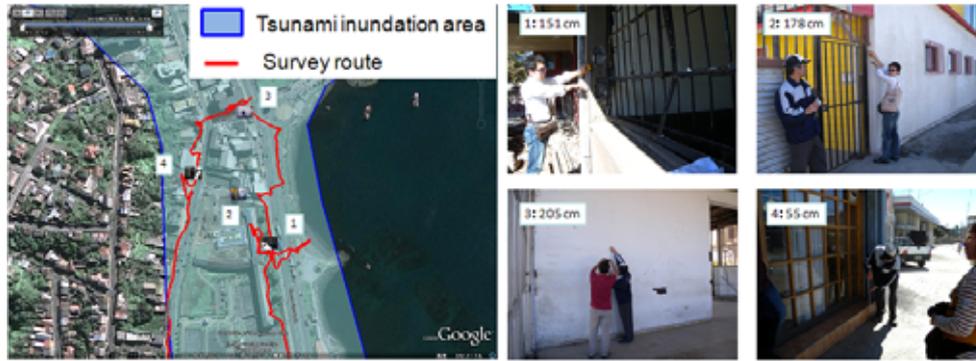
Fig. 10: Measurement of tsunami inundation depth in Talcahuano

As shown in Fig. 10, the inundation depth was measured at several sites in the three cities. The inundation depth along the beachfront street in Talcahuano was larger than 150 cm, but a depth of 55 cm was observed in its bystreet (site 4). Figure 11 summarizes the measurements in the three cities. The inundation depth is presented with respect to the elevation and the distance from the coastline. As for the results in Constitución, the records are shown with respect to the distance from the Maule River. A clear tendency is not seen in the relationship between the tsunami inundation depth and the elevation. The recorded depth in Talcahuano and Constitución decreased with an
