Visual Damage Interpretation of Buildings Using QuickBird Images Following the 2007 Peru Earthquake

Summary

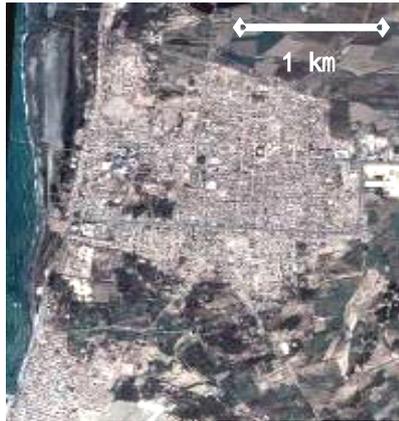
Fig. 1: QB satellite image of Pisco acquired 12 days after the earthquake.

QuickBird satellite captured a clear image of Pisco city on 27 August 2007, 12 days after the quake, as shown in Figure 1. QuickBird also observed Pisco city on 3 June 2007, 3 months before the earthquake. Figure 2 shows partial enlargements of the pre- and post- event QB images. In the post-event image, the building damages could be identified by debris from the variation of texture and the disappearance or decrease of shadow of collapse buildings. As a characteristic of this region in remote sensing imagery, the shadows of buildings are relatively small due to the low-latitude with little vegetation. The building materials in the city are of similar color with that of bare ground.

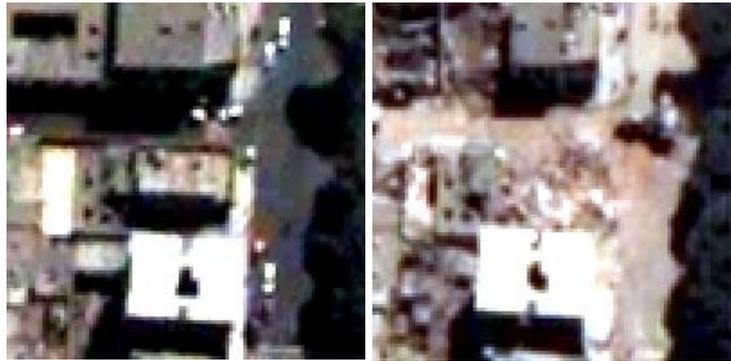
Fig. 2: Enlargement of a part of the images: the pre-event (left) and post-event (right) ones.

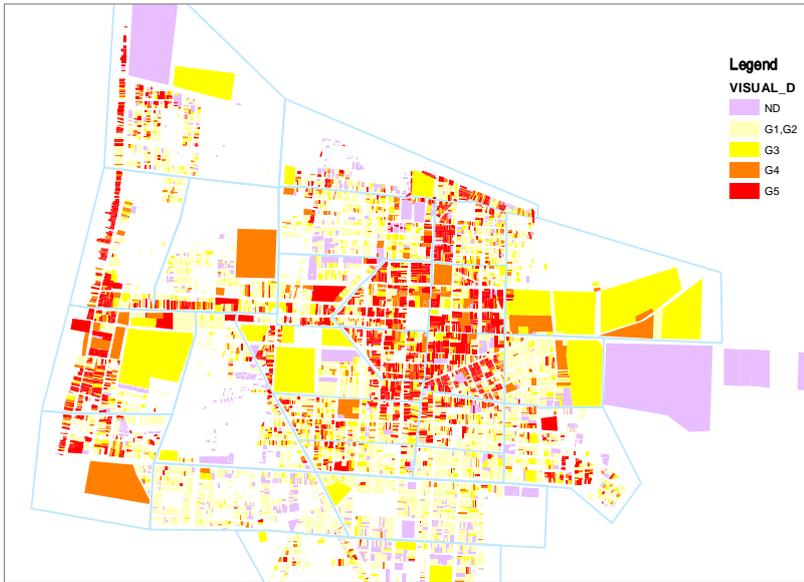
Figure 3 shows the result of interpretation displayed on GIS. In the image interpretation, it was too difficult to distinguish Grades 1 and 2 because these are defined by a slight damage to lateral faces of a building. Therefore, these two damage levels were unified as Grade 1/2 in this study. Severe

Fig. 3: Result of visual damage interpretation plotted on GIS using QB satellite images.

damaged buildings of Grade 5, which represent completely collapsed buildings, were observed in the area along the coast and in the old urban area located in the eastern part of the city. A building with certain damages in roof was classified as Grade 4. Large lots in the outskirts of the city are the properties of schools, hospitals and factories. Approximately, 1,100 lots were categorized as no data, and those are denoted as ND in Figure 3.

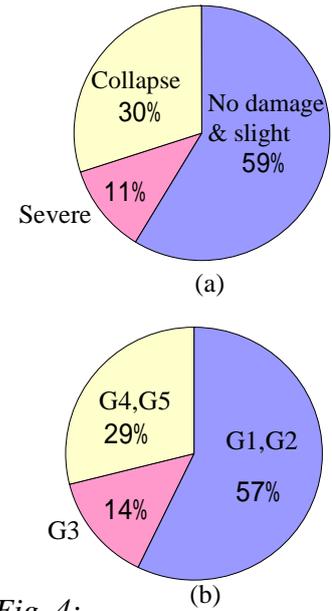
Fig. 4: Ratio of each damage rank by (a) QB visual detection and (b) field survey.

The ratios of damage grade by images interpretation and field survey are illustrated in Figure 4. Each corresponding damage rank is almost the same ratio. Most of the damaged buildings were classified as Grade 4 and Grade 5, and only a few of them were categorized into Grade 3 (moderate damage). The trend of damage observed in this earthquake may depend on the characteristic of masonry structures, specifically lack of rigidity, and thus they collapsed quickly.

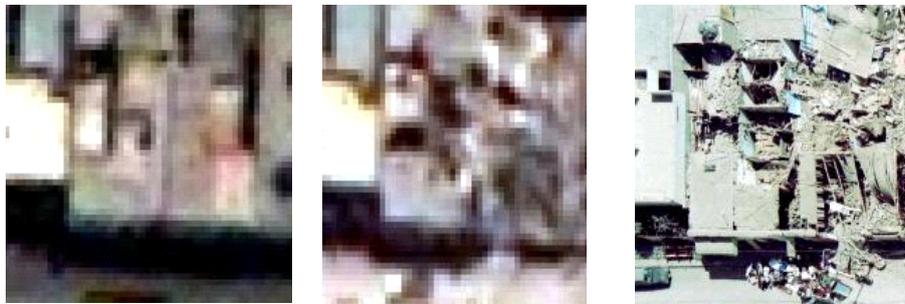
A part of each image is shown in Figure 5. The resolution of the aerial photograph is considered to be about 0.2 m, remarkably high, and thus even the detail of building damage is recognized. It can be clearly confirmed that the roof had been broken down and only the walls remained at the building located in the center of the photo.

(a) the pre-event QB (b) the post-event QB (c) the post-event aerial photo
 Fig. 5: Comparison of the satellite images and an aerial photograph

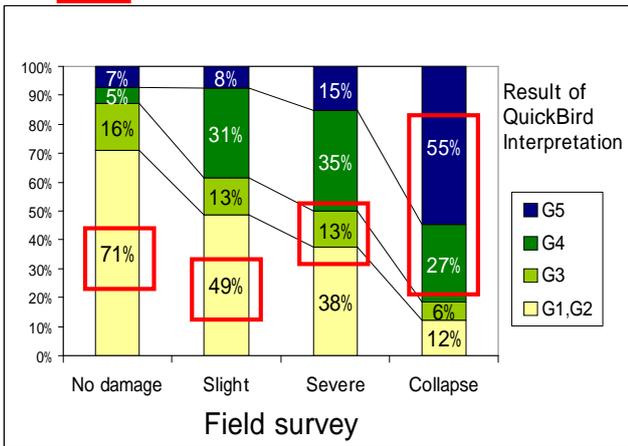
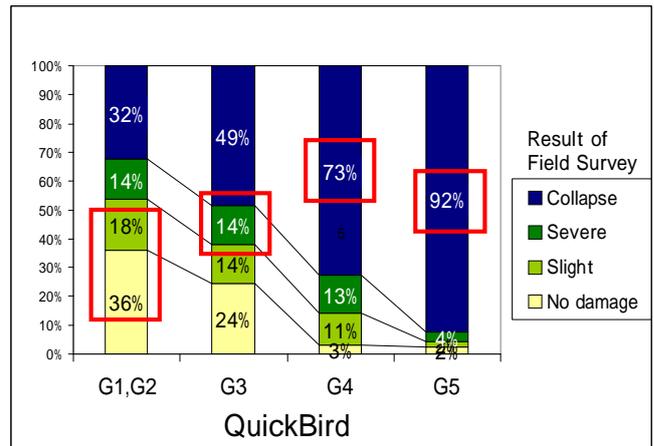
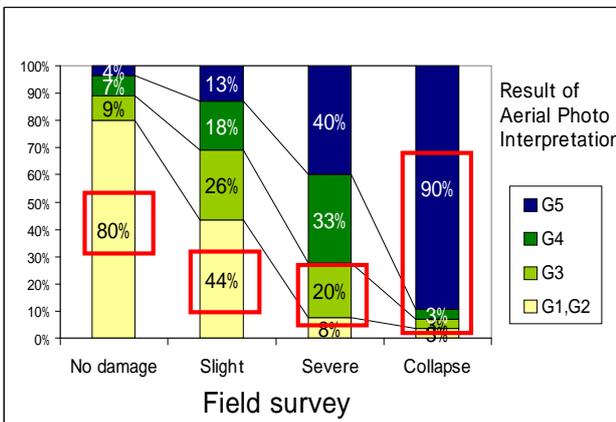
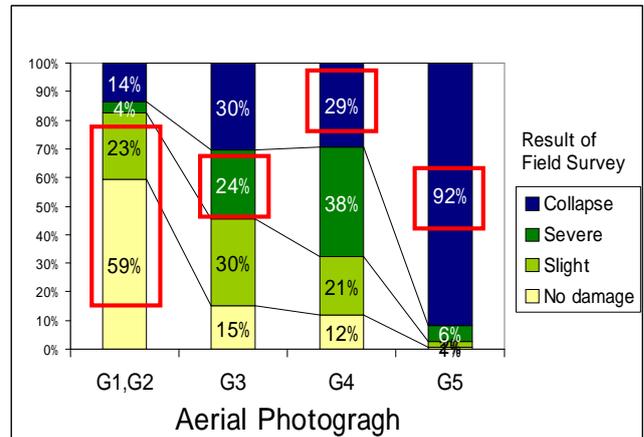
Fig. 6: Producer's accuracy of QB image interpretation in central Pisco.

Fig. 7: User's accuracy of QB image interpretation in central Pisco.

Fig. 8: Producer's accuracy of aerial photo interpretation in central Pisco.

Fig. 9: User's accuracy of aerial photo interpretation in central Pisco.

Figures 6 to 9 summarize the accuracy of building damage classification by visual interpretation against field survey. The accuracy of G5 has significantly improved using the high resolution aerial image. When the levels G4 and G5 are added together, the accuracy of 80% or more is achieved in any case, thereby demonstrating the usefulness of QB high-resolution satellite images in damage detection.
