Evaluation of Buildings Quality and Soil Condition in Boumerdes City Using Damage Data Following the 2003 Algeria Earthquake

A. Meslem, F. Yamazaki & Y. Maruyama

Department of Urban Environment Systems, Chiba University, Chiba, Japan

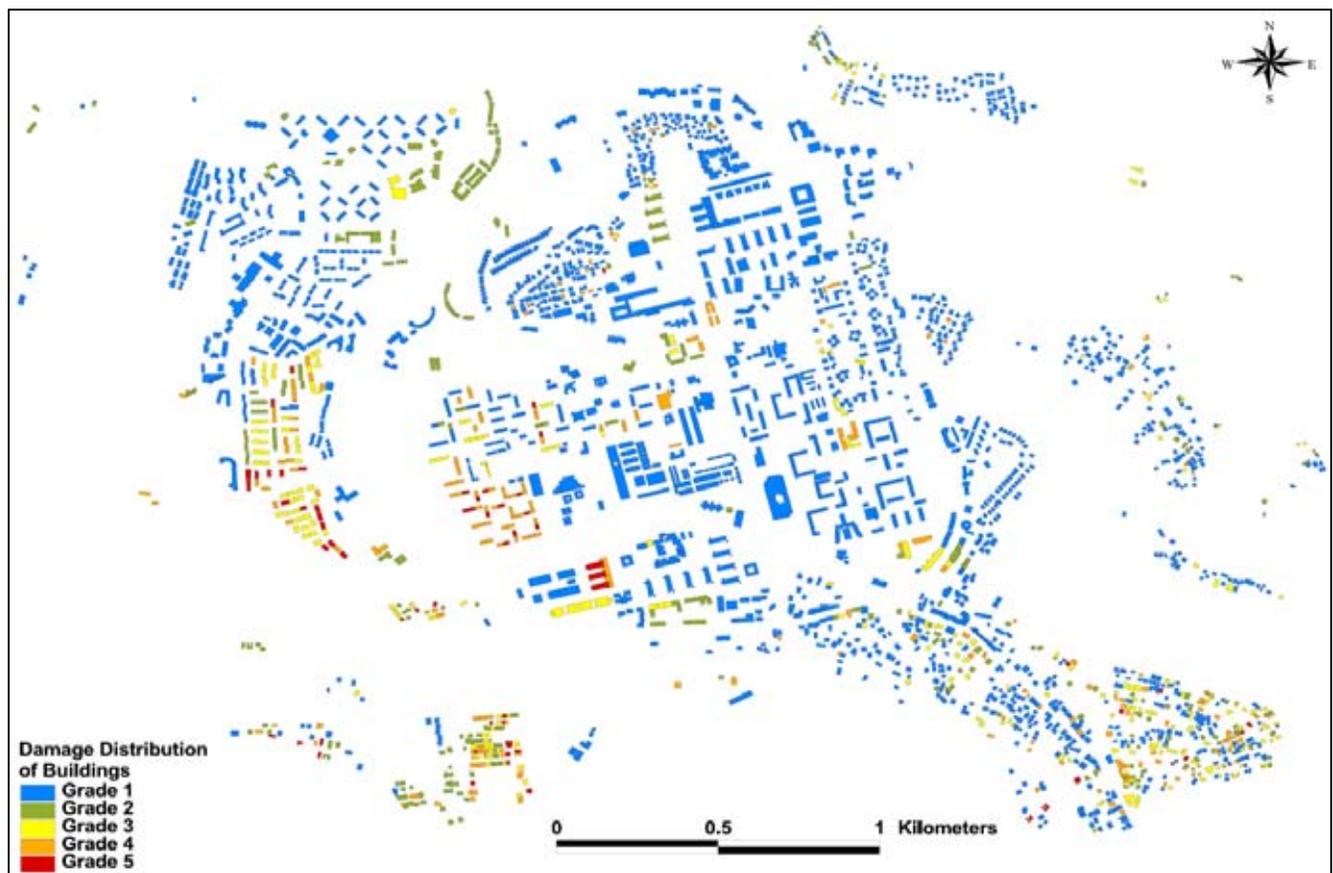
Figure 4. Damage distribution of Buildings in the City of Boumerdes following the 2003 Algeria earthquake.

In the week after the disastrous event of the 2003 Boumerdes earthquake, a mission for damage assessment had been conducted by the Ministry of Housing, covering all the affected areas in the provinces of Boumerdes and Algiers (Belazougui et al. 2003). This mission lasted until 30 June 2003, using five levels of damage classification ranging from negligible/slight damage to very-heavy/collapse. In Boumerdes city, from the identified 2,794 buildings, 65 buildings were totally or partially collapsed (Grade 5), 250 buildings suffered from very-heavy damage (Grade 4), 261 buildings were classified as Grade 3, 313 buildings as Grade 2, and 1,905 buildings as Grade 1. The damaged buildings with Grades 5 and 4 had been completely removed and new constructions have started in the area. Figure 4 shows the GIS map of building damage created in this study.

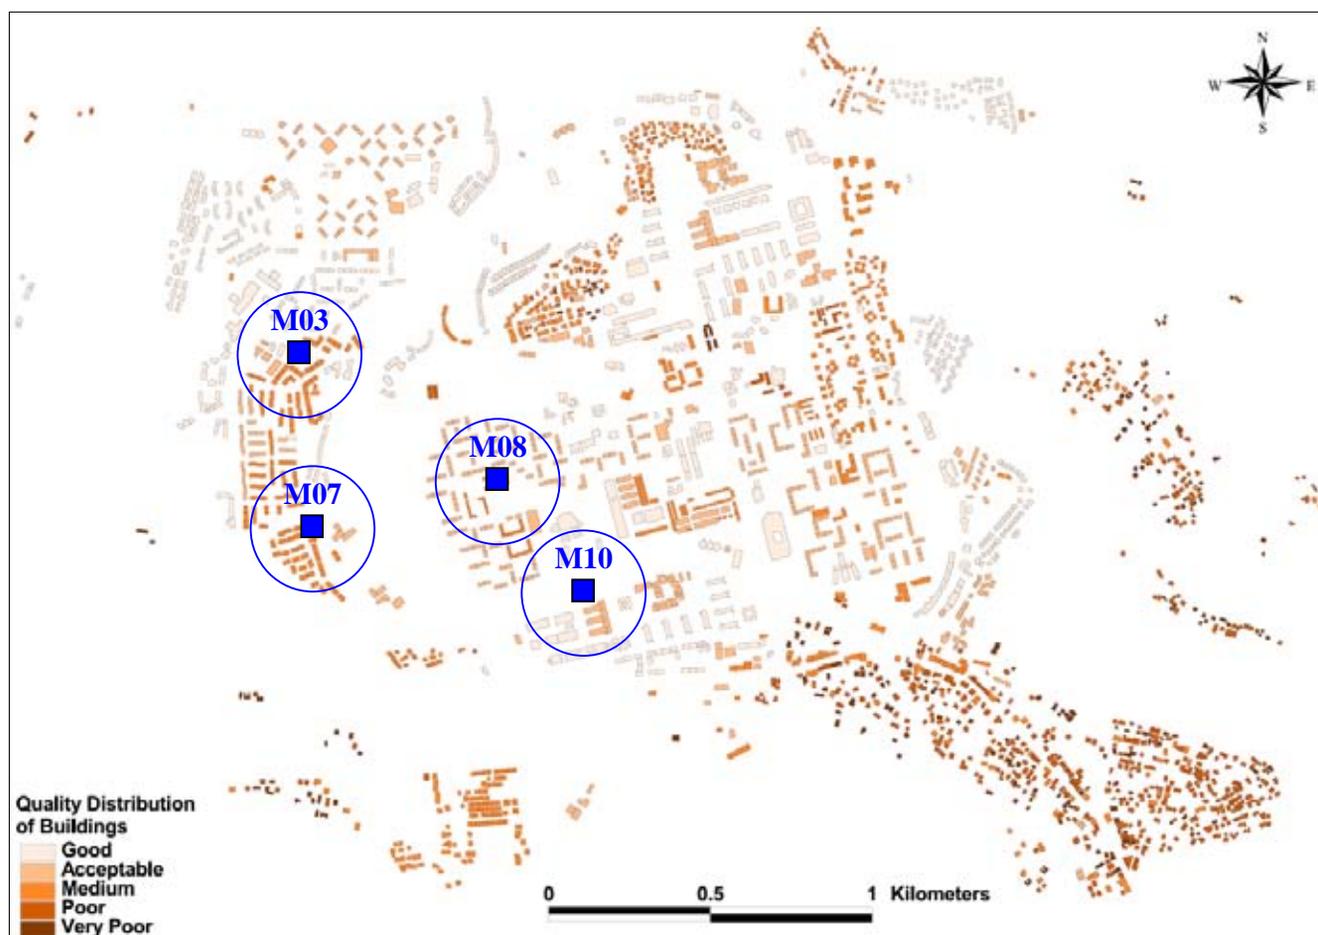
Figure 6. Distribution of buildings with respect to the quality classification in Boumerdes City. Open circles correspond to the selected buildings located within 200 m from microtremor observation points.

binning the different factors presented in the previous section. Figure 5 shows examples of quality classification of buildings. The distribution of building quality in the city of Boumerdes is shown in Figure 6. The results from this analysis show that 22 % (627) are classified as good quality, 19 % (539) acceptable quality, 30 % (827) medium, 20 % (571) poor, and 8 % (230) very poor quality. The buildings associated with poor and very poor qualities are mostly private buildings. The constructions with good and acceptable qualities are mostly for public buildings.

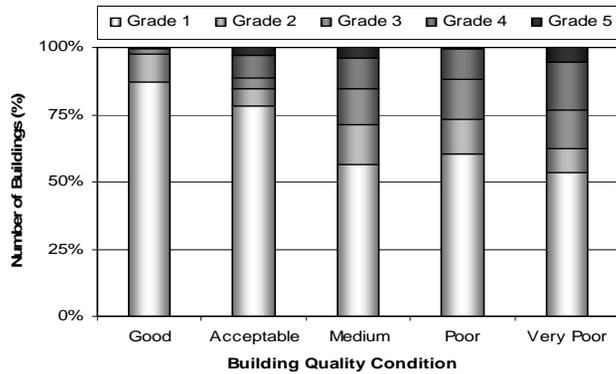
Figure 7. Relationship between Condition of Building Quality and observed Damage Grade.

According to Figure 7, which shows the percentage of building damage grade with respect to the building quality, it is generally observed that severer damages were associated with poor quality condition. However, there are some buildings classified as acceptable or medium quality but suffered from severe damages (Grades 4 and 5) due to the earthquake. On the other hand, even though classified as poor or very poor quality, some buildings did not suffer extensive damages. If we assume the similarity of soil condition and seismic motion for the

whole area, the damage grade should be a function of building quality, i.e. damage Grade 1 mainly corresponds to quality Class 1 (good quality) and damage Grade 5 corresponds to quality Class 5 (very poor quality). Because of dissimilarity of soil condition in different locations, the relationship between the building quality and damage grade includes some variation.

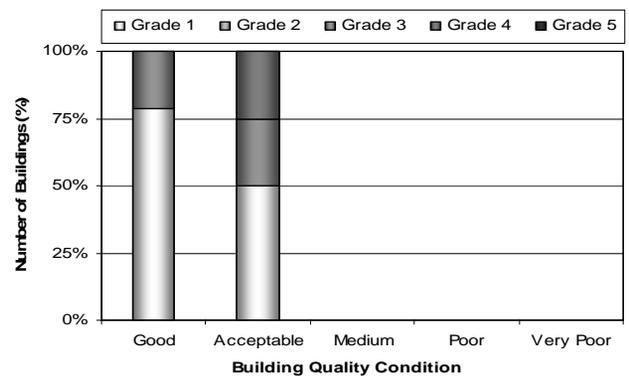
Figure 11. Damage Rank to Quality Class of selected buildings for M10.

To compare the results of microtremor observation with the damage grade and building quality, a certain number of buildings which located within 200m from the microtremor measurement points were selected as in Figure 7. The selected locations M03, M07, M08, and M10 correspond to the most severely affected areas in the city where a large number of buildings were totally collapsed. As shown in Figures 8, 9, 10 and 11, the most of existed buildings are classified between good (Class 1) and medium (Class 2), according to the result of our investigation. The damage grade is between 1 (none or slight damage) to 5 (very heavy to total collapse). In fact, the observed H/V ratios at these locations (Fig. 3) show the peak period around 0.7s, which suggests the existence of soft soil. However, since the amplitude at these peaks is quite small, the soft soil layers seem to be thin.
