# Damage Assessment of Buried Pipes due to Recent Earthquakes in Japan

F. Yamazaki, K. Kimishima & Y. Maruyama

*Department of Urban Environment Systems, Chiba University, Chiba, Japan*

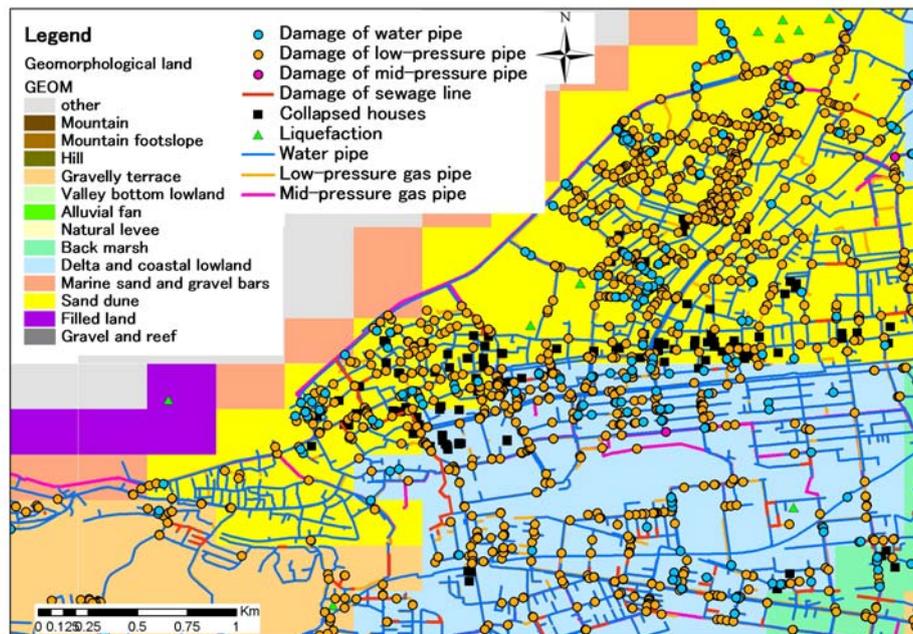
Figure 2 shows the distribution of damages to lifeline systems plotted on the geomorphological land classification map. The geomorphological land classification dataset used in this study is a nationwide digital map constructed by Wakamatsu *et al.* (2006). According to this classification map, the central part of Kashiwazaki City is mainly classified as *sand dune*, *delta and coastal lowland*, and *back marsh*. The damage ratios of water, low-pressure gas, and mid-pressure gas pipes with respect to the geographical land classification are shown in Fig. 3(a). The damage ratio of the sewage system is plotted in Fig. 3(b).

Figure 2. Damage distribution of buried pipes in Kashiwazaki City due to the 2007 Niigata Chuetsu-Oki earthquake plotted on the geographical land classification map

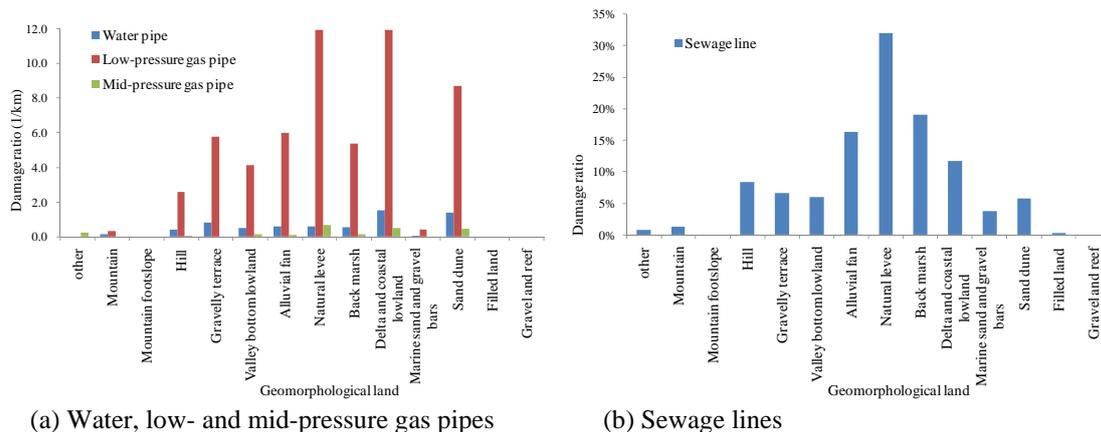
Figure 3. Damage ratios of lifelines with respect to geomorphological land classifications

The damage ratio of water distribution pipes is the highest in *delta and coastal lowland* areas (1.48), followed by *sand dune* (1.35). Similarly, the damage ratio of low-pressure gas pipes is the highest in *delta and coastal lowland* (11.93), followed by *natural levee* (11.92). As for the water and low-pressure gas pipes, the damage ratios are high for the geographical classes, which mainly consist of soft soil. The damage ratio of mid-pressure gas pipes is the highest in *natural levee* (0.65) and the second highest in *delta and coastal lowland* (0.47). The damage ratio of sewage line is the highest in *natural levee* (32%) while it is 19% in *delta and coastal lowland*. As for the mid-pressure gas pipes and sewage lines, the damage ratios are high in *natural levee* and *delta and coastal lowland*.

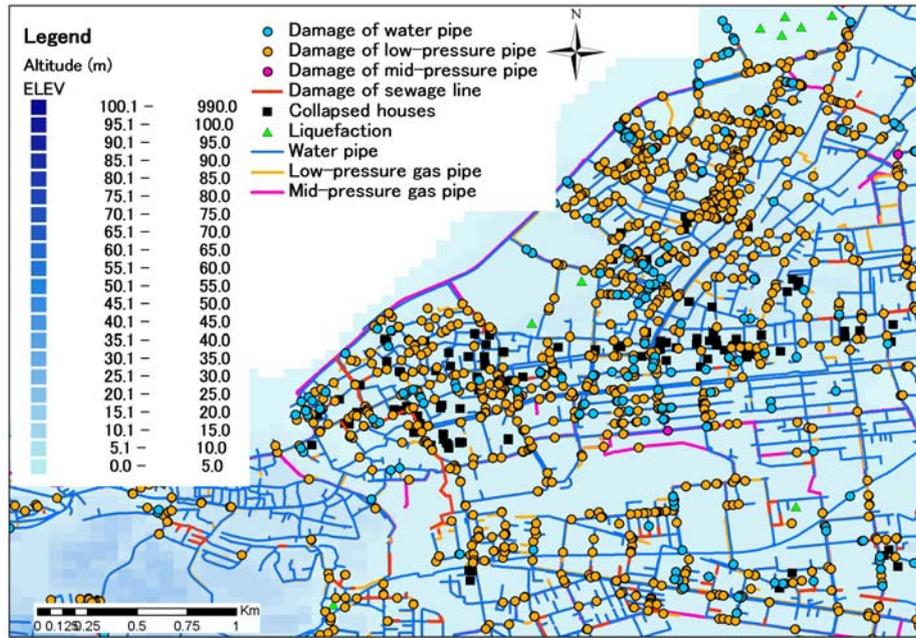
Figure 4 shows the location of damage incidents (breaks/leaks) of lifeline systems and the altitude model, which was developed by the Geographical Survey Institute of Japan (2001). The altitude is shown in 50 x 50 m<sup>2</sup> grid cells. The damage ratios of water, low-pressure gas and mid-pressure gas pipes with respect to the altitude are shown in Fig. 5(a) and that of sewage lines is shown in Fig. 5(b).

Figure 4. Relationship between the altitude class and lifeline damages

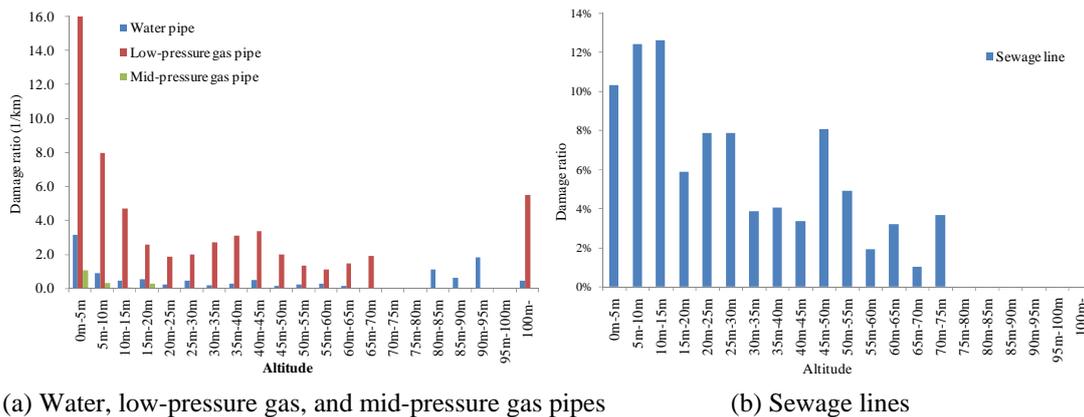
The damage ratios of water, low-pressure gas and mid-pressure gas pipes are the highest for altitude class 0-5 m. The damage ratio of sewage lines is the highest when the altitude is 10-15 m. The damage ratio is still in high values for the altitude 0-10 m. As for water, low-pressure gas, and mid-pressure gas pipes, no notable difference is seen in the trend of the damage ratios of the three buried pipes.

Figure 5. Damage ratios of lifelines with respect to the altitude class
