DETERMINATION OF BUILDING DAMAGE DUE TO EARTHQUAKES USING AERIAL TELEVISION IMAGES

Hirotsada HASEGAWA¹, Fumio YAMAZAKI², Masashi MATSUOKA³ And Izumi SEKIMOTO⁴

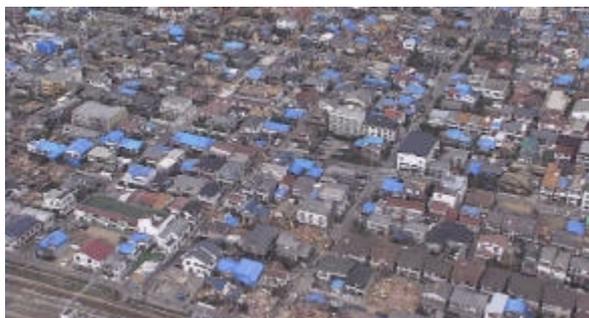
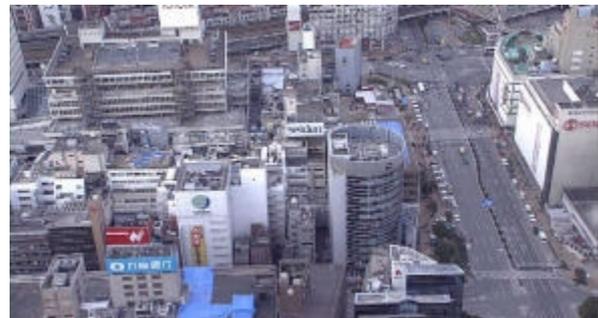
Figure 2: Example of the aerial HDTV images taken by NHK

(a) Area 1 in Nishinomiya

(b) Area 2 in Kobe

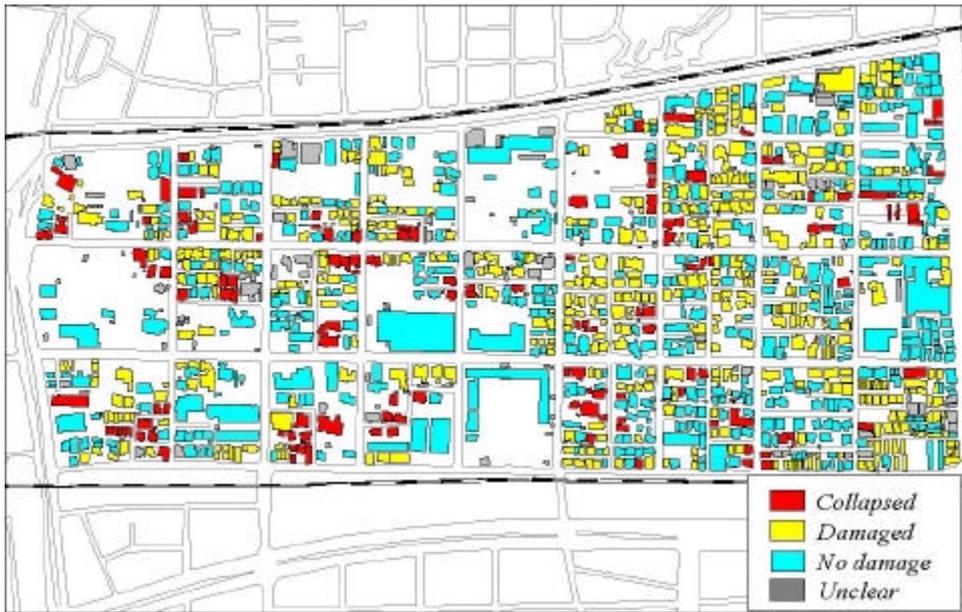
Figure 5: Distribution of building damage in Area 1 interpreted from the aerial HDTV images

In the study areas, the number of buildings whose degree of damage was evaluated from the ground surveys is 939 wooden buildings in Area 1 and 474 nonwooden buildings in Area 2. The distribution of building damage in Area 1 from the aerial HDTV images is shown in Figure 5 and that in Area 2 is shown in Figure 6. The result for the wooden buildings in Area 1 was given as the average of the results obtained by the five people, who engaged in the damage extraction. Interpretation of damage to most buildings was possible for Area 1 (97%). But the rate in Area 2 was lower (79%) than Area 1. The reason for this is that we used aerial images taken from an oblique angle in this study, and thus more buildings were blocked from view in Area 2 than in Area 1. Therefore, the extraction results for the both areas were evaluated without including the buildings for which damage extraction using the aerial images was impossible.

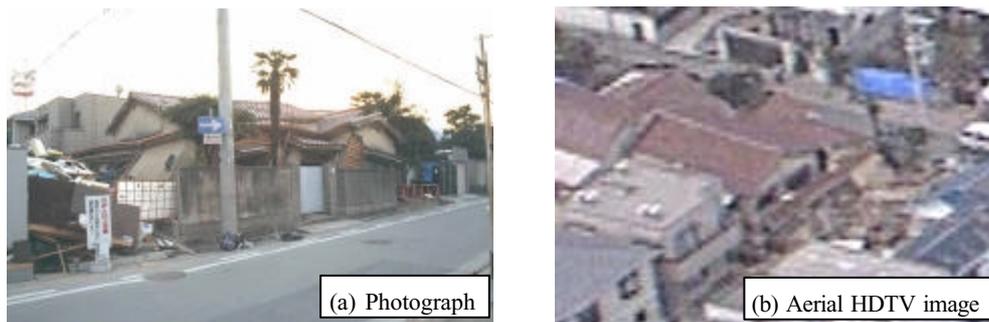
Figure 9: Example of a collapsed building from two different views: (a) a photograph taken from the ground and (b) a snapshot of HDTV images taken from the air

The 55 wooden buildings in Area 1 were classified into 3 damage level (*collapsed*, *damaged* and *no damage*) using photographs taken at the time of the damage survey (Table 4). Figure 9 shows an example of photographs and aerial HDTV images for a damaged building. Figure 10 plots the results of the five interpreters for the 27 collapsed buildings with photographs. It was found that the interpretation results for the collapse-type damage of buildings changed with interpreters. One factor for this fact might be time spent for interpretation; the time spent by Interpreter-4 was about 3 hours while other persons spent more than 5 hours. Furthermore, the criterion of interpretation of collapsed buildings from the aerial HDTV images was not very strict. Therefore, a further elaboration on the damage interpretation from aerial HDTV images may be necessary.
