Building Damage Mapping of the 2006 Central Java, Indonesia Earthquake Using High-Resolution Satellite Images

Hiroyuki MIURA¹, Fumio YAMAZAKI² and Masashi MATSUOKA³

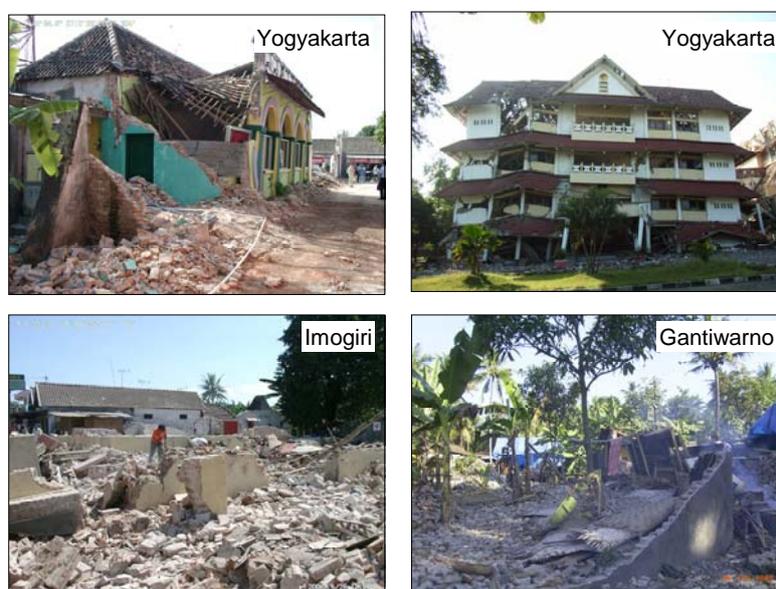
Fig. 2 Ground photographs in the damaged area in Yogyakarta, Imogiri and Gantiwarno

visited the affected area from June 26 to July 1 to gather ground truth data of the building damage and reflectance characteristics of surface materials. Figure 2 shows the ground photographs taken at Yogyakarta, Imogiri, and Gantiwarno. The typical structure of the houses is unreinforced adobe construction with wooden frame and roof tiles. As shown in the photos, not only the adobe houses but also RC-framed buildings are also damaged in Yogyakarta city. In the rural area, numbers of the houses are completely collapsed. The field survey reveals that the heavily damaged area is distributed not only in the south rural area such as Bantul and Imogiri but also in the east rural area such as Gantiwarno, that is located in the northeast of the fault. The UNOSAT map does not contain the damage in Gantiwarno because the QB images used in the interpretation didn't cover the area. According to the report by Murakami (2006), the complete collapse ratios in Imogiri and Gantiwarno are more than 30%.

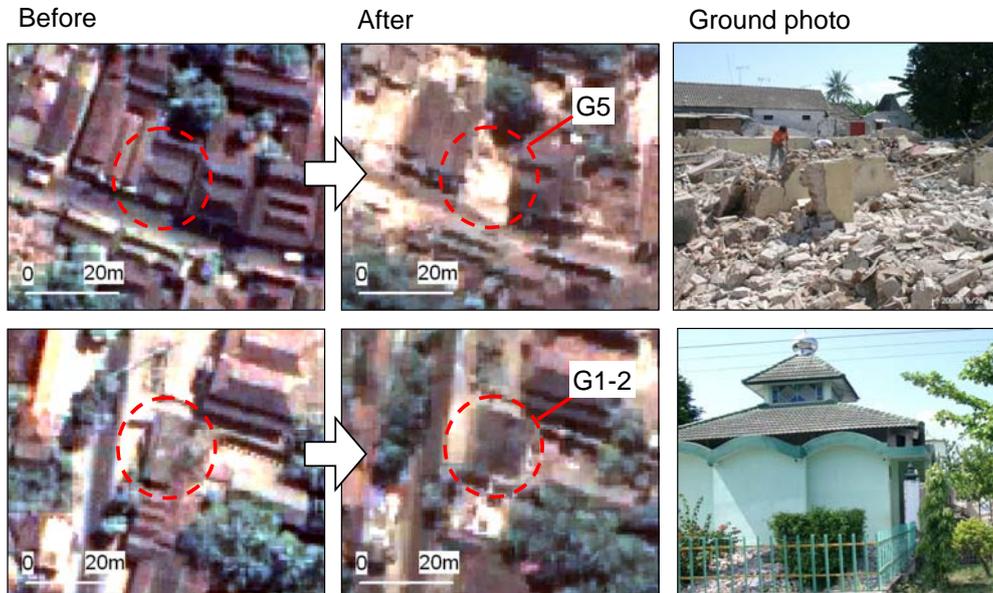
Fig. 5 Comparison of pre- and post-earthquake QB images with ground photographs

Figure 5 shows the comparison of a building between pre- and post-earthquake images. The building surrounded by dotted circle in the upper figures is classified into Grade 5 (G5), completely collapsed damage, since it is whitened and textured in the post-earthquake image. On the contrary, the building in the bottom figures is classified into G1-2, because significant difference is not observed between the images. The right figures show the ground photographs of the buildings, indicating that the classification of the visual detection agrees with the actual damage level. Totally damage levels for 90 buildings in and around Imogiri village are interpreted and compared with the actual damage level classified from the ground photos. Table 1 shows the comparison of the classifications. Most of the buildings are classified into G5 or G1-2. It indicates that the number of moderately damaged building such as G3 is small in the heavily damaged area. According to the table, negligibly damaged buildings and completely damaged buildings are well detected from the QB images. These results show the damaged buildings could be easily extracted from the image because the characteristics of the damaged buildings are totally different from undamaged ones.

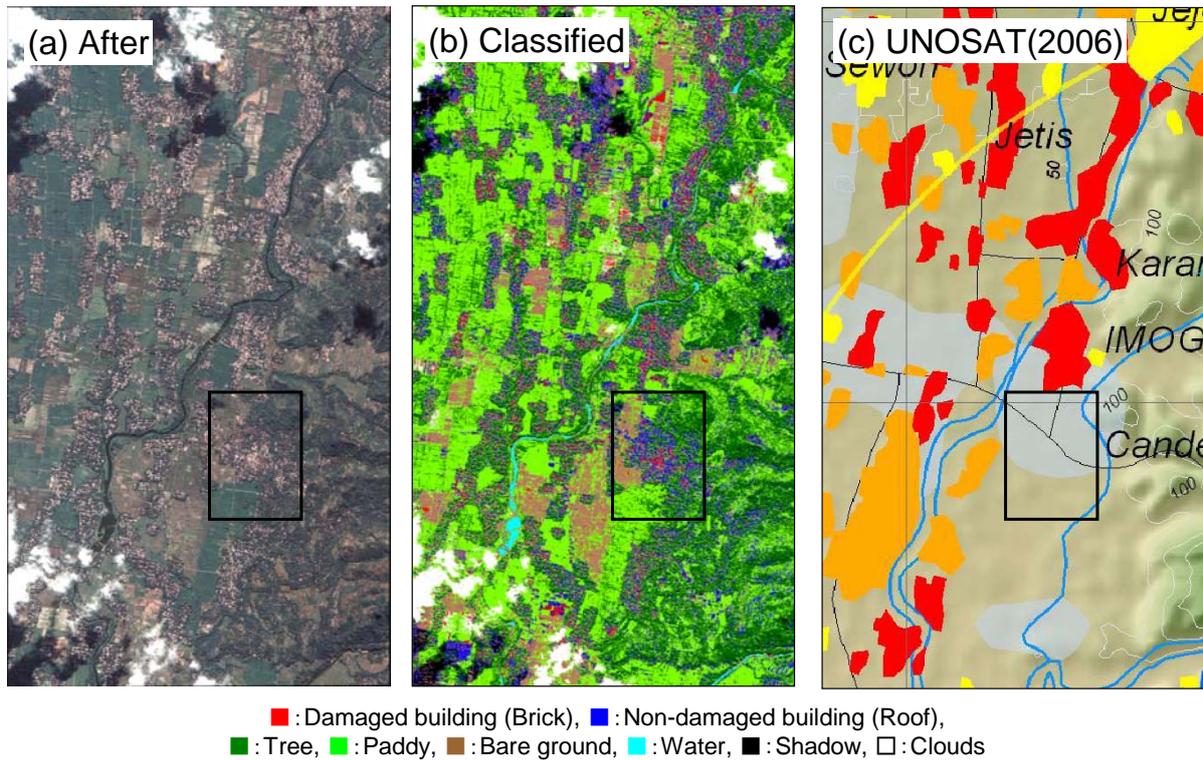
Fig. 6 (a) Post-earthquake image, (b) Result of image classification, and (c) UNOSAT map

Figure 6(a) shows the original image and Figure 6(b) shows the result of the supervised maximum likelihood classification. Red colored pixels indicate bricks and blue colored pixels represent roof tiles. The settlements are dotted in the area, while most of the image is covered with the paddy and the trees. The UNOSAT map is also shown in Fig. 6(c) compared with the classification map. The damage in the area shown by square in the figure is not mapped in the UNOSAT map since the area is covered with clouds in the QB image. The close-up of the square in Fig. 6 is shown in Fig. 7. The pre-earthquake image is also shown in the figure. The comparison between the pre- and post-earthquake indicates that heavily damage is clearly observed in the central part of the image since the color of the buildings is discolored to white. In the classification map, the red pixels are concentrated in the apparently damaged area and the blue pixels are distributed in the settled area. It suggests that the severely damaged areas are well identified by the image classification. However, the red pixels are distributed also in the bare ground area and the road as shown by dotted circles in the figure. They are mis-classified because the color of the ground is similar with the exposed bricks. The number of the mis-classification would be reduced by including the result of the land cover classification of the pre-earthquake image in the analysis.

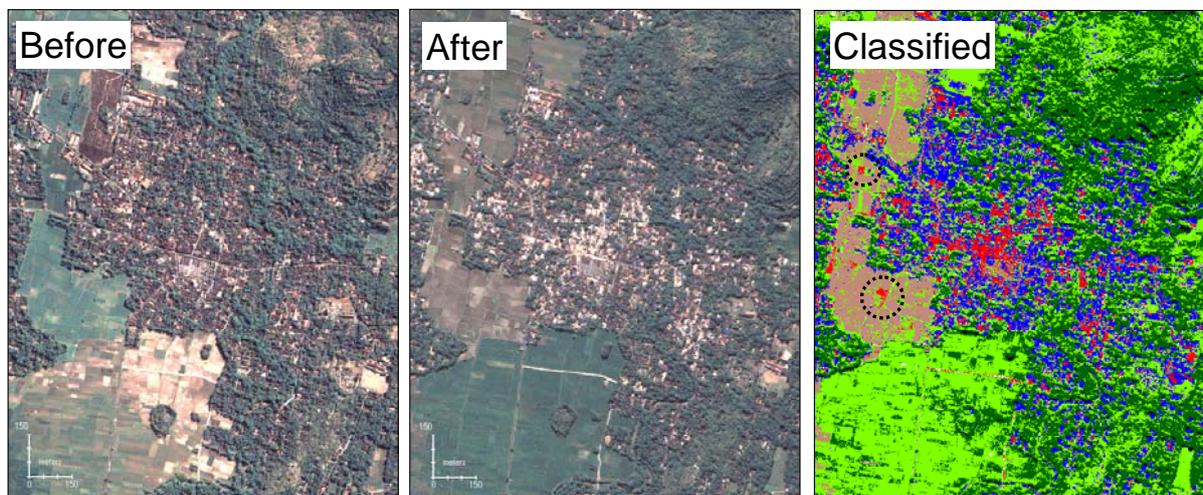
Fig. 7 Close-up of severely damaged area with pre-earthquake image
