Journal of Earthquake and Tsunami, Vol. 5, No. 1 (2011) 57–70 © World Scientific Publishing Company DOI: 10.1142/S179343111100098X

DAMAGE ASSESSMENT OF BURIED PIPES DUE TO THE 2007 NIIGATA CHUETSU-OKI EARTHQUAKE IN JAPAN

YOSHIHISA MARUYAMA, KOTA KIMISHIMA and FUMIO YAMAZAKI

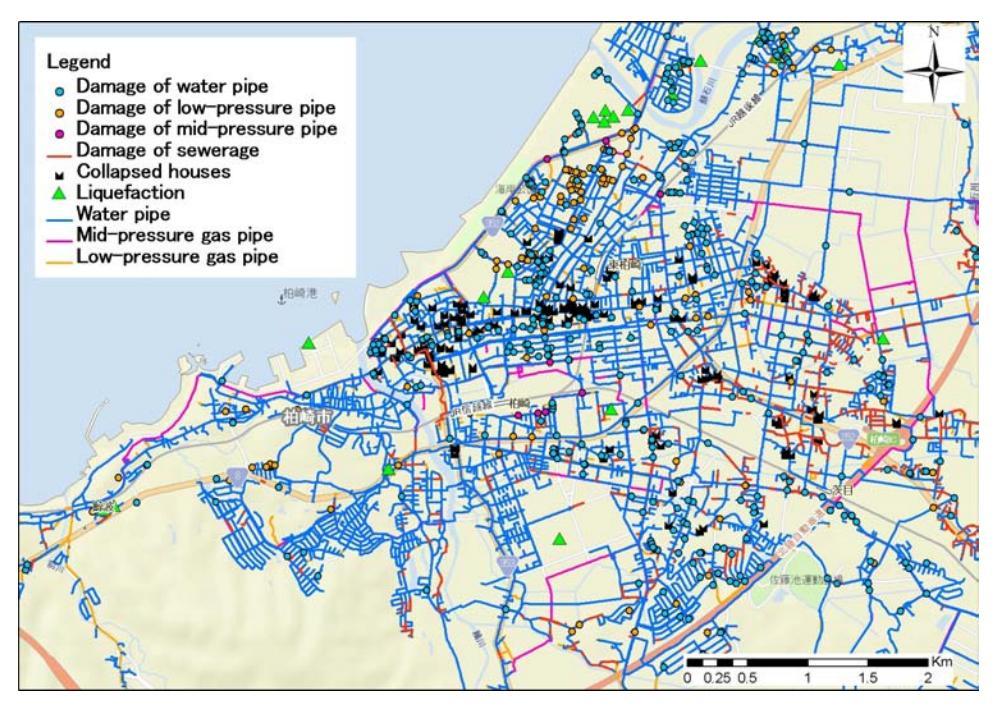
Fig. 1. Inventory data and damage data of lifeline systems in Kashiwazaki city due to the 2007 Niigata Chuetsu-Oki earthquake.

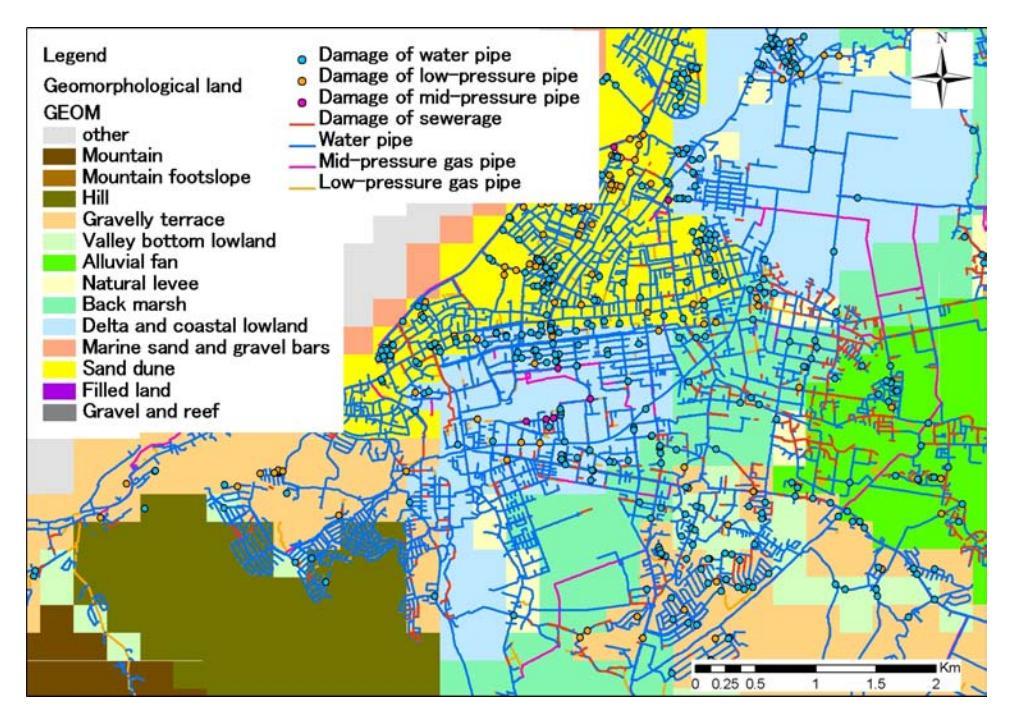
Fig. 2. Damage incidents to buried pipes in Kashiwazaki city after the 2007 Niigata Chuetsu-Oki earthquake illustrated on the geomorphological land classification map by Wakamatsu *et al.* [2006].

Figure 2 shows the distribution of damage to lifeline systems plotted on the geomorphological land classification map. The geomorphological land classifications used in this study are part of a nationwide digital map constructed by Wakamatsu *et al.* [2006]. According to this classification map, the central part of Kashiwazaki city is mainly classified as sand dunes, delta, and coastal lowlands, and back marshes. The damage ratios of water, low-pressure gas, and mid-pressure gas pipes with respect to the geographical land classification are shown in Fig. 3(a). The damage ratio of the sewage system is plotted in Fig. 3(b). The damage ratio of water distribution pipes is highest in sand dunes (1.62), followed by marine sand and gravel bars (1.41). Similarly, the damage ratio of low-pressure gas pipes is the highest in sand dunes (0.66), followed by filled land (0.55). For the water and low-pressure gas pipes, the damage ratio of mid-pressure gas pipes is the highest in natural levees (0.65) and second highest in deltas and coastal lowlands (0.47). The damage ratio of sewage line is the highest in natural levee (32%) while it is 12%

in delta and coastal lowland. For the mid-pressure gas pipes and sewage lines, the damage ratios are high in natural levees.

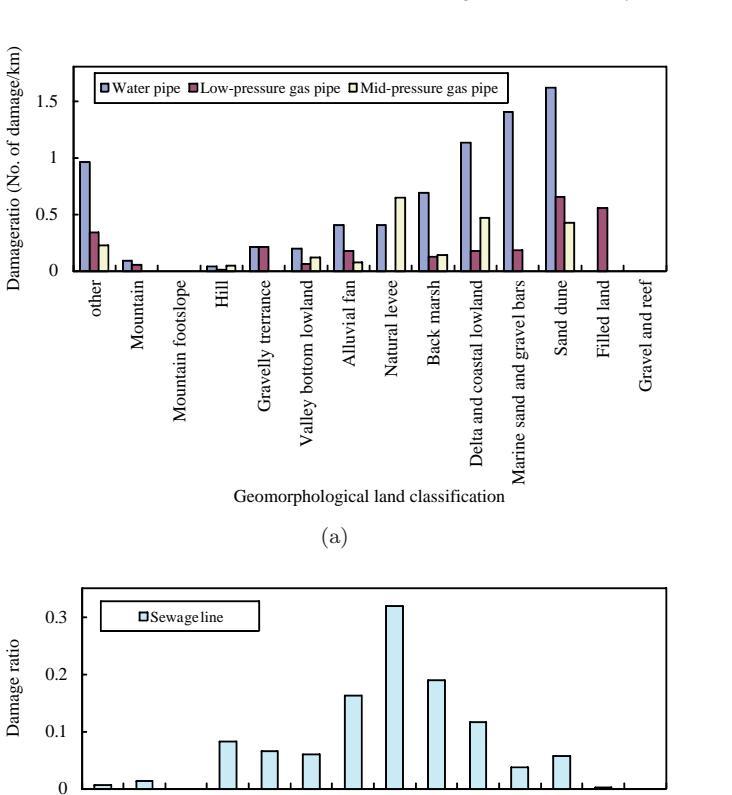
Fig. 3. Damage ratios of (a) water pipes, low-pressure, and mid-pressure gas pipes, and (b) the sewage line with respect to geographical land classifications.

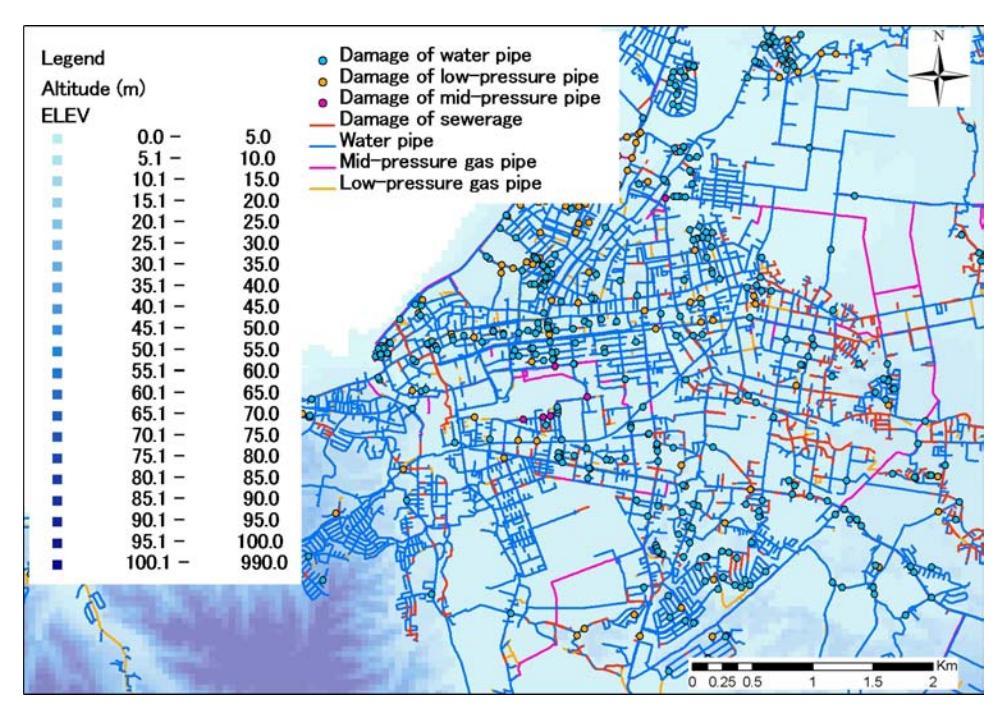
Figure 4 shows the locations of damage incidents (breaks/leaks) for lifeline systems and the altitude model, which was developed by the Geographical Survey Institute of Japan [2001]. The altitude is shown in $50 \times 50 \text{ m}^2$ grid cells. The damage ratios for the water, low-pressure gas, and mid-pressure gas pipes with respect to altitude are shown in Fig. 5(a), and that of the sewage line is shown in Fig. 5(b). The damage ratios for the water, low-pressure gas, and mid-pressure gas pipes are highest at altitudes of 0–5 m. The damage ratio of the sewage lines is highest when the altitude is 10–15 m. The damage ratio of the sewage line is still high for

Fig. 4. Spatial distributions of altitude and damage incidents to buried pipes in Kashiwazaki city after the 2007 Niigata Chuetsu-Oki earthquake.

altitudes of 0-10 m. For the water, low-pressure gas, and mid-pressure gas pipes, no notable differences were observed in the trends for the damage ratios among the three buried pipes.

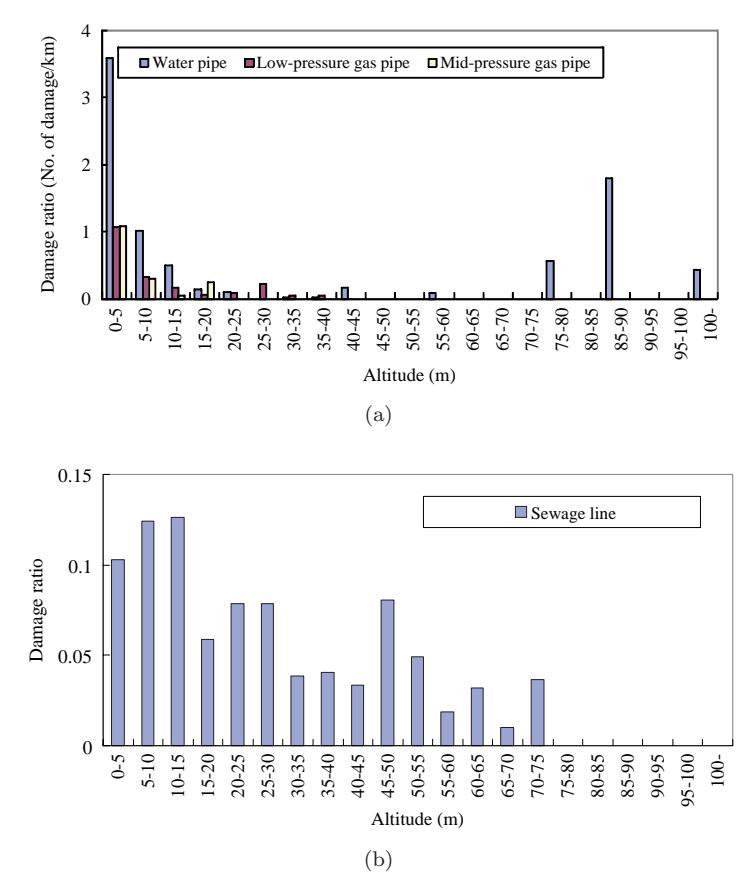
Fig. 5. Damage ratios of (a) water, low-pressure gas, and mid-pressure gas pipes and (b) sewage line with respect to altitude.

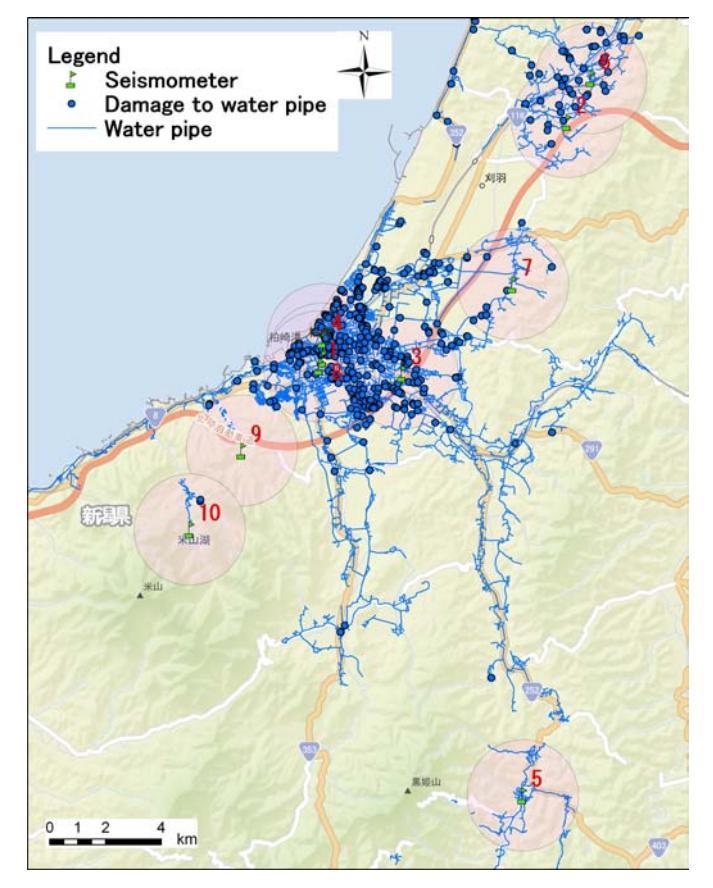
Table 4 lists the PGVs observed by seismometers and the damage ratios of the water distribution pipes. The damage ratios were calculated in areas located within 2 km from the seismometers (Fig. 7), and they were defined with respect to the material of the pipe (CIP, VP, and DIP). The number of pipe breaks in the alluvial plain was divided by the length of the water distribution pipes in the alluvial plain to obtain the damage ratio shown in Table 4.

Fig. 7. Location of seismometers in Kashiwazaki city and damage incidents to water distribution pipe after the 2007 Niigata Chuetsu-Oki earthquake.

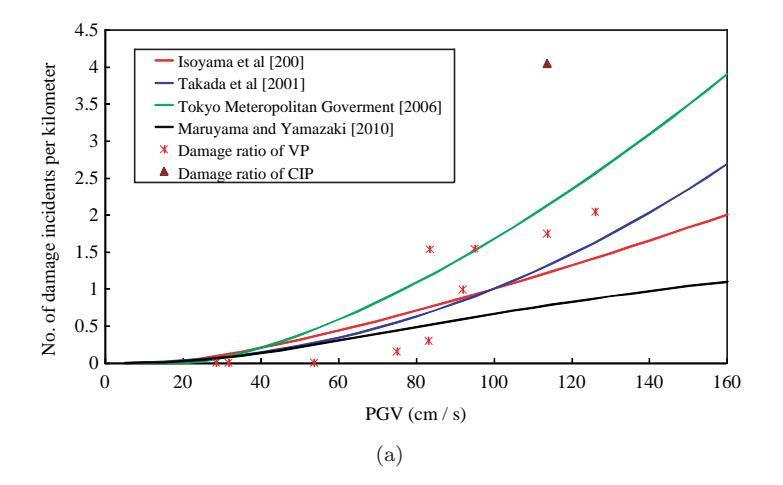
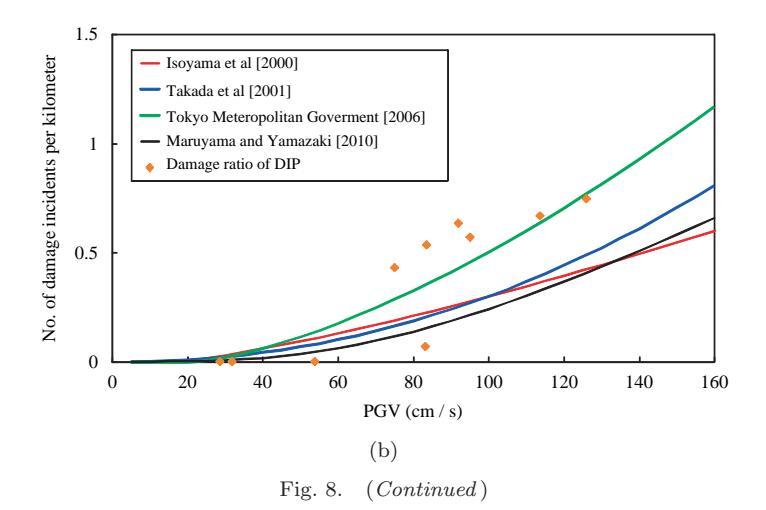
According to the figure, the damage ratios for VPs are lower than the fragility curve estimations when the PGV is smaller than approximately 80 cm/s. The fragility curve used by the Tokyo Metropolitan Government [2006] provides good estimations if the PGV is in the range of 100–130 cm/s. The damage ratio of CIPs is much higher than the estimations of the fragility curves. For the DIPs, the damage ratios are lower than the estimations when the PGVs are smaller than

Fig. 8. Comparisons of damage ratios of water distribution pipes for (a) CIP and VP and (b) DIP after the 2007 Niigata Chuetsu-Oki earthquake with different fragility curves.

approximately 80 cm/s. The damage ratios are higher than the estimations when the PGVs are 80-100 cm/s.

As a whole, the damage ratios of water distribution pipes after the 2007 Niigata Chuestu-Oki earthquake are higher than estimations following previous earthquakes in Japan. This may be a result from the effects of periodic characteristics in ground shaking and geographical and topographical conditions in the affected area. Further research is needed to draw solid conclusions.
