THE 1st JAPAN WORKSHOP ON ENHANCEMENT OF  
EARTHQUAKE AND TSUNAMI DISASTER MITIGATION TECHNOLOGY  
LIMA, MARCH 15-16, 2010

THE OBLIGATORY OFFICIAL TECHNICAL AUDITS  
APPLIED DURING MORE THAN FIFTY YEARS FOR  
THE EARTHQUAKE SAFETY ON THE CONSTRUCTION  
OF SAN JUAN, ARGENTINA

Juan S. Carmona  
Universidad Nacional de San Juan – Argentina  
Profesor Honorario de la U.N.I. – Lima - Perú

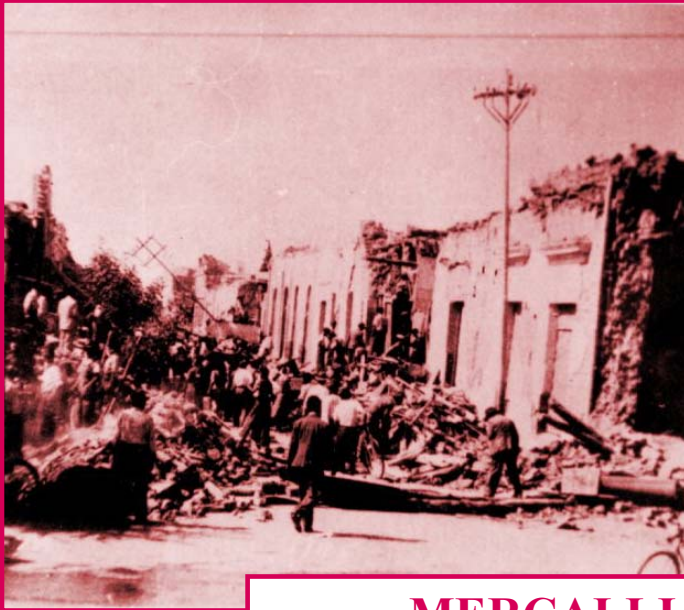
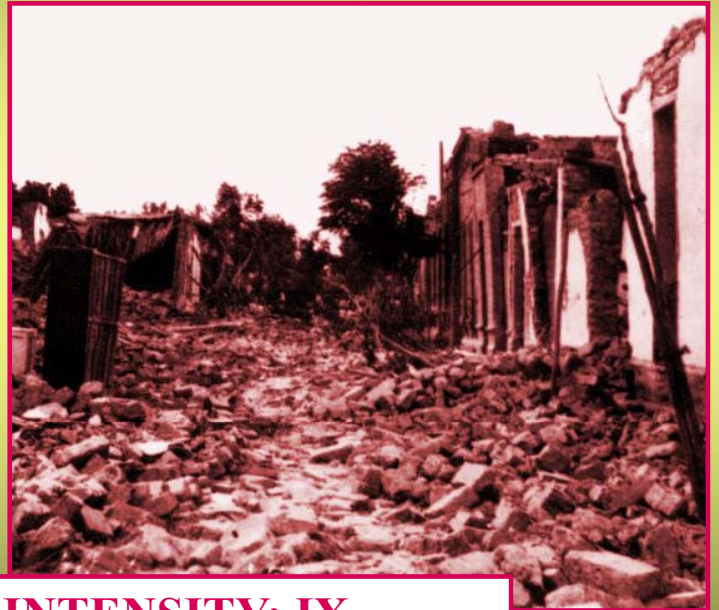
**GREAT DAMAGE ON THE CITY OF SAN JUAN, ARGENTINA,  
8 a 10000 DEATHS , 15% OF ITS POPULATION      epicentral  
distance  $\approx$  30 km**

**MERCALLI INTENSITY: IX**

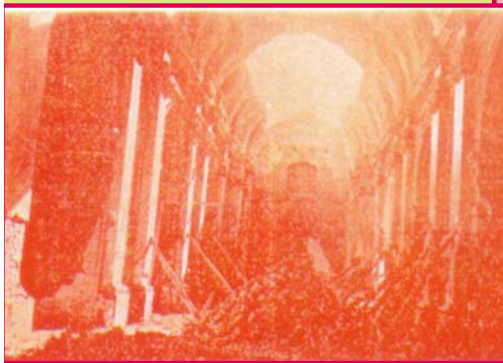
**THE INTERIOR AFTER  
THE EARTHQUAKE**

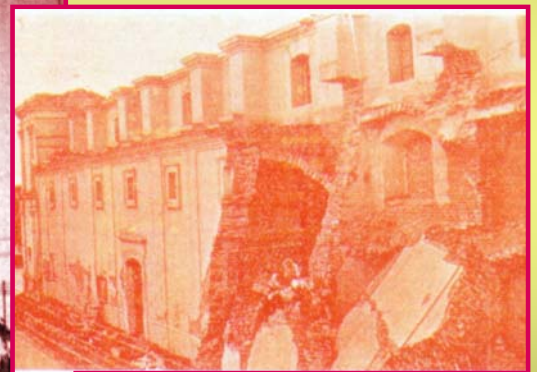
**PARTIAL COLAPSE ON  
EXTERNAL WALL**

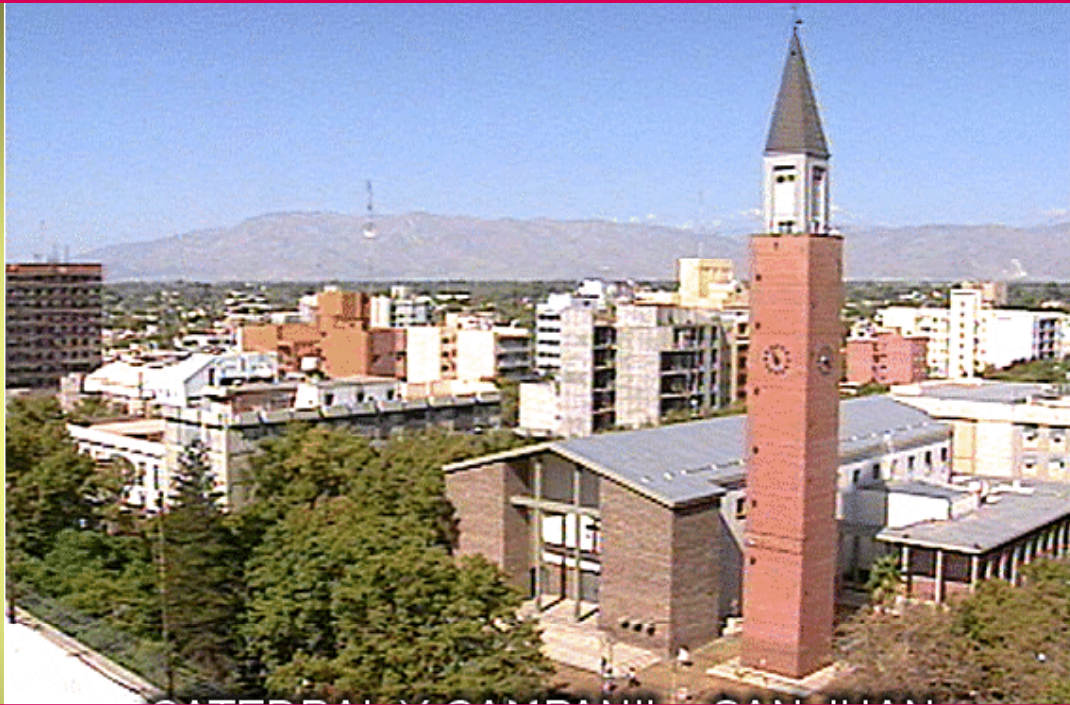
**CITY OF SAN JUAN (epicentral distance  $\approx$  60 km , IMM=VIII)  
NEITHER BUILDING COLLAPSED NOR DEATHS OCCURRED**

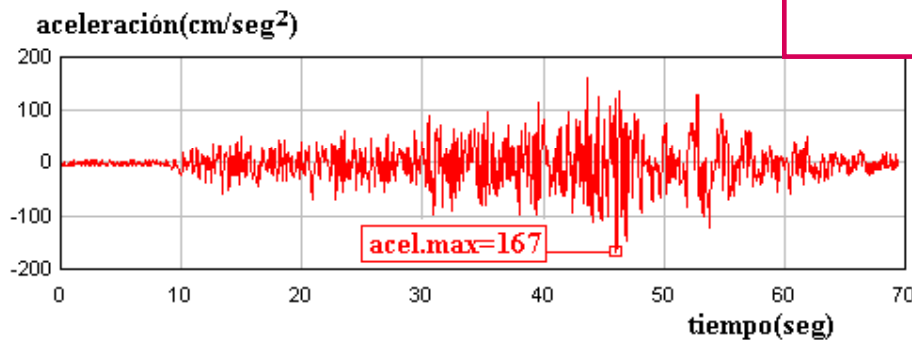
**SISMO CAUCETE 23-XI-1977  
ACELEROGRAMA IDIA77-EO**

**SEISMOSCOPE IN I.D.I.A.  
SA= 0,26g**

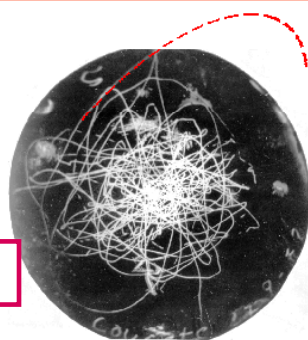
**SISMO CAUCETE 23-NOV-1977  
ESCUELA VIEYTES - CAUCETE  
SISMOSCOPIO TIPO WILMOT  
PERIODO 0,7seg , AM=10%  
SA = 0,75 a 0,80 g**

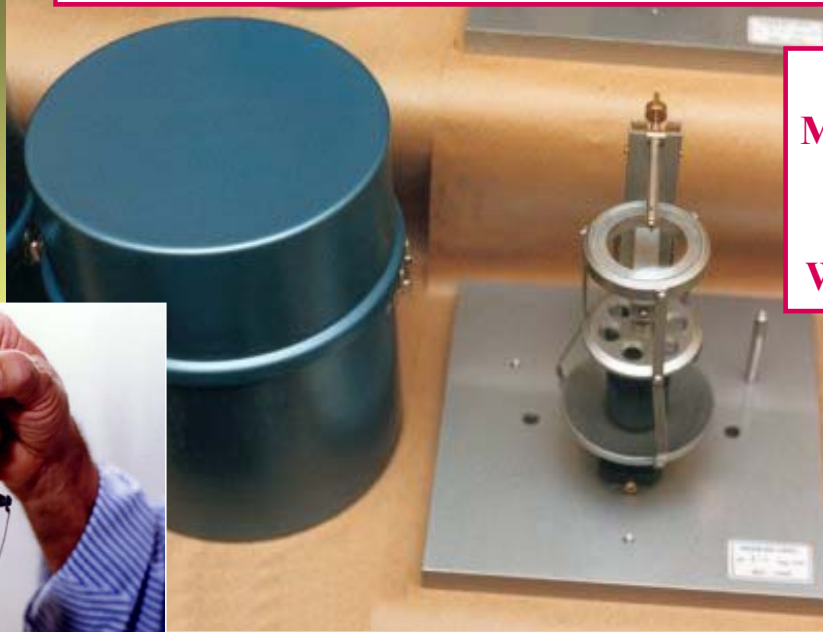
## WILMOT TYPE SEISMOSCOPE

**EQUIVALENCE OF  
MERCALLI INTENSITY  
WITH AMPLITUDE OF  
THE RECORD ON  
WILMOT SEISMOSCOPE**

<u>IMM</u>	<u>SA(SisW)</u>
VI	0,08g
VII	0,15g
VIII	0,30g
IX	0,60g
X	1,20g

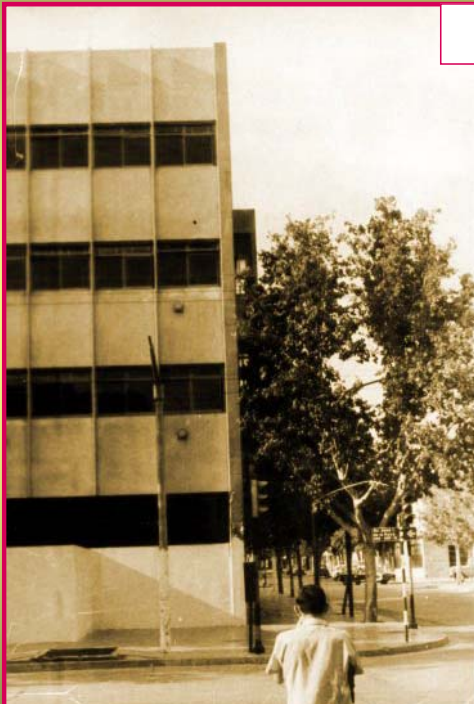
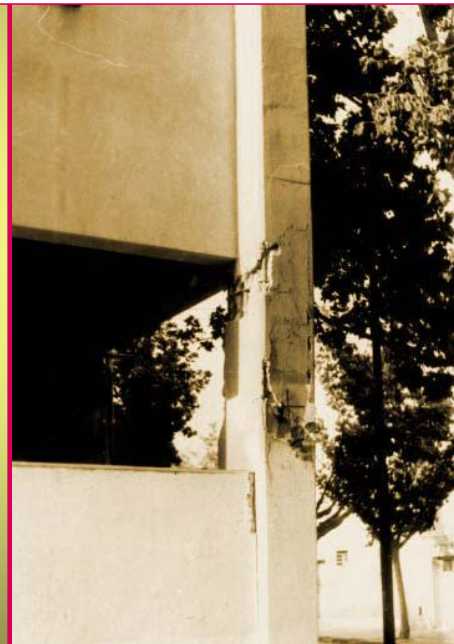
**CITY OF SAN JUAN - ENET N°4 BUILDING SCHOOL  
FIRST FLOOR WITHOUT WALLS - IMPORTANT DAMAGE ON COLUMNS**

**epicentral distance  $\approx$  60 km , IMM = VIII**

**LESSON LEARNED AND THEN INCLUDED ITS CONSIDERATION IN THE CODE**

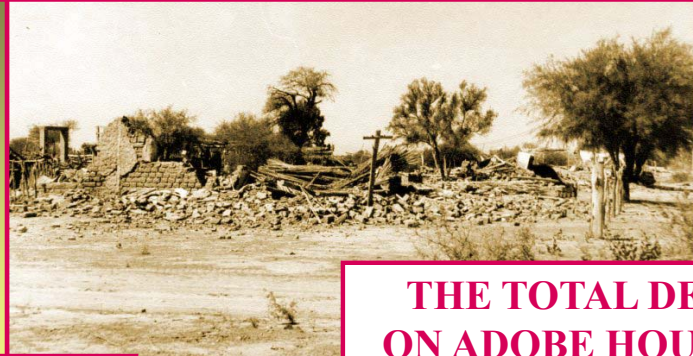
**THE TOTAL DESTRUCTION  
ON ADOBE HOUSES SEVERAL  
DEATHS CAUSED**

**BERMEJO TOWN  
EPICENTRAL AREA**

**IMM  $\approx$  IX - X**

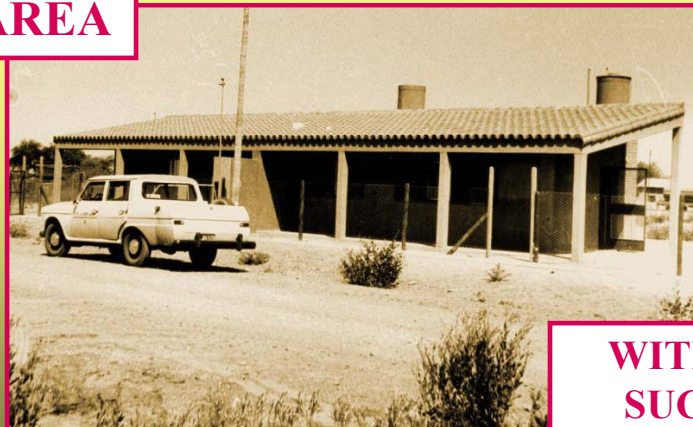
**WITHOUT DAMAGE,  
SUCCESSFUL TEST**

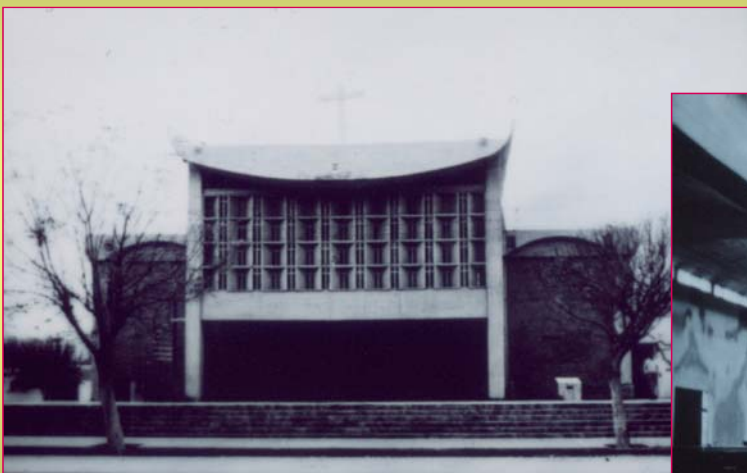
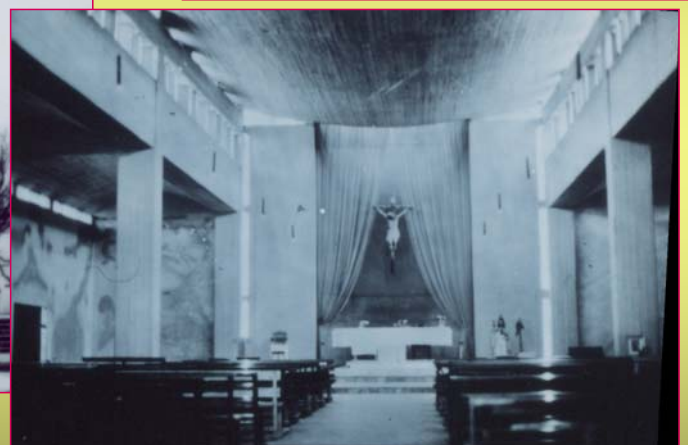
**CRISTO REY CHURCH**

**ONLY MINOR DAMAGE**

**CAUCETE CITY  
epicentral distance  $\approx$ 30km  
IMM = IX**

**WILMOT SEISMOSCOPE  
SA= 0, 55g**

**DESIGNED WITH HORIZONTAL FORCES FROM  $C_s= 0,15$**

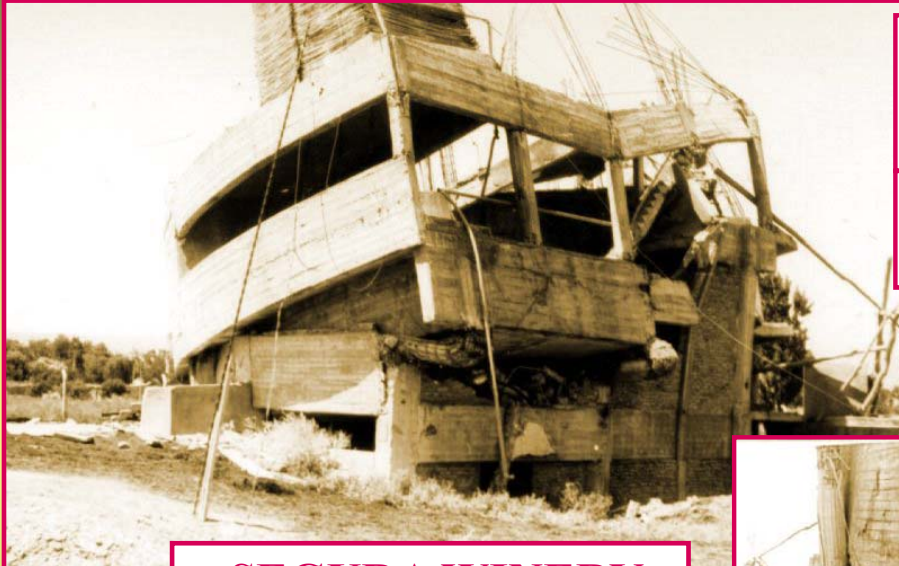
**SEGURA WINERY  
COLAPSED**

**CAUCETE CITY**  
epicentral distance  $\approx 30\text{km}$   
IMM = IX

**WILMOT SEISMOSCOPE**  
SA= 0, 55g

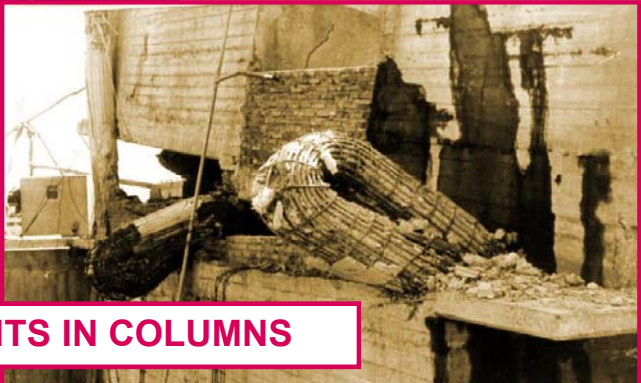
**HIGH DENSITY OF STEEL REINFORCEMENTS IN COLUMNS**

**LESSON LEARNED AND THEN INCLUDED ITS CONSIDERATION IN THE CODE**

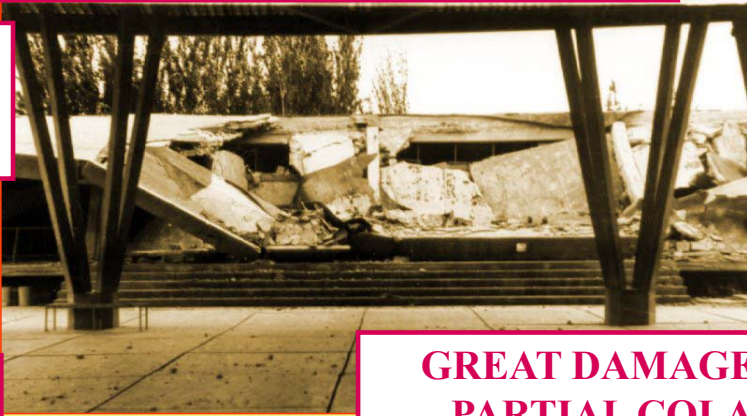
**“ESCUELA NORMAL”  
SCHOOL BUILDING**

**GREAT DAMAGE WITH  
PARTIAL COLAPSES**

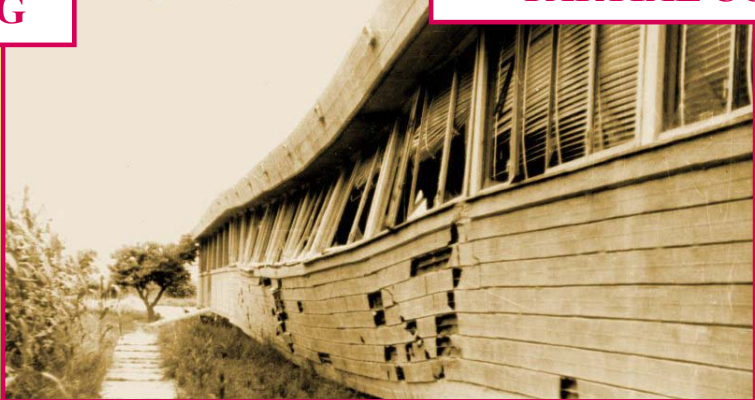
**BUILDING WITHOUT THE OBLIGATORY OFFICIAL TECHNICAL AUDITS**

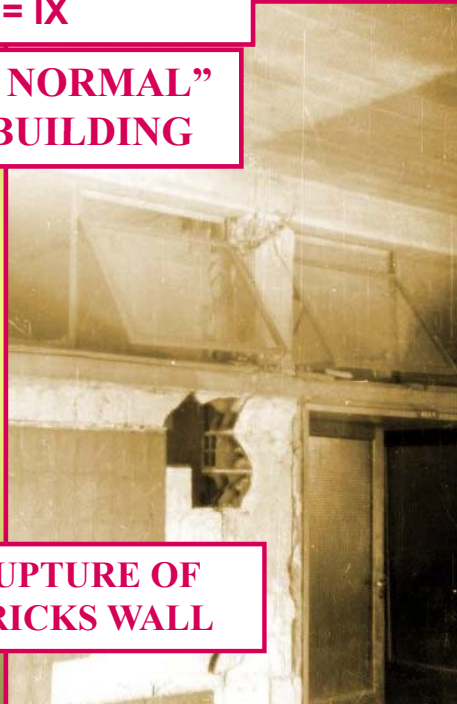
**BRITTLE RUPTURE OF  
HOLLOW BRICKS WALL**

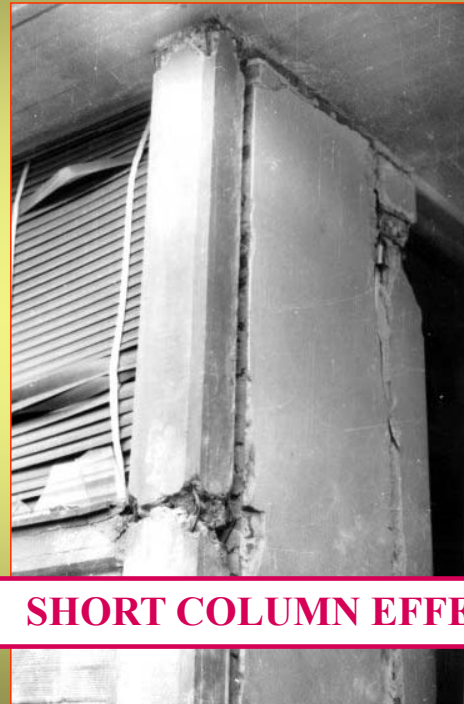
**SHORT COLUMN EFFECT**

**LESSON LEARNED AND THEN INCLUDED ITS CONSIDERATION IN THE CODE**

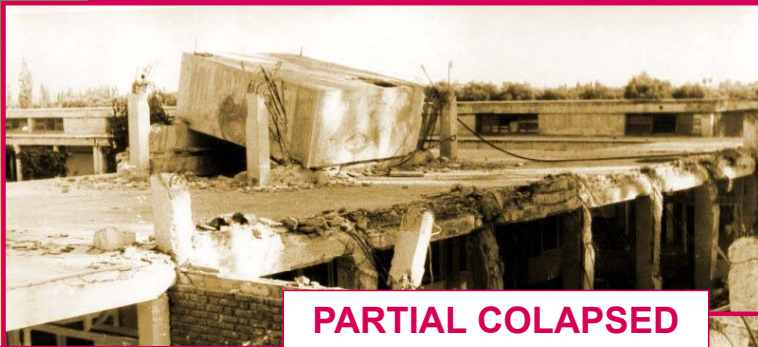
**“ESCUELA VIEYTES”  
SCHOOL BUILDING**

**PARTIAL COLAPSED**

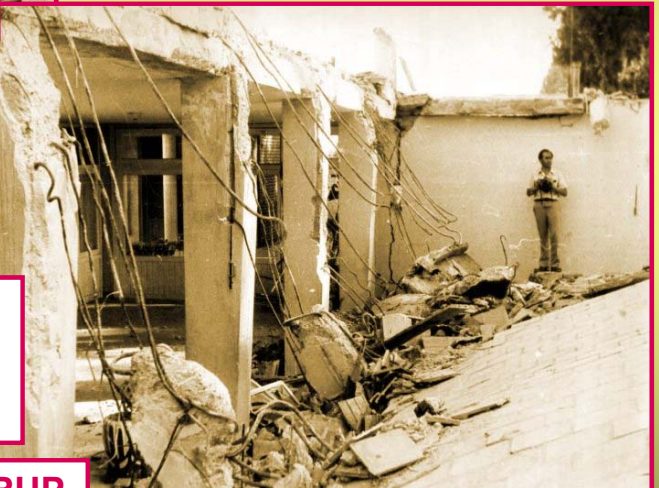
**SHORT COLUMN EFFECT – SCARCE STIRRUP**

**LESSON LEARNED AND THEN INCLUDED ITS CONSIDERATION IN THE CODE**

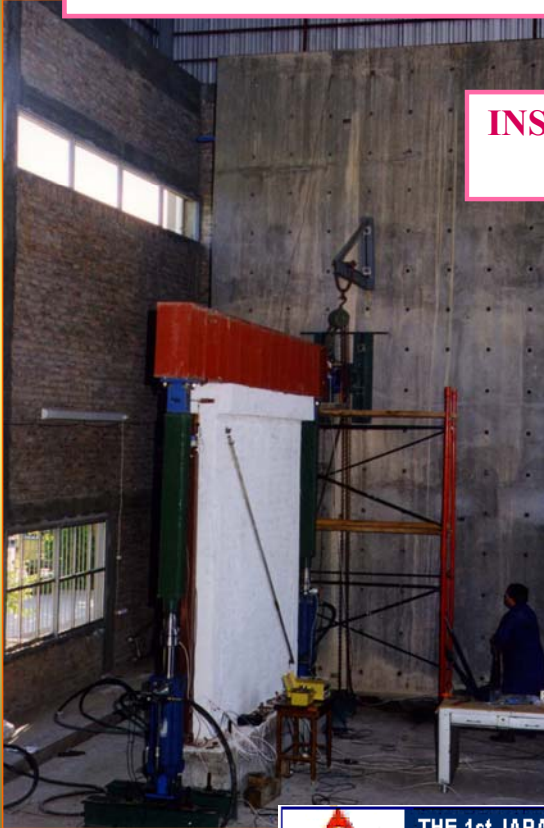
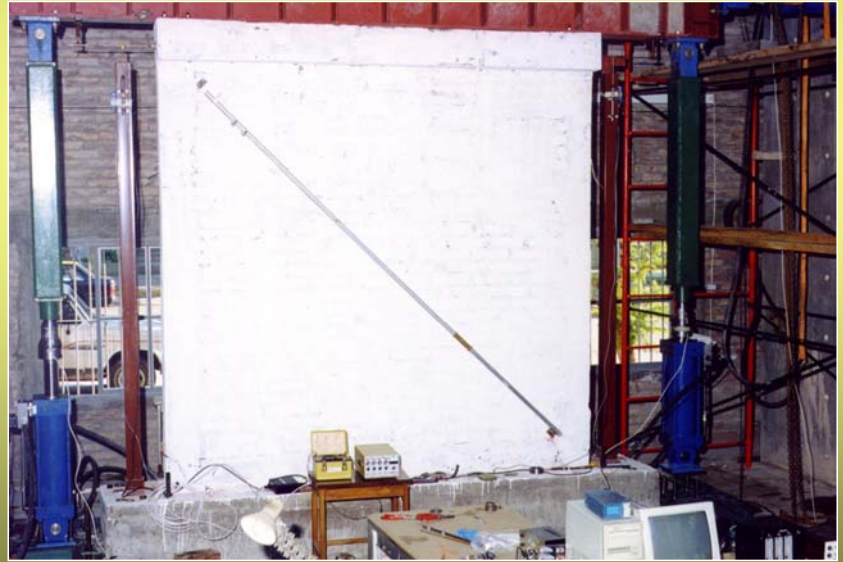
**ENSAYOS EN MURO REACTIVO  
PANELES DE MAMPOSTERIA EN ESCALA NATURAL  
APLICACIÓN DE FUERZAS HORIZONTALES ALTERNATIVAS**
