BUILDING GROUP (G3)

Enhancement of Seismic Resistance of Buildings

9-10 March 2011

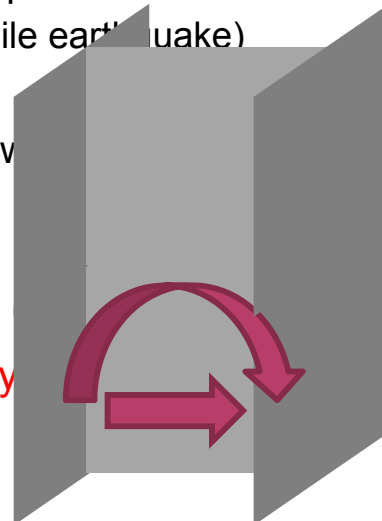
Structural Test (1)

- Objectives
 - Focus on the failure mechanism of shear wall with perpendicular elements
 - Adequate confinement at wall end to prevent brittle failure (inspired by the building damage in Chile earthquake)
- Structural test in CISMID
 - Installation and preliminary test of new
 - Low ductile RC wall
 - Confinement masonry wall
 - Adobe-quincha wall
- Structural test in Yokohama University
 - RC wall with perpendicular elements

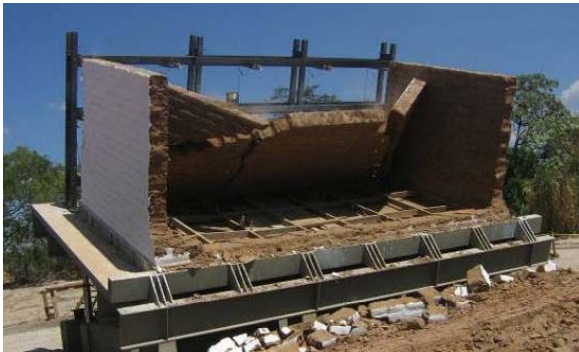
Tilting table test of Adobe house
in El Salvador, JICA-TAISHIN Project

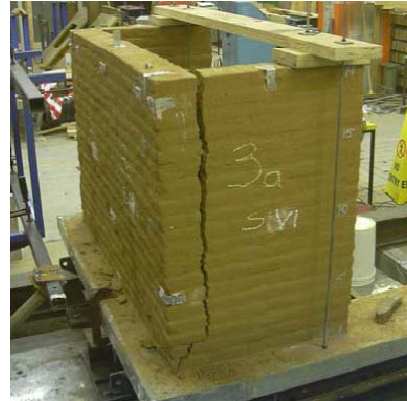
Shaking table test, Sidney

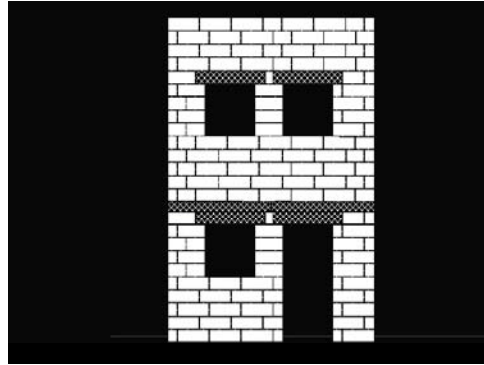
DEM analysis (original)

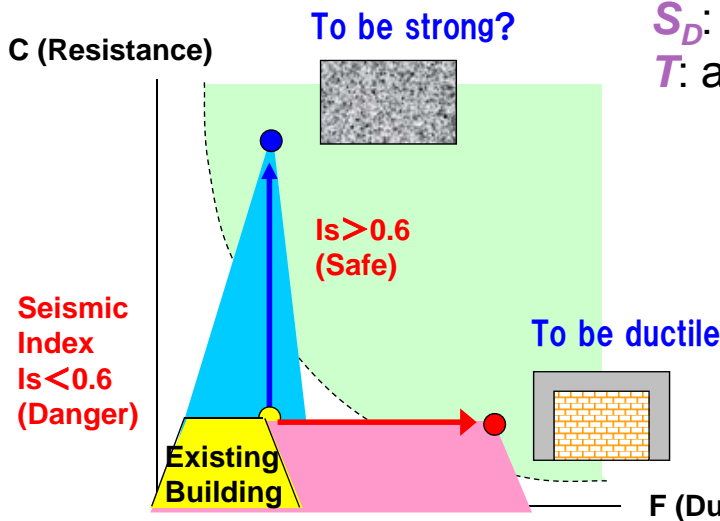
Seismic Structural Index I_s

$$I_s = \phi \times ((C \times F)) \times S_D \times T$$

ϕ : story index
 S_D : irregularity index
 T : age index

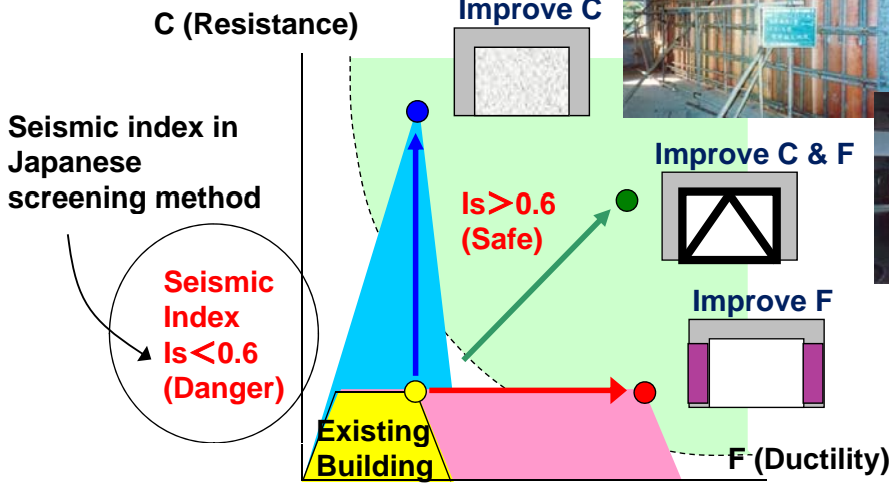
$$I_s = (\phi \times C \times F) \times S_D \times T$$

Replace brick wall to infill RC wall

Retrofitting by steel brace

Retrofitting by FRP sheet

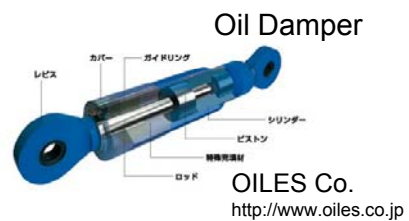
Retrofit using seismic dampers

Many other devices

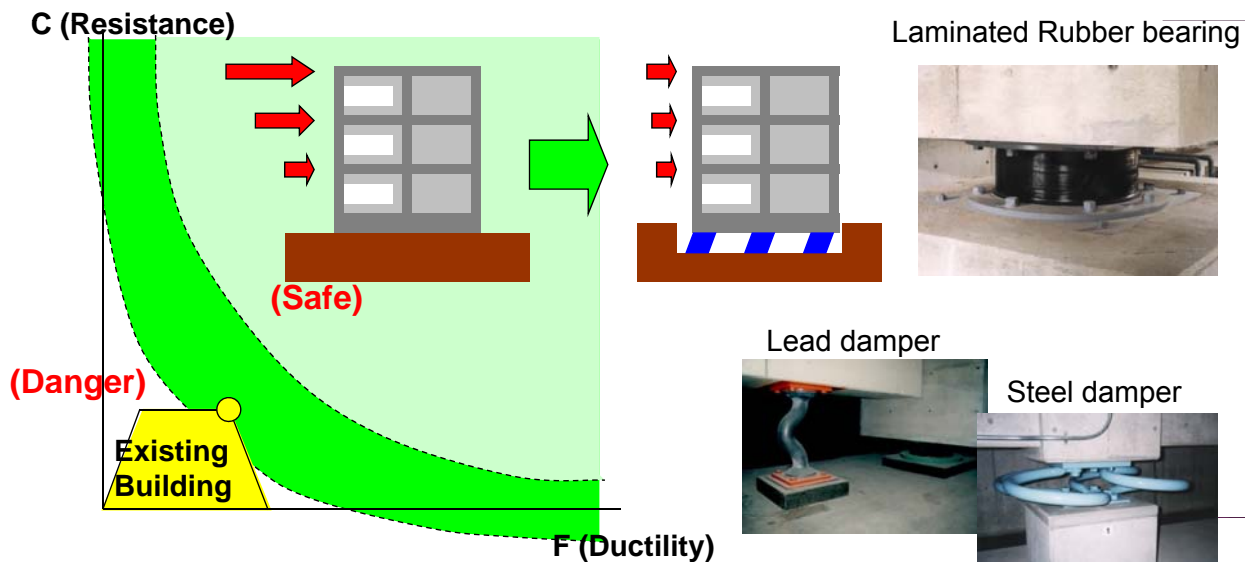
Retrofit using seismic isolation

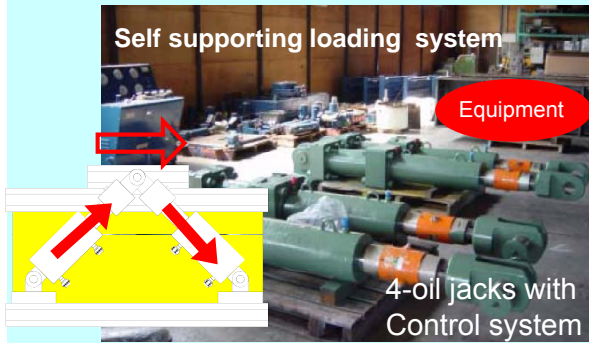
Structural testing

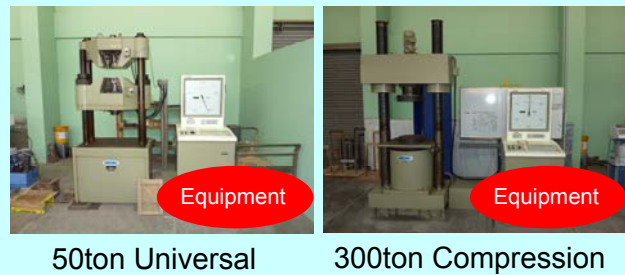
Material testing

Renewal of old CISMID machine

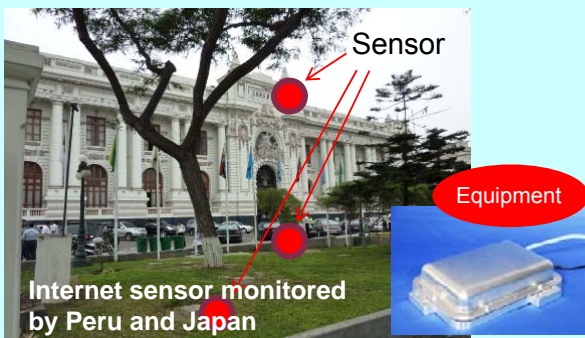
Building monitoring

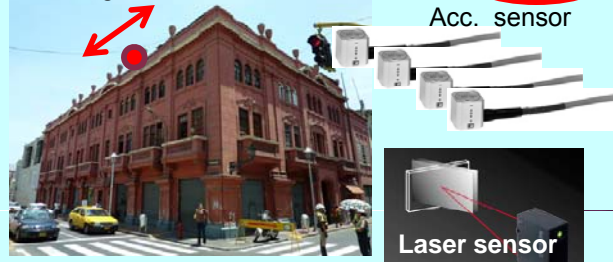
Dynamic behavior monitoring & test

Shaking machine

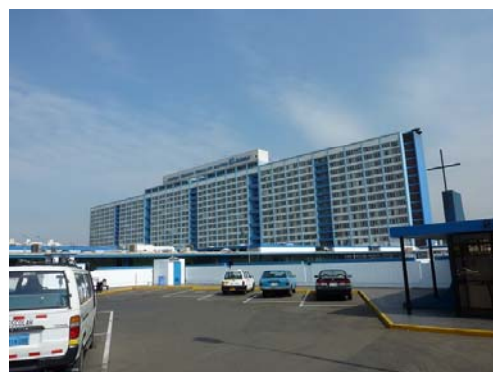
Target building 1: Rebagliatti Hospital

RC building, largest hospital in Lima, important building, necessary for evaluation & retrofit (in transverse direction)

Three buildings are connected by seismic joints, no damage by previous earthquake except some pipes and nonstructural walls.

All drawings are available (concrete strength 21MPa – 36MPa).

Non-destructive test for concrete strength, Micro-tremor measurement for dynamic characteristics

Make analytical model based on drawings, Perform nonlinear analysis (static and dynamic)

Propose seismic retrofitting plan

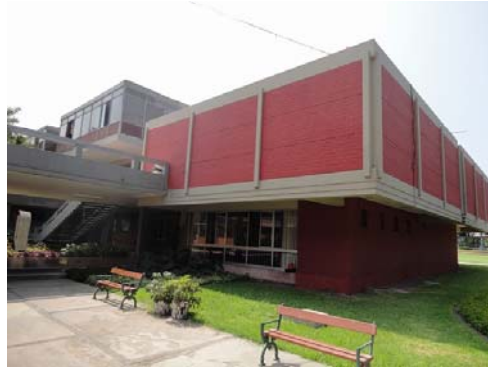
Target building 2: UNI CE Faculty building

RC building, educational facility, easy access from CISMID, necessary for evaluation & retrofit
All drawings are available

Non-destructive test for concrete strength, Micro-tremor measurement for dynamic characteristics

Make analytical model based on drawings, Perform nonlinear analysis (static and dynamic)

Apply Japanese evaluation method

Propose seismic retrofitting plan

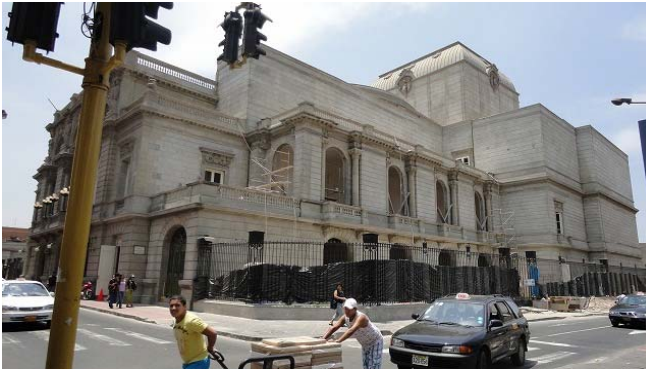
Target building 4: Teatro Municipal

Reconstruction of quincha wall

Monument, rehabilitation work in underway after the damage by fire
Masonry + concrete, New adobe + quincha building for annex building
Already studied by CISMID (SAP model, retrofit of column using steel angle, etc.)

Micro-tremor measurement of main building and annex building
Nonlinear FEM analysis (using DIANA) ... very complicated
Install of sensor?

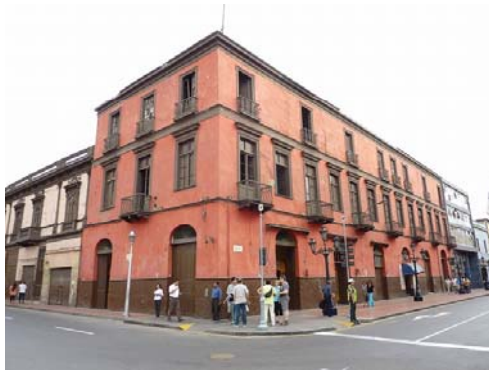
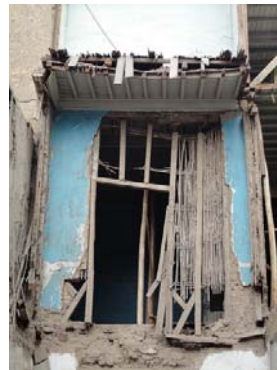
Target building 5: Comercio Hotel

Severe deterioration in upper stories

Monument, typical building in Centro Lima (Historical Area)
Adobe + quincha building, partially collapsed because of deterioration.
Already studied by CISMID (SAP model)

Micro-tremor measurement
Nonlinear FEM analysis (using DIANA) ... very complicated

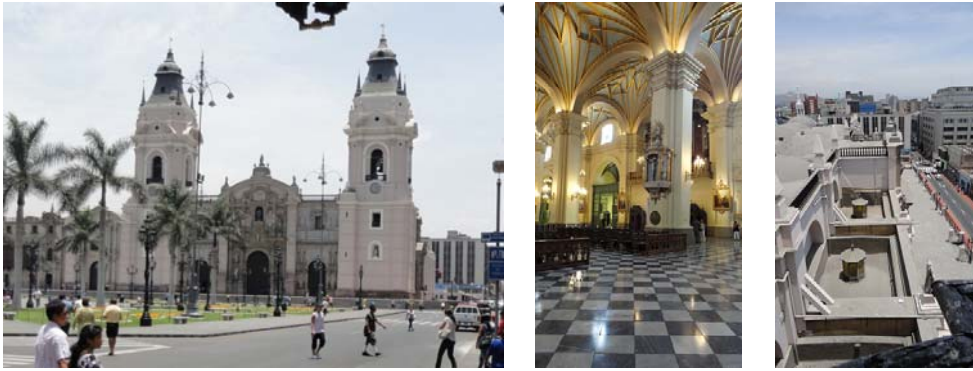
Target building 6: Lima Cathedral

Monument in Centro, Lima, collapsed three times by earthquakes, roof is supported by wood columns, one column is inclined, small crack on the outside wall in out-of-plane direction

Already studied by CISMID (SAP model)

Micro-tremor measurement

Nonlinear FEM analysis (using DIANA) ... very complicated
