# 1<sup>st</sup> Joint Coordinating Committee

## Enhancement of Earthquake and Tsunami Disaster Mitigation Technology in Peru

### G4: Damage Assessment

## Progress Report Geo-Spatial Database

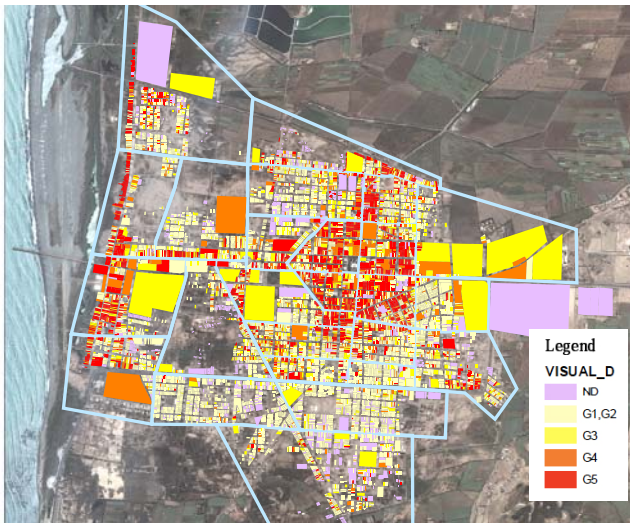
The 2007 Pisco, Peru Earthquake

Visual Interpretation of Satellite Images

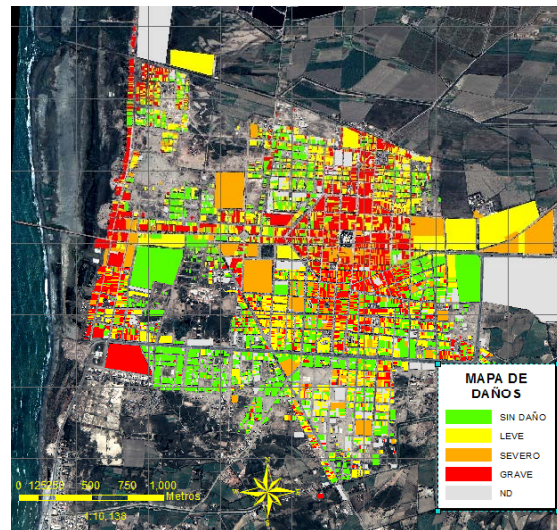
Building damage by Field Survey

Validation

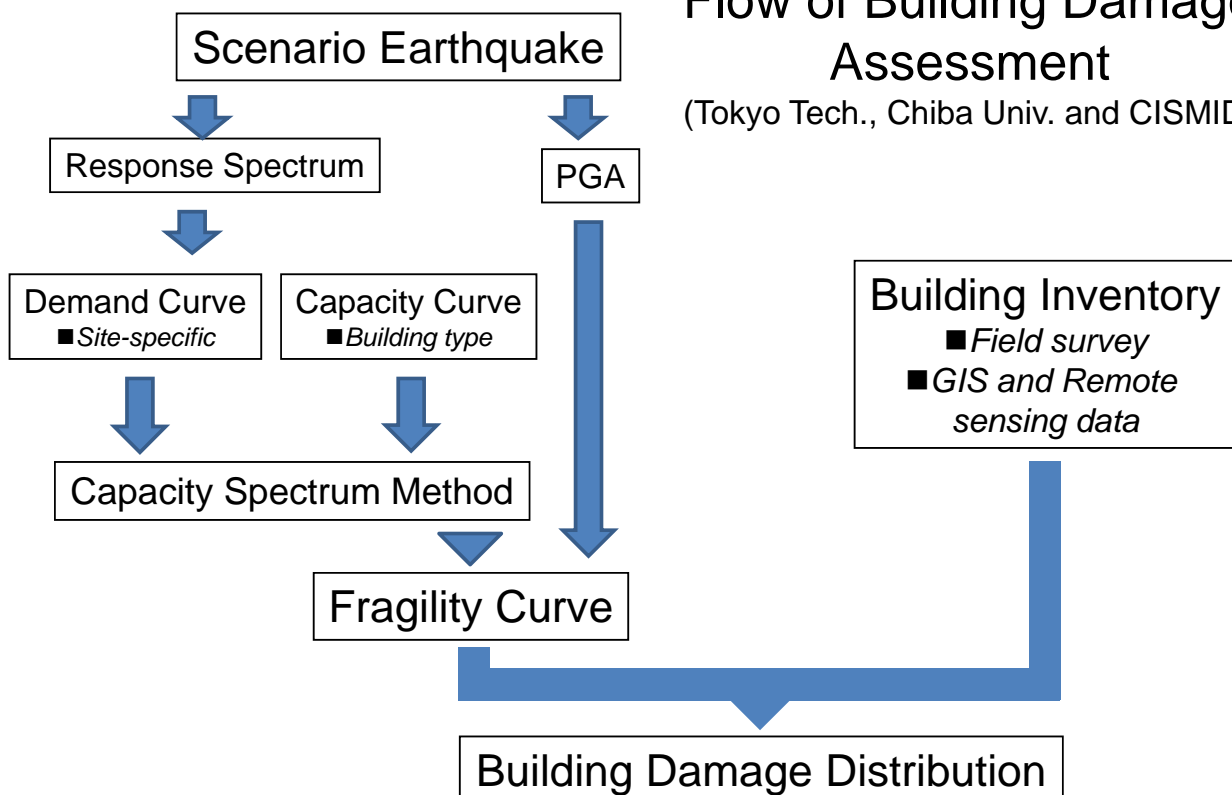
Flow of Building Damage Assessment

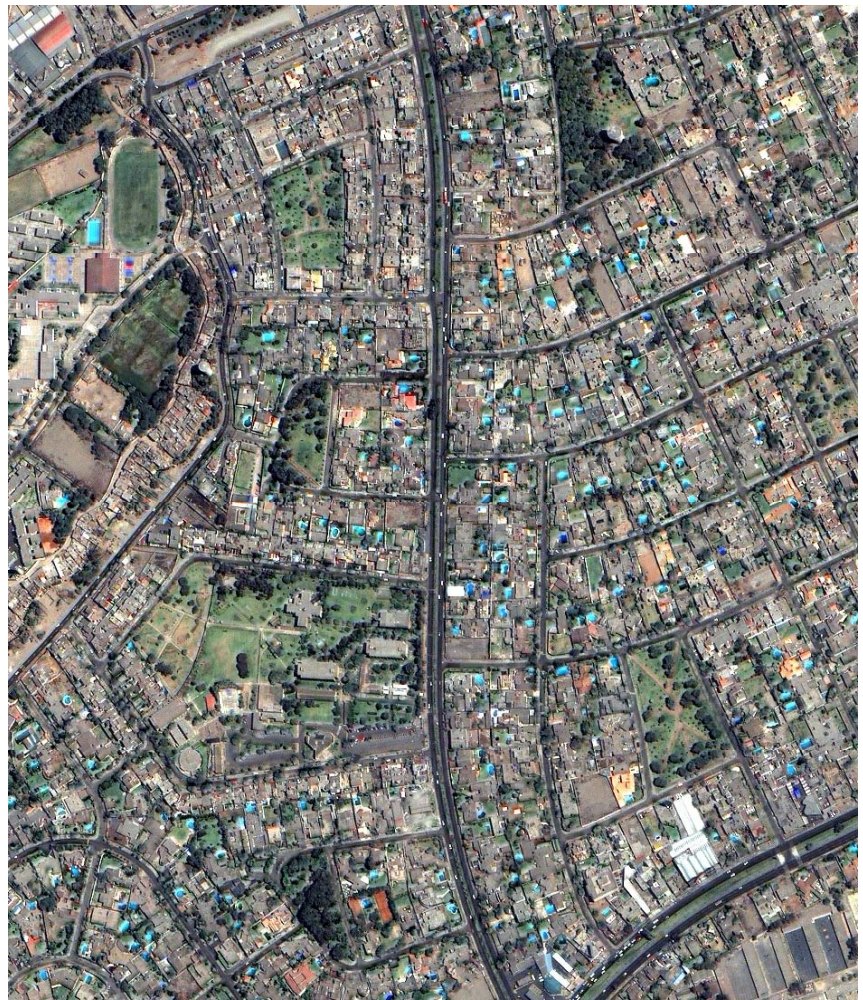
# Image Sharpening

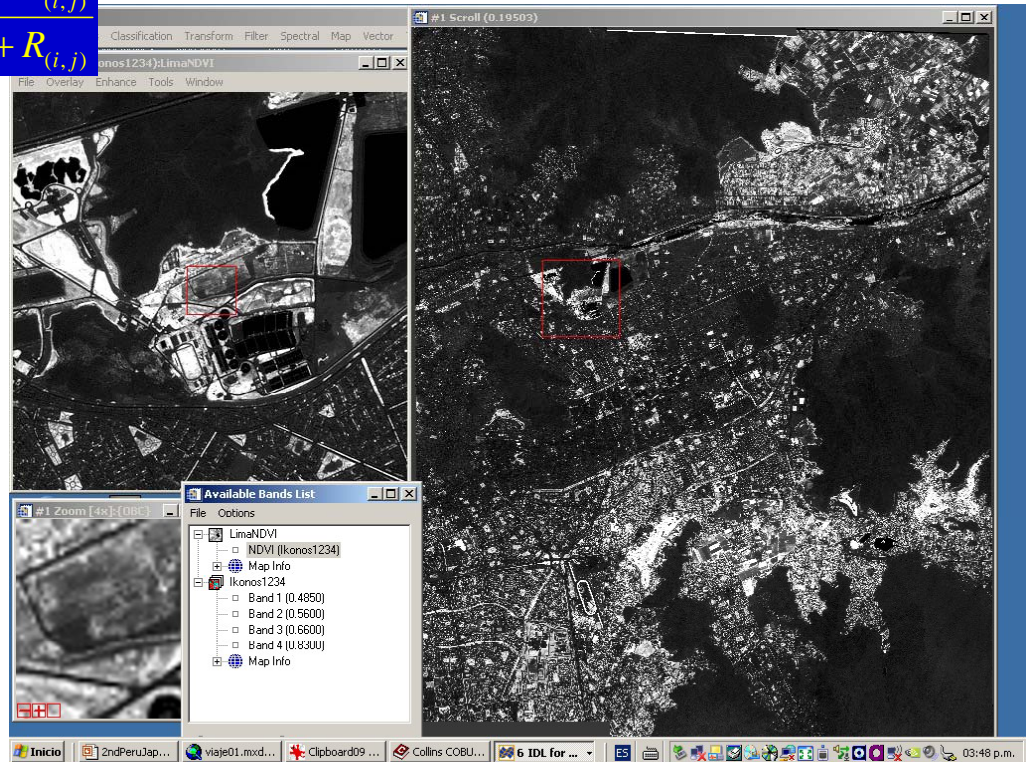
# Vegetation Index

$$NDVI_{(i,j)} = \frac{NIR_{(i,j)} - R_{(i,j)}}{NIR_{(i,j)} + R_{(i,j)}}$$

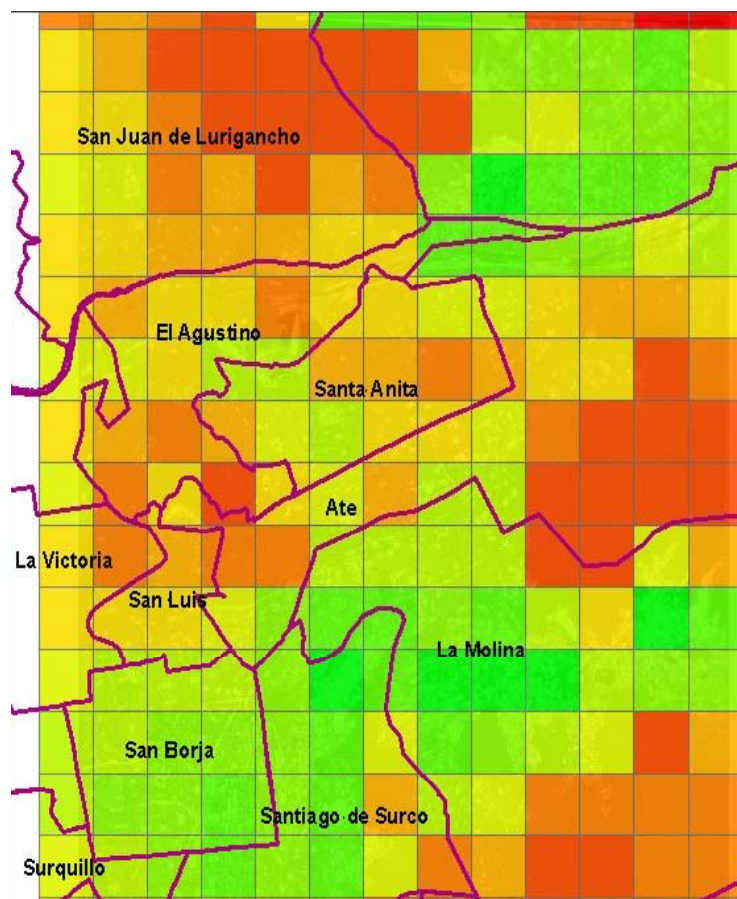
# Cluster Analysis

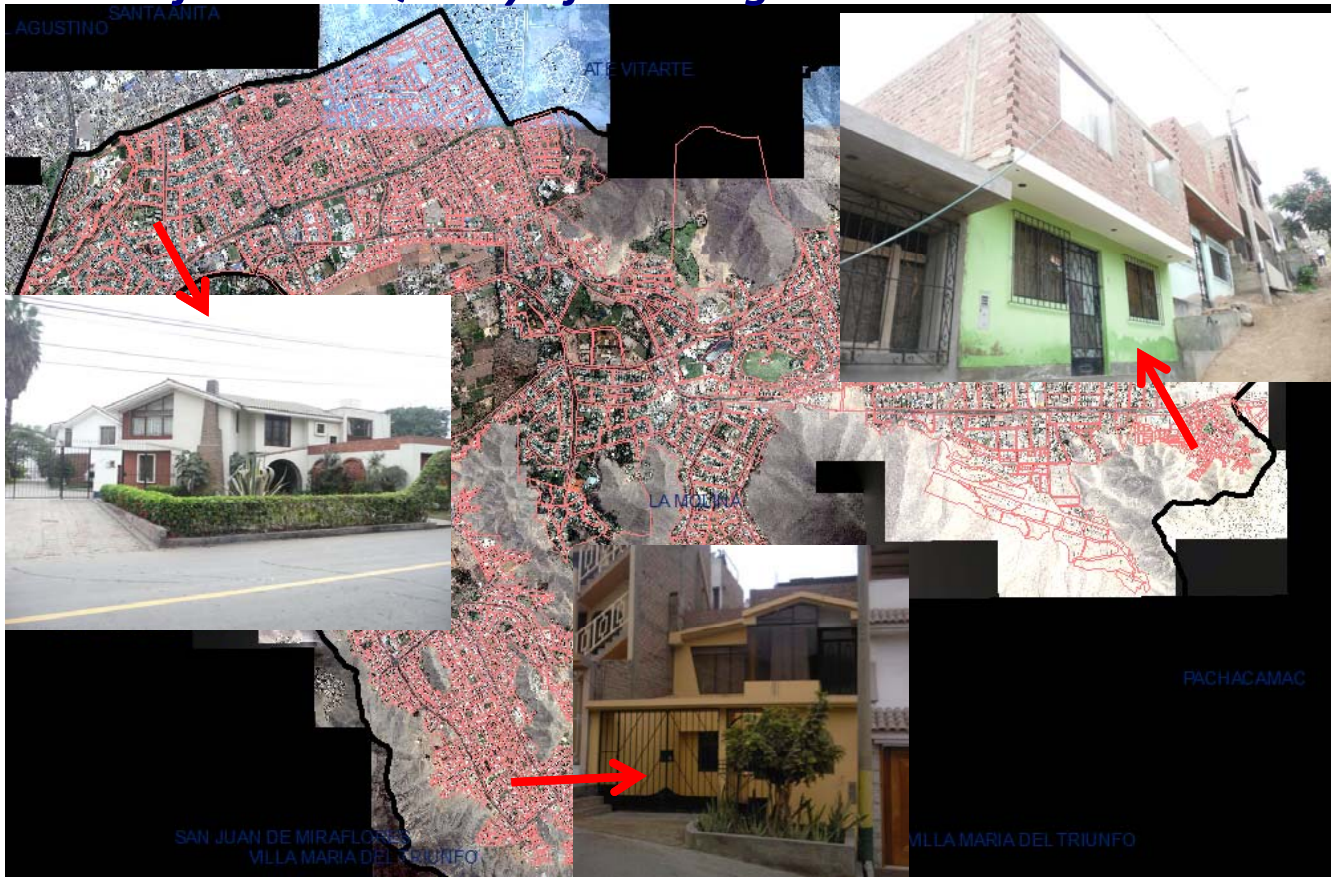
# Same Material but Different Social Class Defines the Quality of Buildings – La Molina District

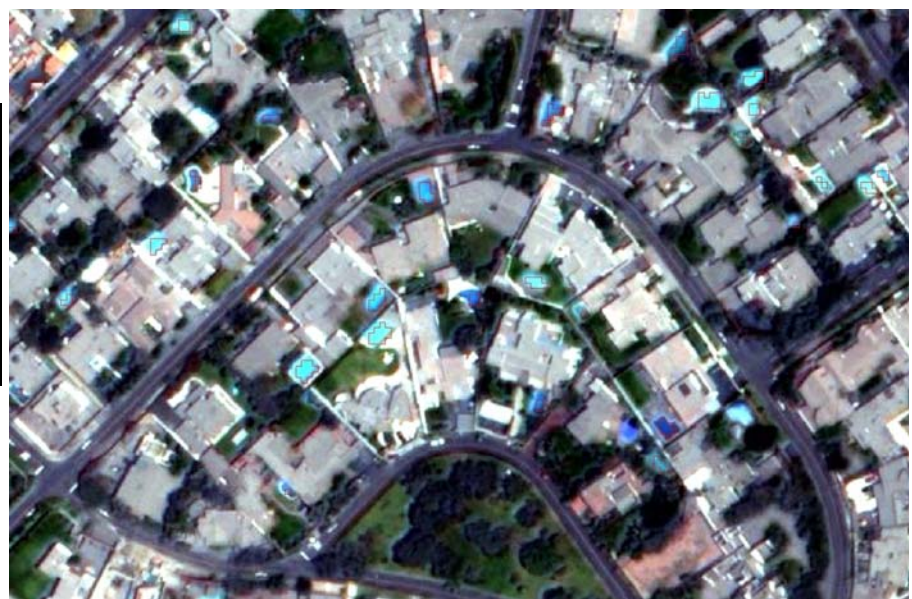
Good agreement  
between classification  
and real Image data

The classification model was even used to delineate the pool

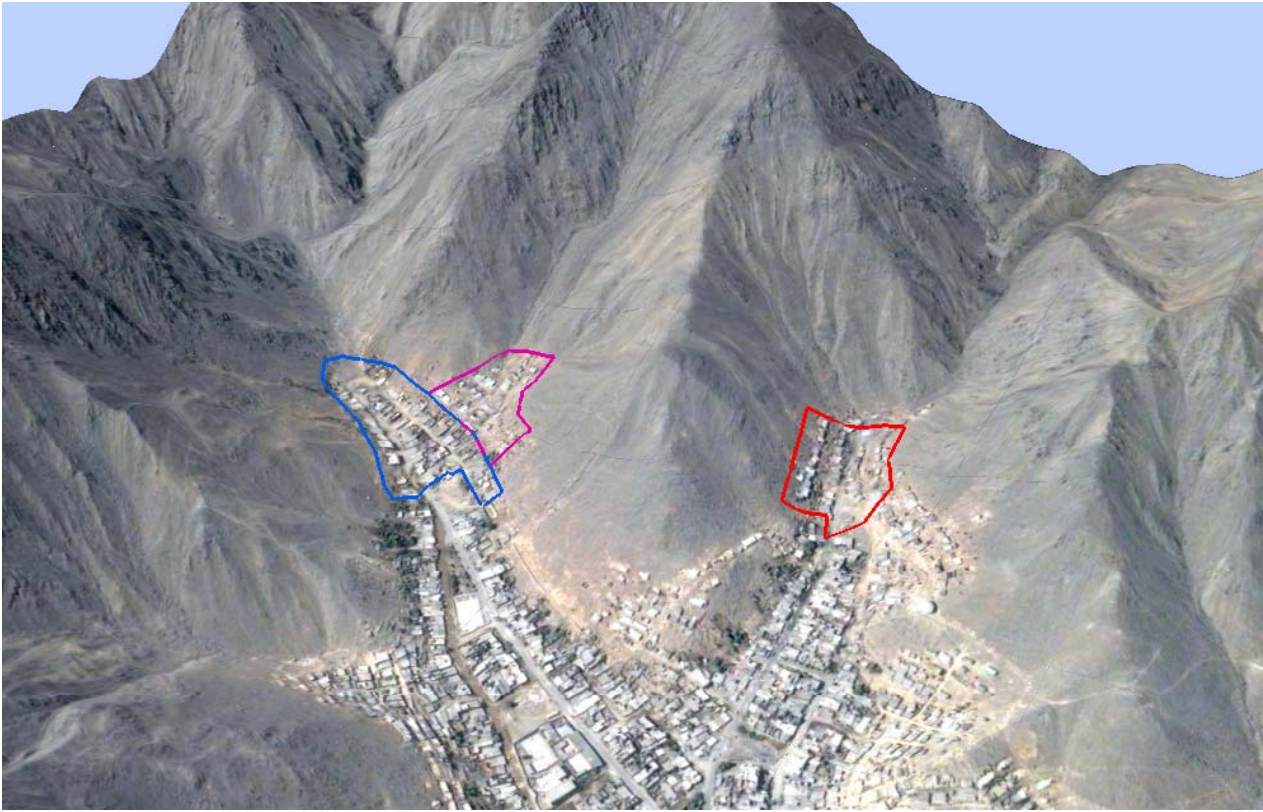
## High Resolution Satellite Image overlaid on PRISM satellite DEM – Comas District

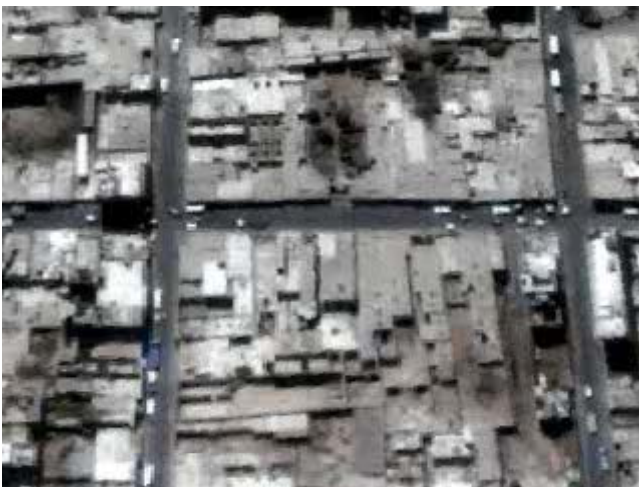
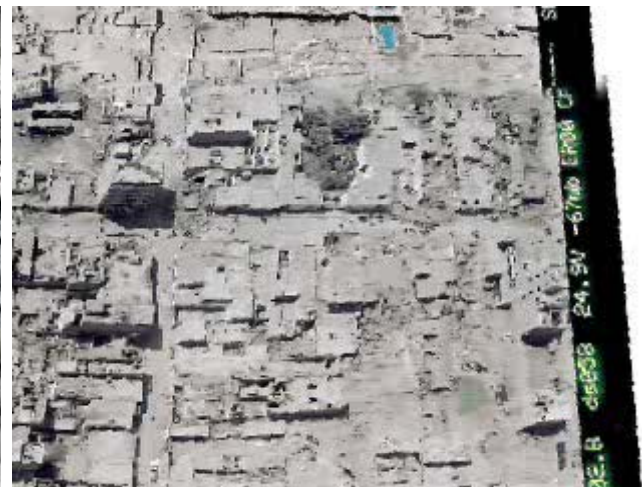
## Visual Image Comparison Satellite vs. Aerial Picture
