G3: Seismic Resistance of Buildings

GL: T. Saito (BRI), C. Zavala (UNI)

Project Flow-chart

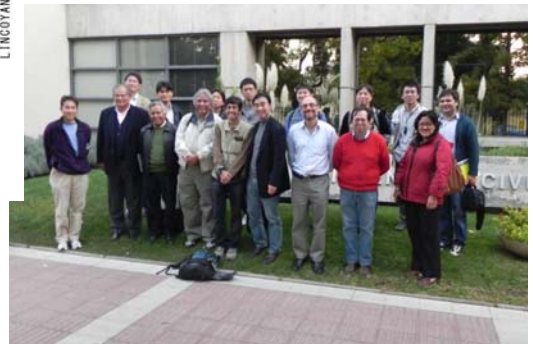
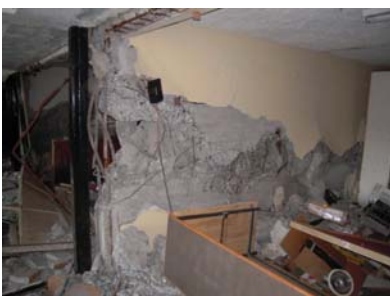
2010 Chile Earthquake

Japan-Peru-Chile joint investigation team

Wall structure suffered flexural failure.

Shear failure of wall ... studied well
 Flexural failure of wall ... need more study

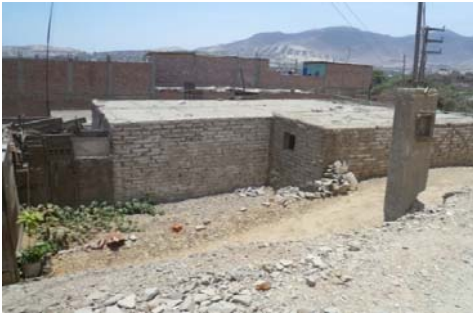
OUT-OF-PLANE FAILURE

Puente Piedra – Lima - Perú

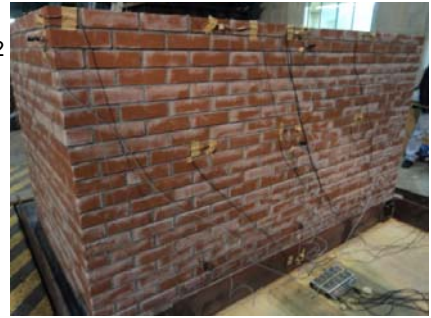
Positions of accelerometers

INSTRUMENTATION FOR THE TEST

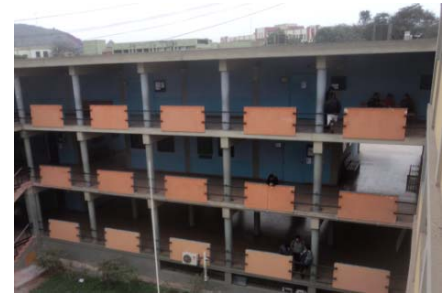
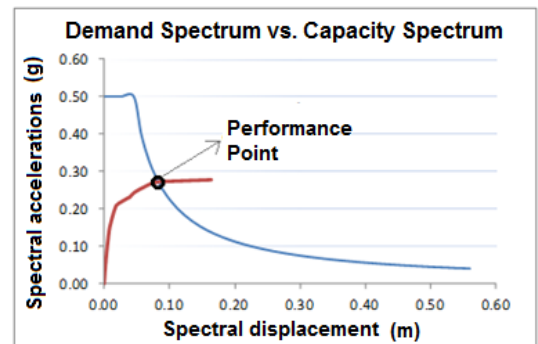
Simulation of dynamic performance of a building

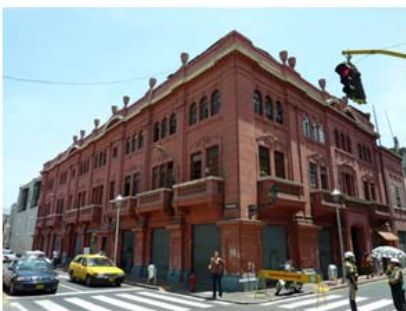
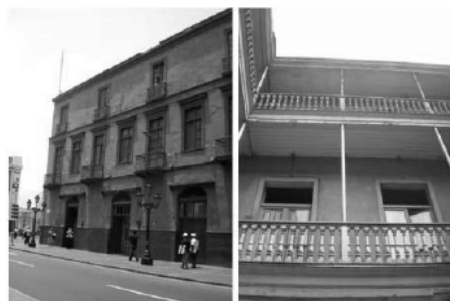
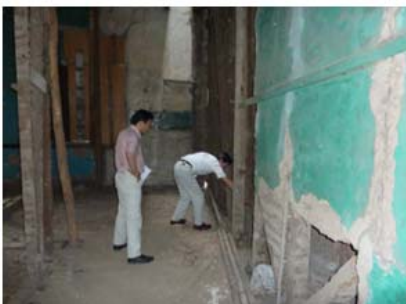
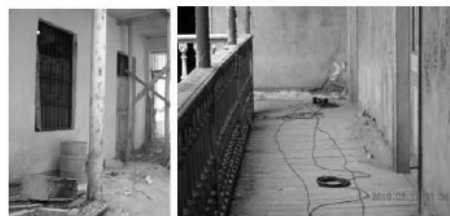
Comercio Hotel

Vibration Characteristics of Traditional Adobe-Quincha Buildings
(Akita Prefectural University, BRI and CISMID)

Micro-tremor measurement

Dominant frequency
