EXPERIMENTAL STUDY ON DYNAMIC BEHAVIOR OF UNREINFORCED MASONRY WALLS

SUMMARY

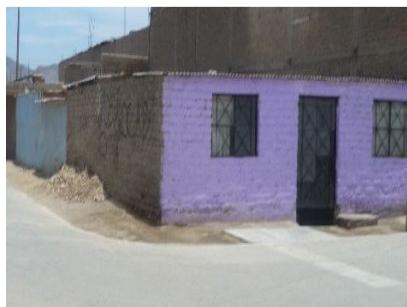
Figure 1 House consists of URM walls

A fundamental issue to be resolved is mitigating the seismic hazard of unreinforced masonry (URM) walls. This concern is relevant to Peru because residential buildings located in areas with low economic resources are mostly non-engineering houses. Figure 1 illustrates a non-engineering house built with URM walls and without floor diaphragm. And Figure 2 illustrates typical URM exterior walls of a masonry building, which could injure people around the building when it collapses during earthquakes.

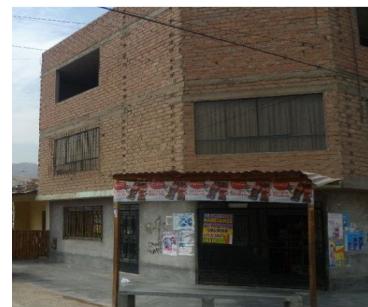
Figure 2 Masonry building with URM external walls

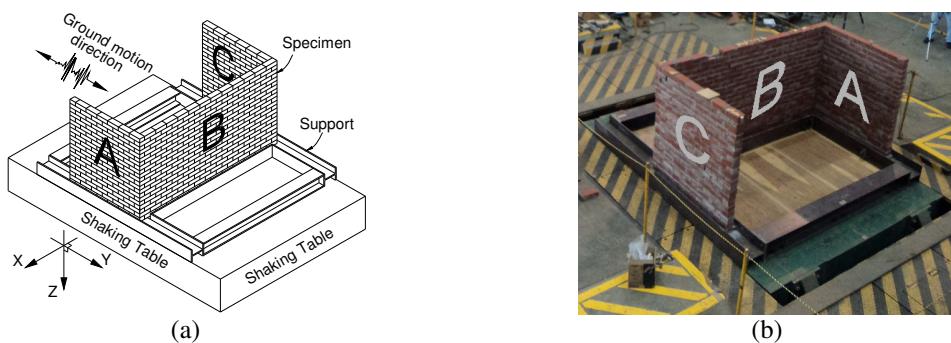
Figure 3 Specimen 1: (a) Scheme of the test setup (b) Specimen on the shaking table

On January 2012 two specimens were constructed on the shaking table of the Structural Engineering Laboratory at Building Research Institute. Figure 3 and 4 illustrate the idealized models which represent an URM wall of a single-story building and an upper level of a multistory building respectively. Each specimen consists of three masonry walls: A, B and C. The ground motion direction was applied perpendicular to the wall B. Therefore, the walls A and C will behave in-plane and the wall B will behave out-of-plane. In the second specimen, a constant axial load of 18kN approximately was applied by means of a weight suspended over the floor diaphragm.

The wall B has height, width and thickness of 1440 mm, 2850 mm and 100 mm, respectively. The orthogonal walls (A and C) have 1440 mm, 1450 mm and 100 mm of height, width and thickness, respectively. The above dimensions give a slenderness ratio of 14.4. Solid bricks and type O mortar were used in the specimen. Masonry prisms of four bricks tall were made when the brick were moist cure for 28 days. The average compressive strength of the masonry prism was found to be 6.09 MPa. Diagonal tension tests according to the ASTM E519 were carried out on 430mm x 410 mm specimens. The average shear strength of the masonry after 28 days was found to be 1.28 MPa.

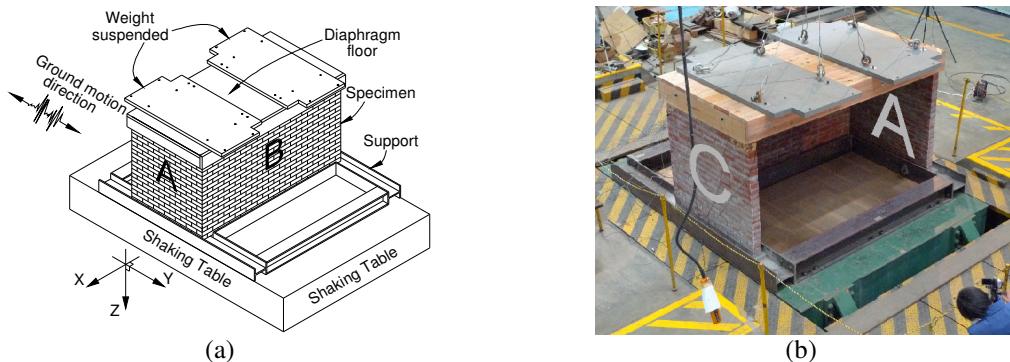
Figure 4 Specimen 2: (a) Scheme of the test setup (b) Specimen on the shaking table

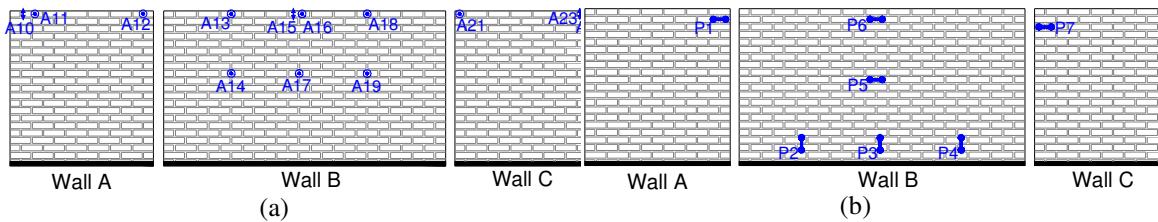
Figure 5 Instrumentation for the wall test: (a) accelerometers and (b) pi-gauges

Fourteen accelerometers, seven pi-gauges and a data acquisition system were used to record the dynamic characteristics of the walls in the specimens. The figure 5 (a) shows the position of the accelerometers. The A00, A05 and A13 accelerometers recorded vibrations in the up-down direction and all the others recorded vibrations in the direction perpendicular to the wall where they are located. Assuming that the wall “B” will fail similar to the shape of failure of a slab (out-of-plane behavior), it was decided to collocate the pi-gauges as illustrated in figure 5 (b). As you can see, most of the accelerometers were placed on the wall B. That is because previous researchers showed the out-of-plane as the weakest mode of failure

Three additional accelerometers were placed over the floor diaphragm, for the second specimen. The accelerometer located at the middle of the diaphragm recorded the acceleration in the same direction of the shaking table and the other two, which were located at the ends, recorded the acceleration in the up and down direction.

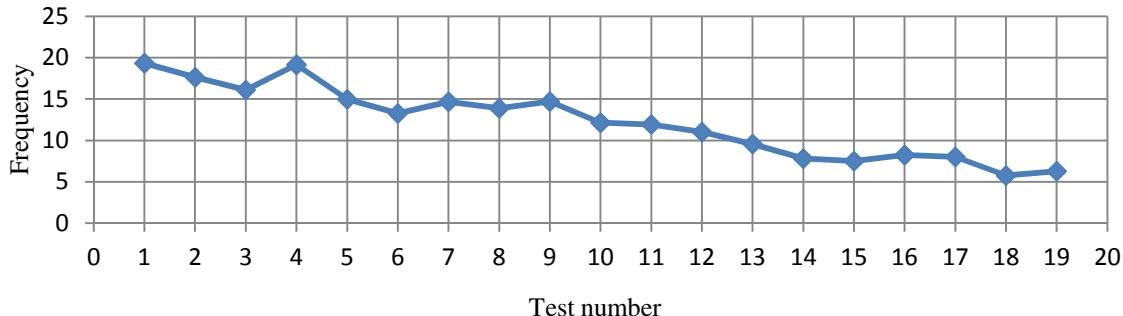
Figure 6 Variation of the natural frequency of the first specimen

Two types of signals were applied over the tests: frequency sweep test and frequency random test. Frequency sweep test was useful to monitor the shift of the natural frequency of the wall B. As a result of the damage produced in the specimen during the tests, the natural frequency of the specimen had been decreasing continuously. As shown in Figure 6, which is the record of the

accelerometer placed at the middle top of the wall B, the natural frequency decreased from an initial value of 19.34 Hz to 6.29 Hz by the end of the 19th dynamic test run.

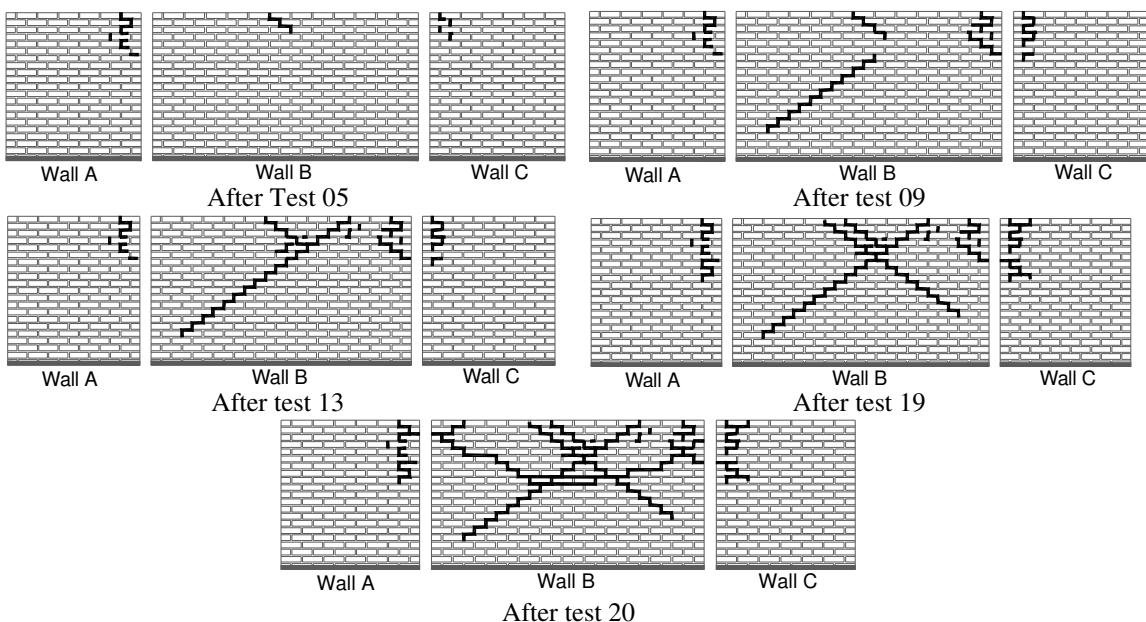
Figure 7 Crack patterns developed in the first specimen

Although most of the cracks were observed over the out-of-plane wall component, the crack patterns before the failure was different than previous investigations. As shown in Figure 7, the first cracks were observed after the 5th test and it was located at the middle top of the wall B and also at the top of the corners. After the 9th test the initial cracks become wider and a diagonal crack appears over the wall B. This diagonal crack has not been seen in previous research. Another diagonal crack appears in the same wall after the 19th test. Besides, the cracks located at the upper corners became larger and they reached the half-height of the wall. Finally, when the connection between in-plane and out-of-plane walls were partially lost, a horizontal crack formed at the middle of the wall, which corresponds to the collapse of the specimen (see Figure 8).

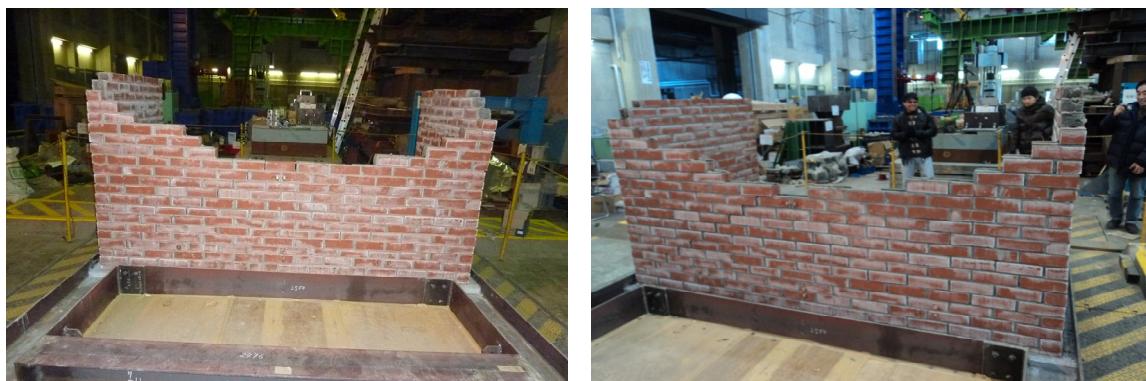
Figure 8 Shape of failure of the second specimen

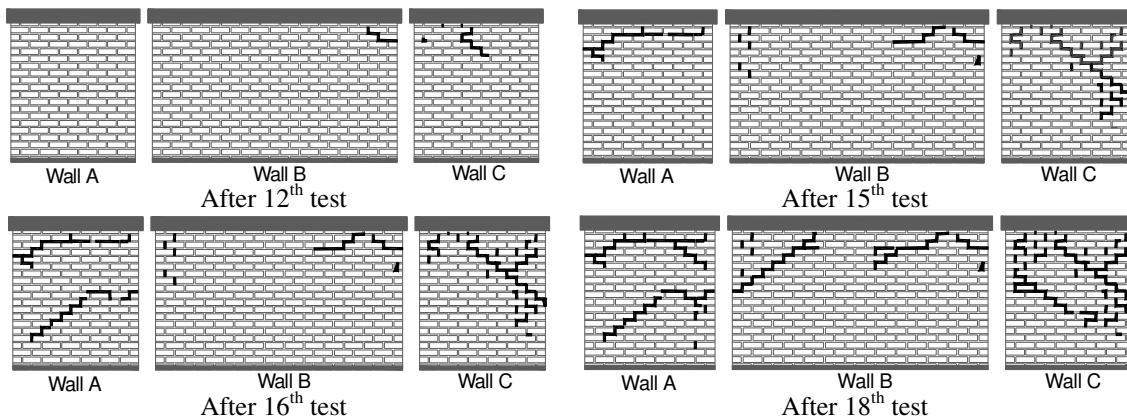
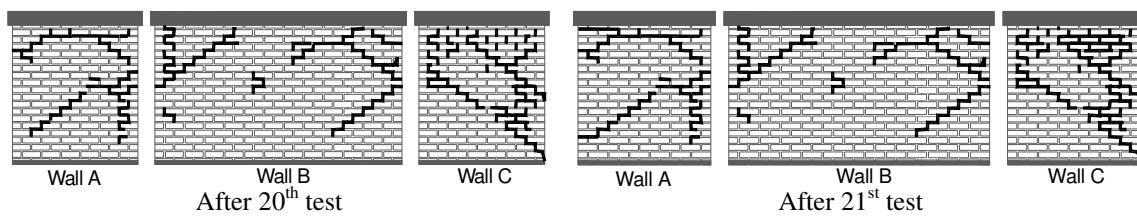
Figure 9 Crack patterns developed in the second specimen

Figure 9 Crack patterns developed in the second specimen (continuation)

This time most of the cracks were developed over the in-plane walls. It seems that the axial load produced by the weight suspended at the top had improved the flexural strength of the wall B. Furthermore, a kind of confinement is provided by the floor diaphragm and the roof. As shown in Figure 9, at the beginning the cracks patterns developed over the in-plane walls components were totally different between them. After the 15th test, a bed-joint sliding on a horizontal plane located at the top was developed in the wall A; on the other hand, a sliding on a stair-stepped diagonal crack was developed in the wall C. Due to the difference of behavior between the in-plane wall components, torsional movements was developed in the specimen. After the 18th test, diagonal cracks, which began in the in-plane walls and end up on the wall B, were developed because the torsional behavior. Finally, the shape of failure is illustrated in Figure 10.

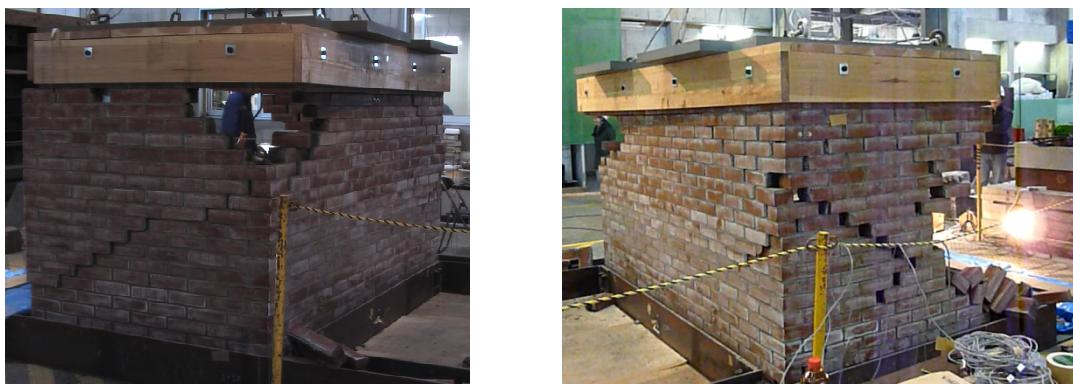
Figure 10 Shape of failure of the second specimen

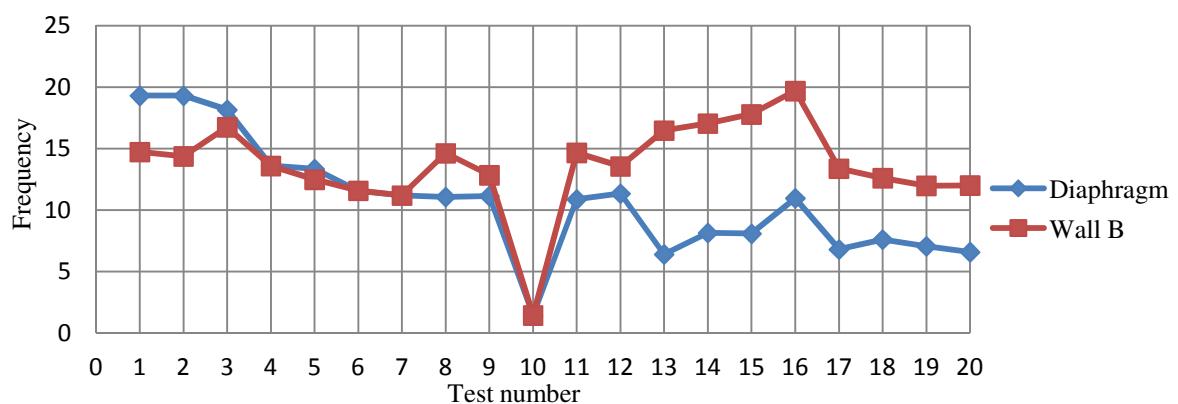
Figure 11 Variation of the natural frequency of the second specimen

The change of the natural frequency can be used as a trace of the damage produced in the specimen. The figure 11 illustrates how the natural frequency of the accelerations recorded over the diaphragm had been reducing. However, the natural frequency recorded at the middle-height of the wall B had not been reducing significantly.
