CAPACITY EVALUATION OF STEEL STOPPERS OF REINFORCED CONCRETE CHILEAN BRIDGES

SUMMARY

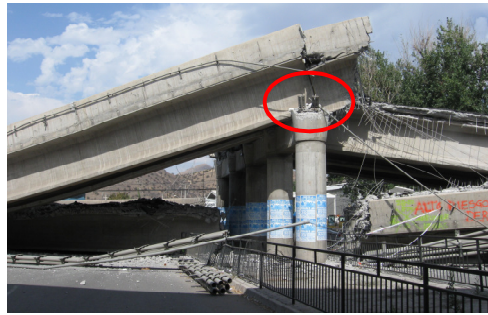
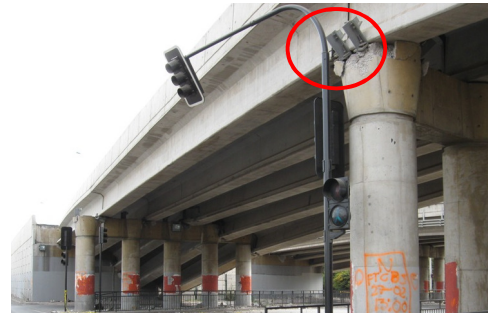
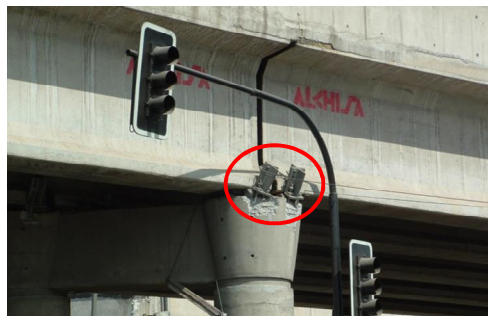
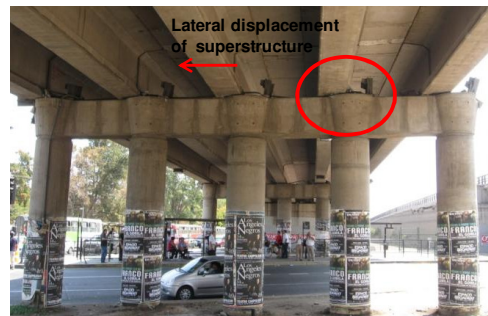
Figure 2: Observed damage to bridges with steel stoppers

(a) Collapse of eastbound Lo Echevers overpass

(b) Collapse of eastbound Miraflores overpass

(c) Damage of westbound Lo Echevers overpass

(d) Damage of eastbound Independencia overpass

During 2010 earthquake, new bridges designed with steel stoppers suffered considerable damage to its stoppers, lateral displacement of the superstructure, and three bridges collapsed. The collapsed bridges, which were located in Santiago, are the eastbound of Lo Echevers overpass, and the eastbound and westbound of Miraflores overpass. Figure 2a and 2b show the collapse of these bridges, where the damaged steel stoppers are encircled. The damage observed to the steel stoppers in the westbound of Lo Echevers overpass and the eastbound Independencia overpass is shown in Figure 2c and 2d, respectively. For the Independencia bridge (Figure 2d) the superstructure displaced laterally more than 0.5 m destroying the steel stoppers located at the south of the girders (left of the girders in Figure 2d). The girders of this bridge did not unseat because enough transverse seat width was provided at the cap beam.

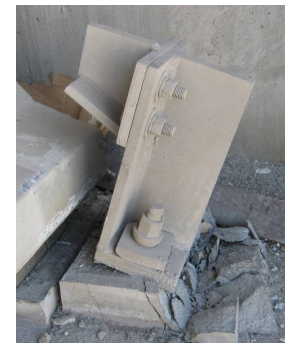
Figure 3: Steel stopper detailing

(a) Steel stopper drawings

(b) Damaged to steel stopper

Since several existing bridges of the concessions companies are detailed with steel stoppers, the question that wants to be answered in this study is what is the strength provided by these stoppers. Figure 3a shows the drawings of steel stoppers and Figure 3b shows a picture of a damaged stopper located in a bridge of Vespucio Norte concession highway. This stopper was bolted on top of a concrete base, but other stoppers were bolted directed to the cap beam. The stoppers are detailed with a 220 x 150 x 25 mm base plate which contain oval holes for bolting the stopper to the pier cap or abutment with two 25 mm threaded reinforcing bars. Below the washer of each of these anchor bars, an additional 90 x 90 x 20 mm steel plate is specified. The dimension of the vertical plate of the stopper is 338 x 220 x 15 mm and the dimension of the vertical stiffener is 338 x 135 x 20 mm. The specified distance between the anchor bolt and the end of the base plate is 90 mm. However, this specified distance can not be achieved because the oval holes specified in the base plate allow a distance that vary between 50 mm to 80 mm. In fact, the distance between the anchor bolt and the end of the base plate is about 75 mm in the stopper shown in Figure 3b. Finally, the specified gap distance between the stopper and the bottom flange of the PC girder is 35 mm.

The stoppers were built with the described dimensions (Figure 3) using A36 steel. The upper pieces of the stopper, which are used to restrain the vertical displacement of the girders (Figure 3b), were not considered because the stoppers were not tested for uplift conditions. The stopper was bolted to a 800 x 500 x 600 mm RC block that simulate the cap beam using two 25 mm threaded reinforcing bars with nominal yield strength of 280 MPa. Since the location of the anchor bars is variable due to the oval holes of the base plate, conservatively a distance of 60 mm between the anchor bars and the end of the base plate was considered, Figure 4. Note that the allowable distance of the anchor bars range between 50 mm and 80 mm. The anchor bars were bend inside the RC block with a 90° hook to provide enough development length according to ACI code [10]. The RC block was anchored to the strong floor with a reaction beam and the horizontal displacement at the bottom of the block was restrained. The RC blocks were constructed using normal weight concrete with specified design strength of 20 MPa and maximum

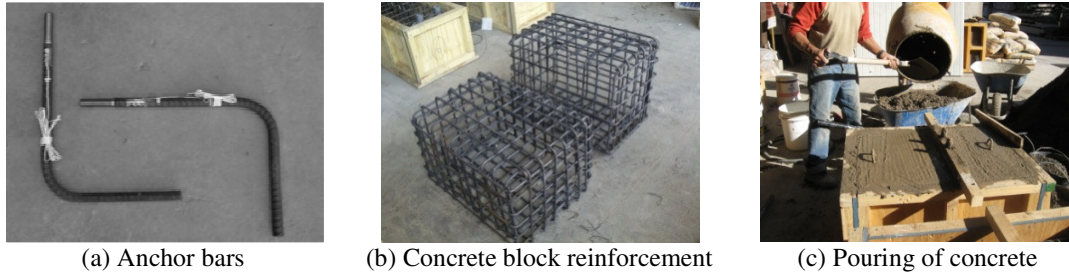
Figure 5: Construction process

aggregate size of 13 mm. They were reinforced in both direction using 10 mm bars spaced at 100 mm. Figure 5s show pictures of the construction process of the RC blocks.

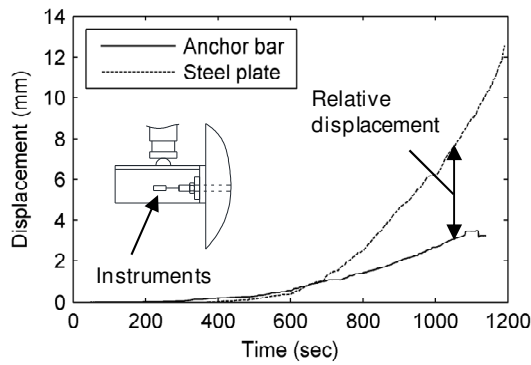
(a) Displacement versus time

(b) Instruments details

Figure 8: Behavior of anchor bar and 90 x 90 x 20 mm steel plate, stopper S3, north side

The pullout horizontal displacement of the anchor bolt and the horizontal displacement of the 90x90x20 mm steel plate of the north side of specimen S3 is shown in Figure 8a. The details of the instrumentation is shown in Figure 8b, where an horizontal displacement transducer is used to measure the horizontal displacement of the steel plate. The pullout displacement of the anchor bar is measured with another displacement transducer (transducer not shown in Figure 8b) which is connected to the end of the anchor bolt using a string and a pulley. The horizontal displacement of the anchor bolt and the plate are similar until about 660 seconds, which correspond to approximately 50% of the peak load of specimen S3. After this time, a relative displacement between the steel plate and anchor bolt started to occur because due to the damage in the thread of the anchor bar and nuts.
