Seismic-Resistant Technology in Japan

Taiki SAITO

**Chief Research Engineer,
International Institute of Seismology and Earthquake Engineering (IISEE),
Building Research Institute (BRI)**

**Lessons of recent gigantic
earthquake disasters in Japan**

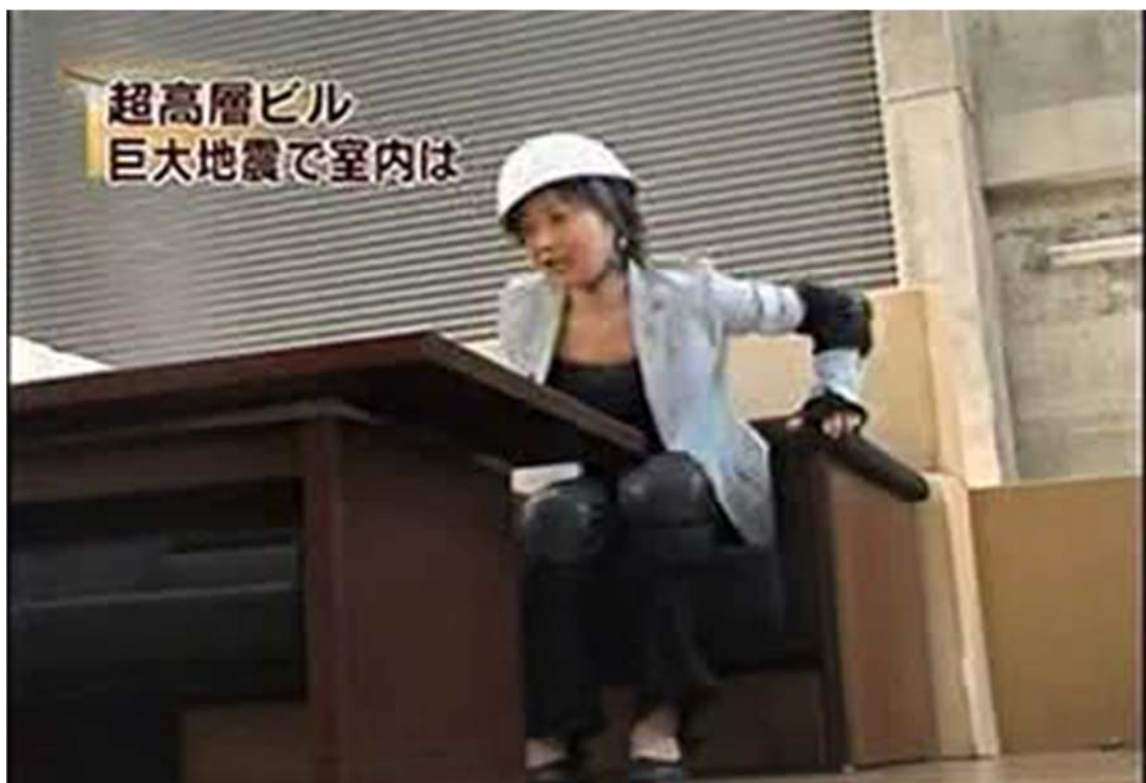
3m movement by BRI shaking table

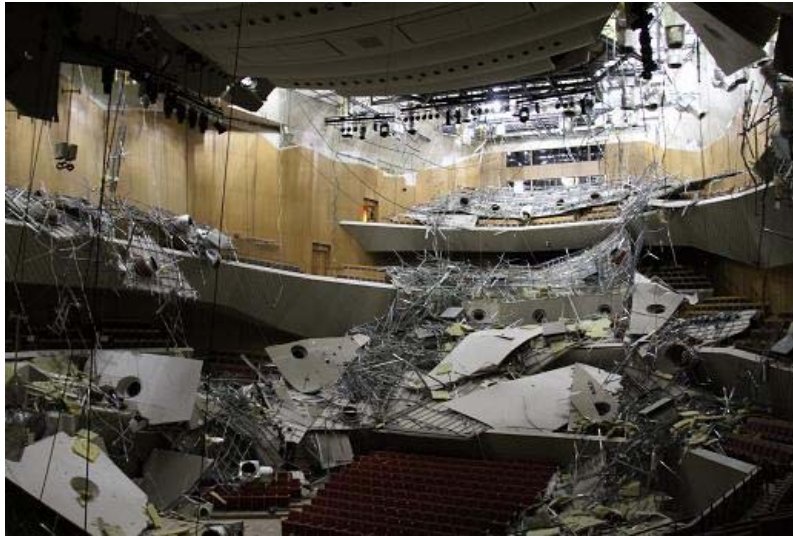
Fall of Suspended Ceiling in Symphony Hall

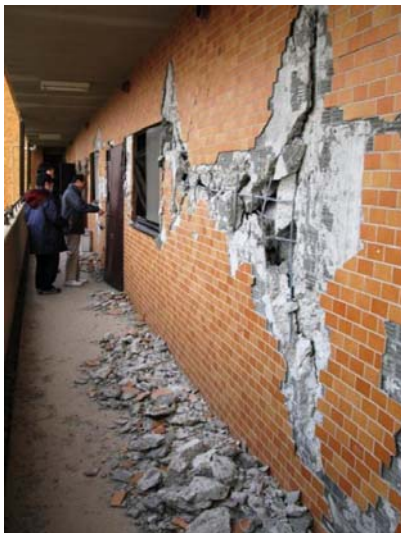
Damage of non-structural wall

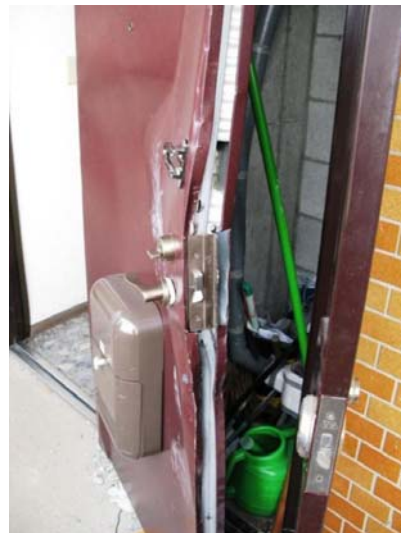
Damage of door

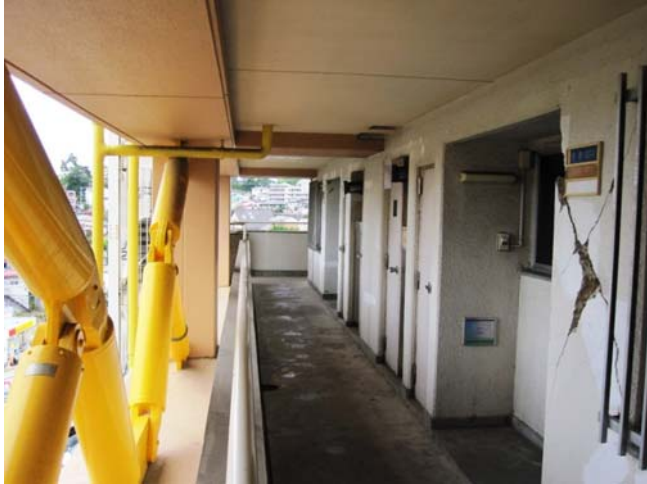
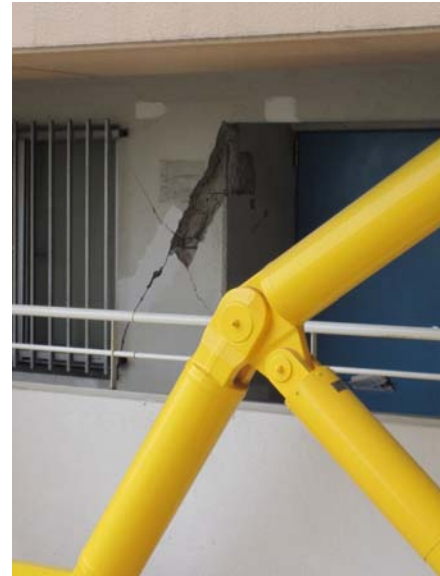
Damage of non-structural walls of a building retrofitted with oil dampers
