Science and Technology Research Partnership for Sustainable
Development (SATREPS)

Progress of G3 Activity

Presented by:
Dr. Carlos Zavala
Dr. Taiki Saito

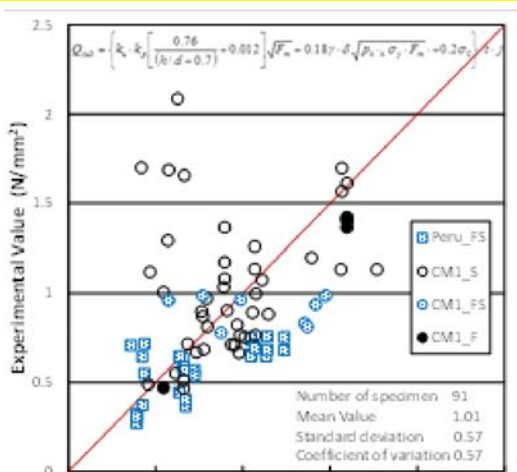
Significant improvement

Maximum shear strength using AIJ equation (stand. dev = 0.57)

Maximum shear strength using proposed equation (stand. dev = 0.28)

Empirical equations for strength and deformation of walls are developed base on the multiple regression analysis.

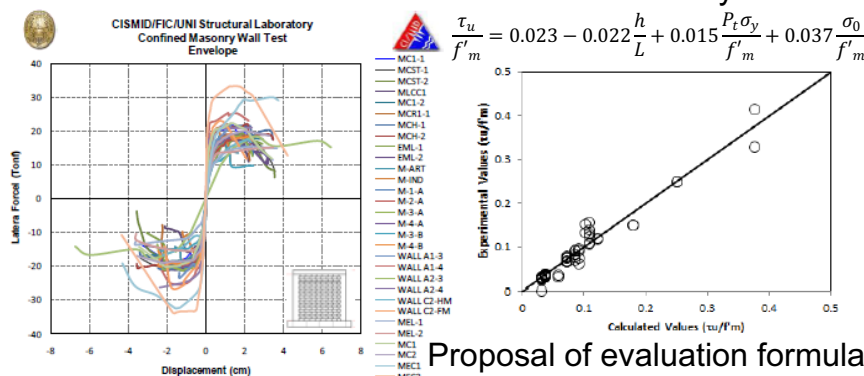
Process of limit states of confined masonry wall

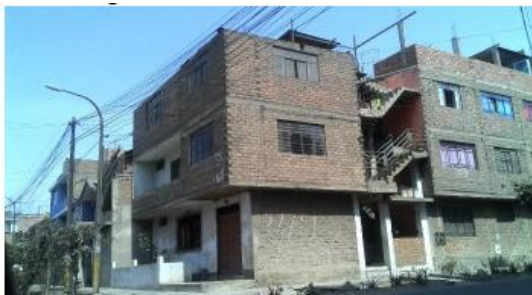
Behavior of a tubular brick wall was investigated by structural test in CISMID Lab.

Tubular brick walls show more than 30% lower capacity than solid walls.

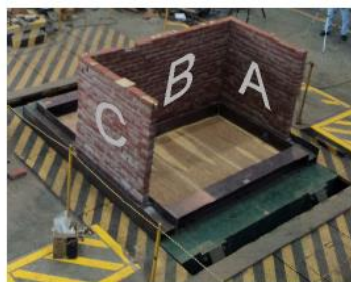
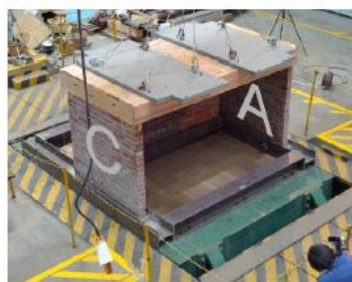
Dynamic behavior of an unreinforced masonry walls were investigated through a shaking table test.

The first specimen showed the out-of-plane flexural failure mechanism, the other specimen exhibited in-plane shear failure mechanism.

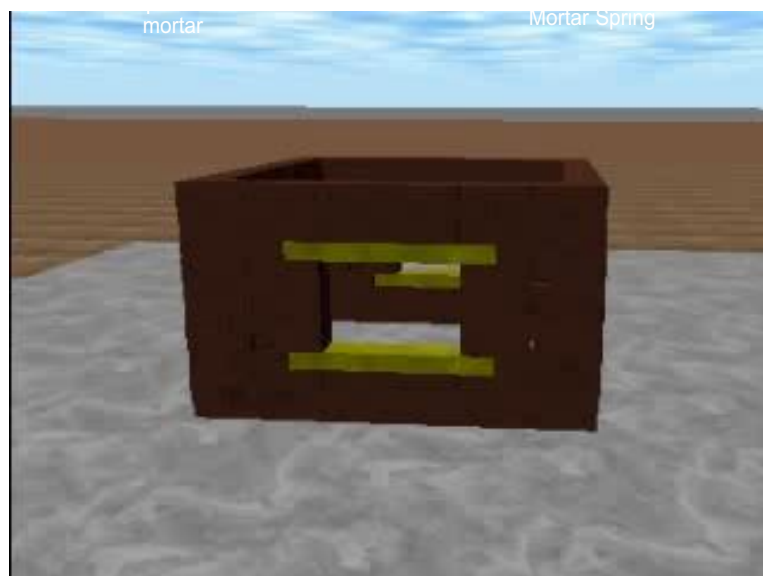
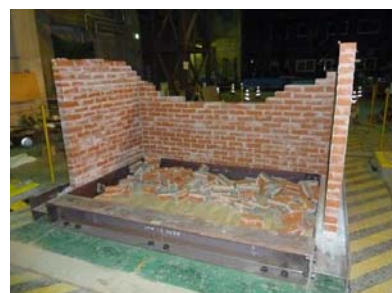
A software was developed using Discrete Element Method (DEM) for simulating collapse behavior of masonry structure.

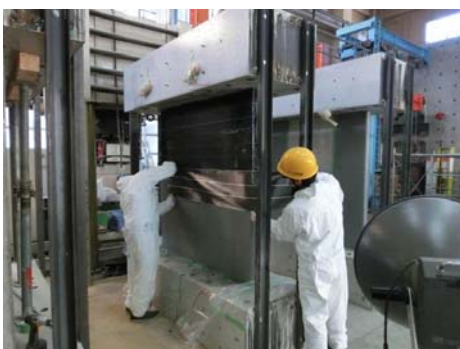
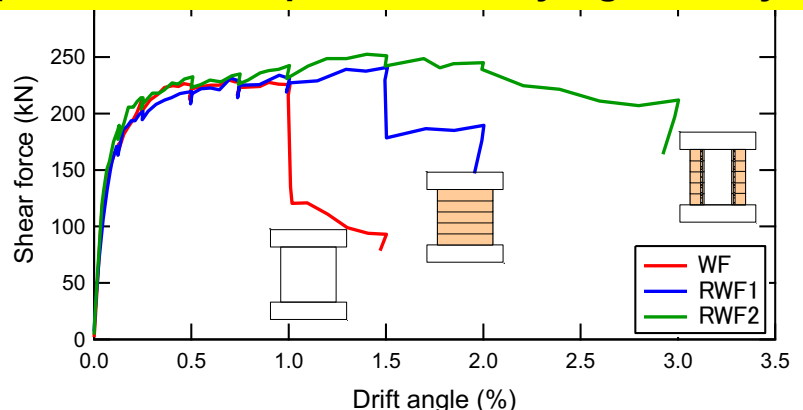
Even partial retrofit improved ductility significantly.

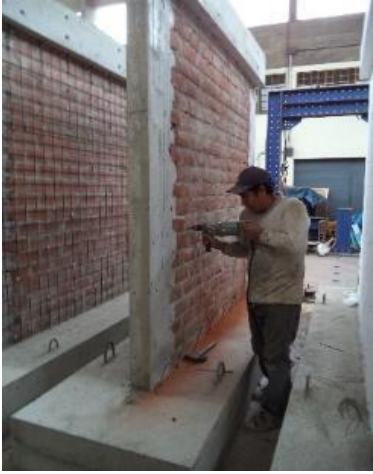
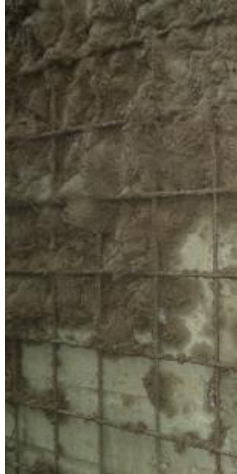
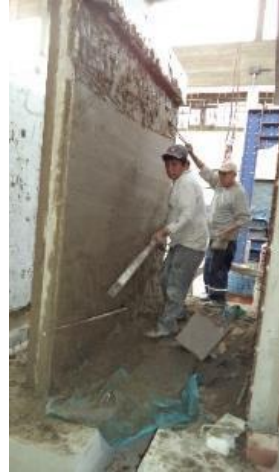
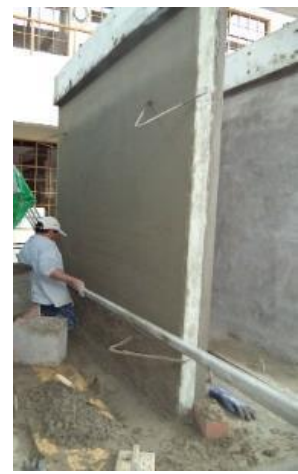
Retrofit of Masonry Walls using Steel Wire Mesh

Procedure of retrofitting work:

- To fix the wire mesh to the wall by anchoring side to side.
- Wire mesh is anchored to foundation by dowels.
- Surface is covered by mortar (1:4, cement:sand ratio).
- Plaster the surface till obtain uniform surface.
