The challenges of protect historical adobe constructions in Peru

This paper attempts to describe the general structural conditions of historical adobe buildings which are mainly located in the coast of Peru that is a zone of high seismic activity. The seismicity of the zone is discussed through an earthquake hazard analysis and the importance of action towards the protection of heritage architecture in Peru is emphasized. It is noted that the state of general disrepair and the intrinsic weakness of the earthen constructions add to the seismic vulnerability of this kind of heritage architecture. Besides, the repair after actual damage or destruction from earthquakes, even when timely undertaken, may lead to alteration of valuable originality of heritage structures, owing to the unavailability of materials or skill from the time of the original constructions. The need for initiatives towards preventive actions for protection from damages and prevention of collapse due to earthquake disasters appears quite evident.

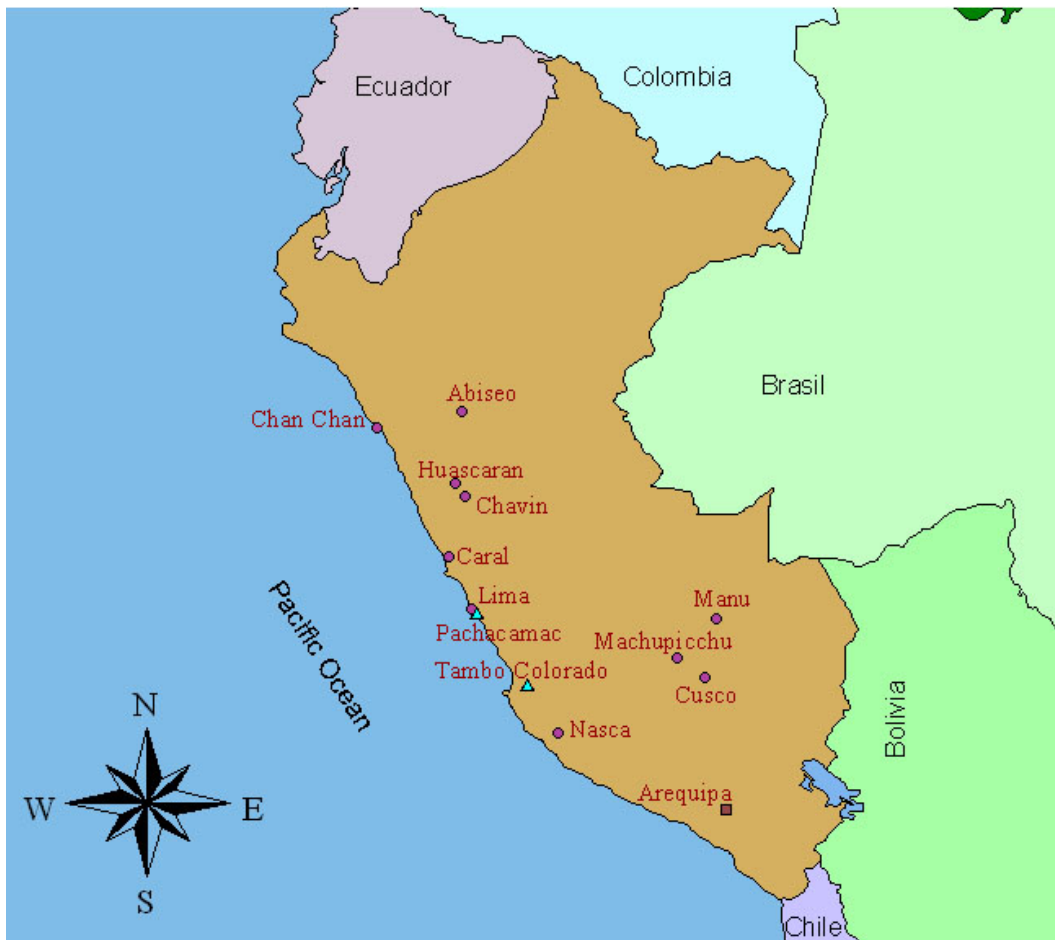
Figure 4: Peruvian world heritages distribution

Peru has many sites of cultural and natural heritage reflecting the pre-Inca era, Inca era as well as the subsequent era following Spanish conquistadors in the 17th century. The distribution of these heritages can be observed in Figure 4 and includes the world heritages declared by UNESCO which are marked by circles. Of the eleven Peruvian heritage sites in the UNESCO world heritage list, seven are considered cultural and two are considered natural. The remaining two are considered mixed category, meaning that the sites reflect the cultural as well as the natural heritage. Additionally to this UNESCO list, other architectural heritages located in the coast of Peru are included in Figure 4 and are marked by triangles. These selected architectural heritages correspond to structures made of adobe and are describe in the following sections.

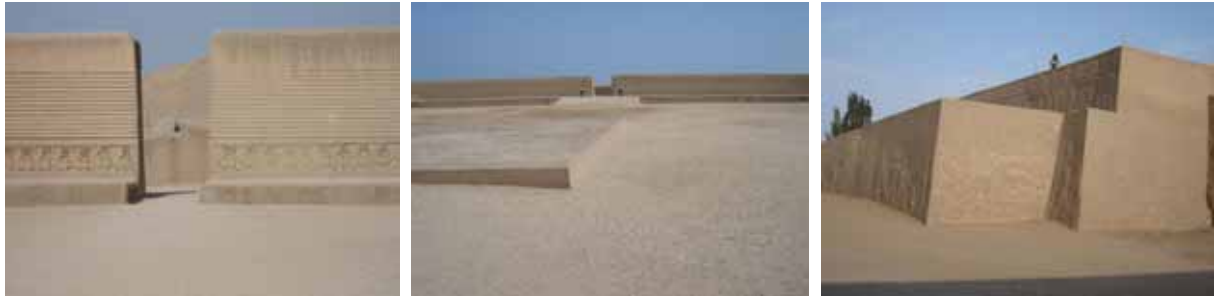
Chan Chan is considered the largest old city of South America that was made of adobe. Chan Chan was the capital of a pre-Inca kingdom of Chimú. The remains of the city can be found in nine parts that are considered separated units or palaces because only around these places can be appreciated remarkable constructions. In Figure 5 some views of adobe constructions can be observed.

Figure 5: Some views of Chan Chan adobe city

The adobe constructions are quickly damaged by natural erosion due to the air, salt, humidity and rain and they require continuous conservation efforts. This zone is also subjected to the impact of El Niño current which affects climate world-wide. Some years like 1983 and 1998 this phenomenon was unusually strong, leading to torrential rain and flooding. As was shown previously the seismic activity in this north part of Peru are smaller in comparison to the southern and central parts. However, historical earthquakes distribution and hazard analysis shown that this area is not free of earthquakes and on the contrary occurrence of rarely earthquakes could strike and damage earthen structures like Chan Chan.

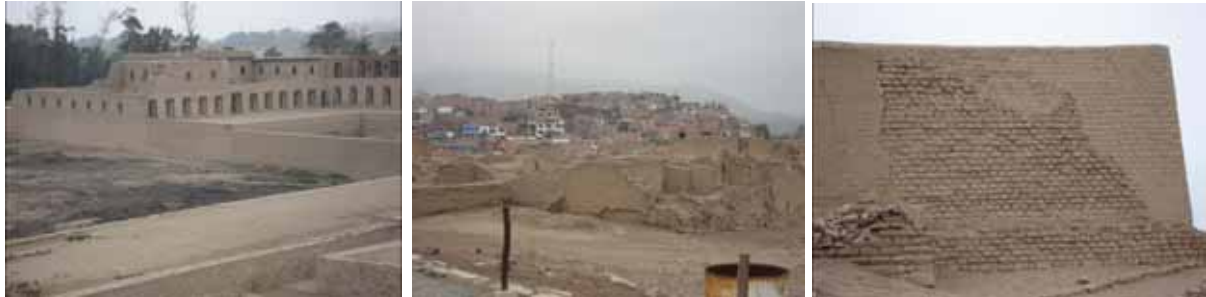
Figure 7: Some views of Pachacamac archaeological complex

and cover completely the buildings. It is difficult to infer the action of past earthquakes because the damage condition of the building could be the result of the action of earthquakes and the lack of appropriate maintenance. Another hazard to this complex becomes the rapidly development of the urban area near the complex that affect not only the landscape of the zone but the architecture heritage itself since construction materials are obtained from the historical place.

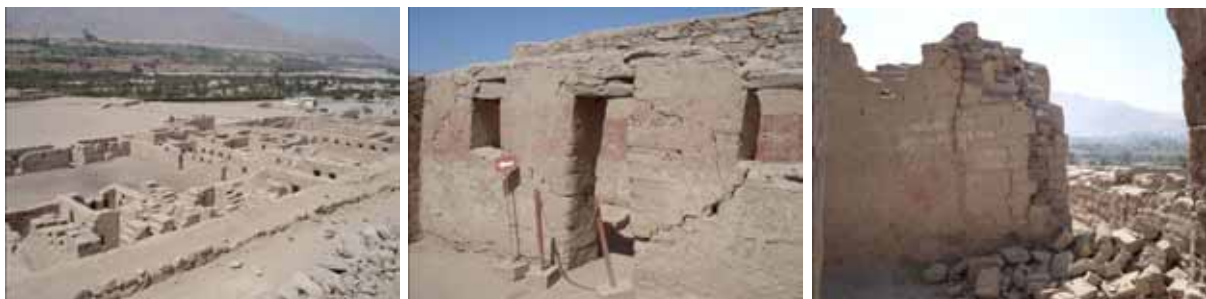
It is believed that Tambo Colorado was one of the administrative centres of the Inca Empire. It is strategically located at the entrance to the Pisco valley, just 35 km inland from the port city of Pisco on the southern coast of Peru, and dominates access to the Inca road leading to the highlands and eventually to Cusco. All constructions are made of adobe and some of them have a coloured plaster with horizontal, alternating, ribbons of white, red and yellow. During the recent earthquake of Pisco of July 2007 many walls were affected and some of them fall down producing not only the failure of the structure itself but also the destruction of the coloured plaster. Some of these damages can be appreciated in Figure 8. In this case, together with the seismic vulnerability analysis it is necessary to analyze the plaster material to try to reconstruct the painted walls. It is obvious that it also has suffered considerable deterioration and damage during the years and urgent conservation measures are required to preserve this monument.

Figure 8: Some views of Tambo Colorado effected by earthquake motion

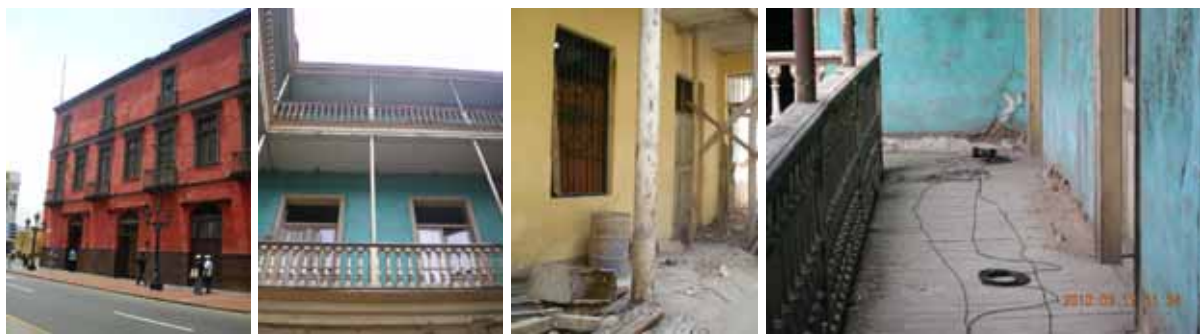
Figure 9: Some views of a historical building at historic centre of Lima

suffered the action of many earthquakes that have severely affected historical buildings and reconstruction works have been done keeping the originality of the buildings. However due to the age of buildings studies for retrofitting or strengthening are necessary. In this study a preliminary evaluation of structural condition of buildings is presented. As example a building that correspond to an old hotel is presented where ambient vibration measurements were performed to estimate the period of vibration. This building can be observed in Figure 9. Walls are made of quincha that consists of a wooden frame with a mesh of cane that receives a mud plaster. The first story is made of adobe walls and the upper two stories are made of quincha. The building presents some partial collapse of interior walls and serious deterioration of the quincha walls. Results of ambient vibration show a predominant frequency of the order of 3.3 Hz. Figure 10 shows the predominant frequencies for NS and EW directions respectively. The NS direction was taken as the direction parallel to the façade and the predominant frequency is 3.37 Hz. In the EW direction that is perpendicular to the façade the predominant frequency is 3.21 Hz. These frequencies represent reasonable values for a building of 12 m of height however more detailed measurement are necessary to detect the local vibration of portions of the building that could indicate the condition of deterioration.
