## VIBRATION CHARACTERISTICS OF TRADITIONAL ADOBE-QUINCHA BUILDINGS LOCATED AT LIMA HISTORIC CENTRE

**Abstract:** The historic centre of Lima city was declared as World Heritage site in the year 1988 for its originality and high concentration of historic monuments constructed in the time of the Colonial period and at the beginning of the Republican era. The architecture of the buildings corresponds in general to typical Hispano-American baroque of the 17<sup>th</sup> and 18<sup>th</sup> centuries. Together with churches and palaces there are particular buildings constructed of traditional adobe-quincha materials. These buildings consist of a first floor made of adobe or sun-dried bricks and upper floors made of wooden frame or panels which support a mesh of cane to receive a finishing plaster of mud and gypsum. In this paper a preliminary study of the dynamic characteristics of these traditional buildings is presented. Microtremor measurements have been performed in one typical building to obtain its vibration characteristics. Although light weight of the upper stories could signify a better seismic behavior, deterioration and lack of repair and maintenance make critical the vulne

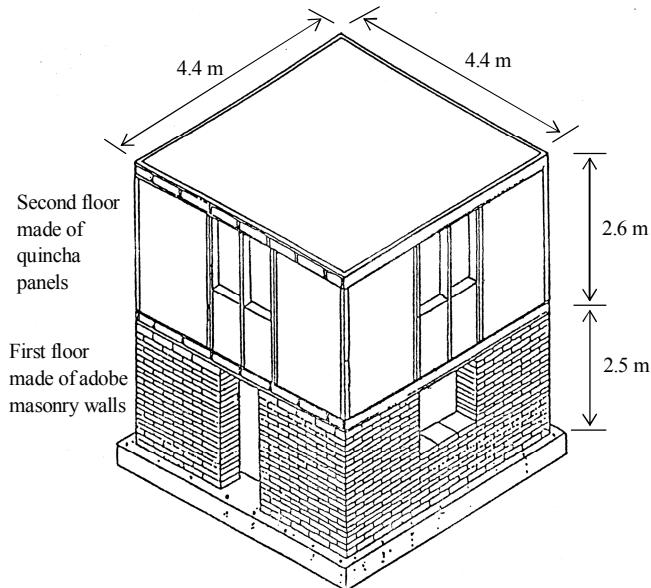
To explain the characteristics of the adobe quincha system the model employed by Miranda et al. (2000) are used. This model is shown in Figure 1.

Figure 1 Prototype of the adobe-quincha system

The quincha system of construction consists, basically of wood panels with a kind of bamboo mesh and a plaster made of mud and gypsum. The construction of this full-scale model permitted to solve some constructive problems in relation to the inter-story floor and the connection between the adobe walls and the quincha panels of the second floor. As it is observed, the first floor is made of adobe masonry and the second floor consists of wood panels with finishing plaster of mud and gypsum. The thickness of the walls of the first floor is 40 cm, while the second floor walls are of 10 cm of thickness. In order to connect appropriately the first floor and the second floor, eucalyptus rods of 7.5 cm of diameter were fixed in the foundation to act as columns. These rod columns are embedded in the adobe wall and are located at the corners and distributed along the wall with 1.2 m of spacing. To permit the inclusion of the rod columns in the walls, the adobe masonry units have an especial shape as is shown in Figure 2. The adobe masonry units have a modular dimension of  $40 \times 40$  cm and 10 cm of height with semicircular incisions of 10 cm of diameter in two opposite

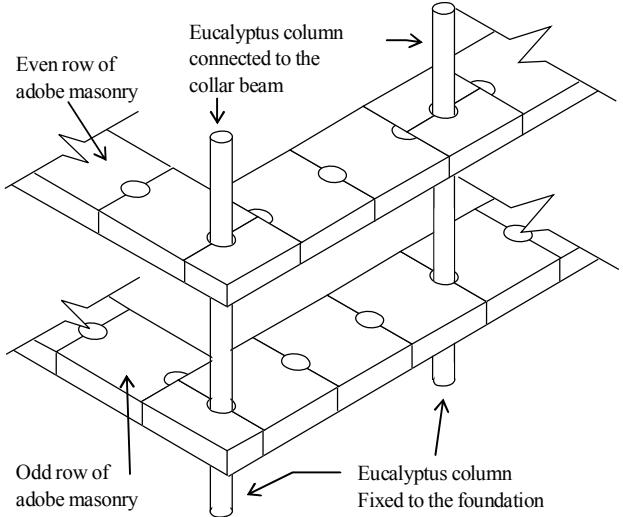
sides. Also there are adobe units which are half units to permit the appropriate fabric of the masonry. The incisions of the adobe masonry units permit to form the cylindrical space to allocate the eucalyptus rod columns.

Figure 2 Detail of the adobe masonry and eucalyptus columns

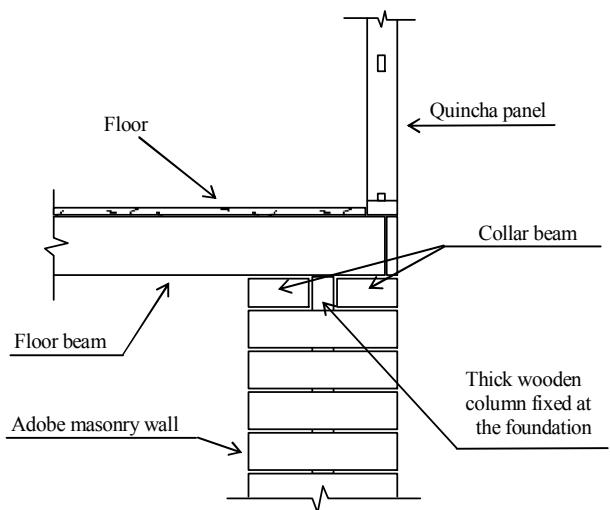
These rod columns permit to fix the collar beam in the upper perimeter of the adobe walls. In this way the adobe masonry wall is confined and the collar beam on the top of the masonry wall permit an efficient connection with the quincha panels as is shown in Figure 3. These rods also contribute to take the tension stress produced by the lateral load during earthquakes. The inter-story floor is supported by the floor beams, which rest on the collar beam, transmitting the load to the walls of the first floor. Also these beams receive the load transmitted by the quincha panels. The quincha panels are fixed to the inter-story floor beams with nailed connections.

Figure 3 Detail of the connection between adobe wall and quincha panel

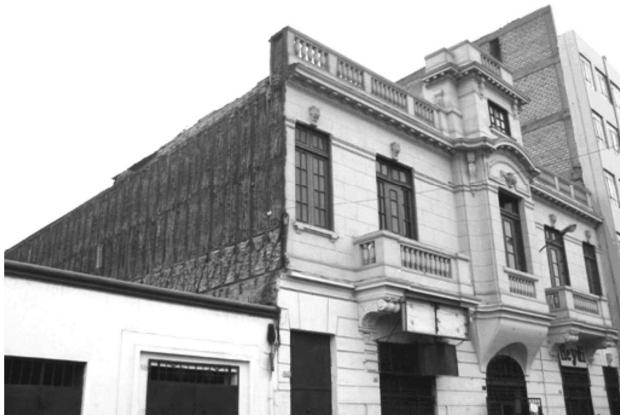
found in Lima Centre, the dimensions of the walls and inter-story heights are quite large. The adobe walls of the first floor have a thickness that varies from 60 cm. to 100 cm. The height of the first floor reaches sometimes 5 m. or more. The thickness of the upper floors ranges from 20 cm to 50 cm. In general the wooden frames were constructed in-situ and the connection between elements presents different patterns like insertions of beam ends into the columns, nailed joints, joints fixed with ties made of animal fur or leather, etc. The mesh of cane is made of very thin canes called "carrizo", and "caña brava". These canes are fixed to the wooden structure by means of cords or ropes made also of vegetal material. To fix the quincha system to the adobe walls the bottom part of the wooden frame is constraint by means of heavy materials like adobe itself or clay bricks as can be observed in Figure 4.

Figure 4 Typical quincha wall at Lima centre

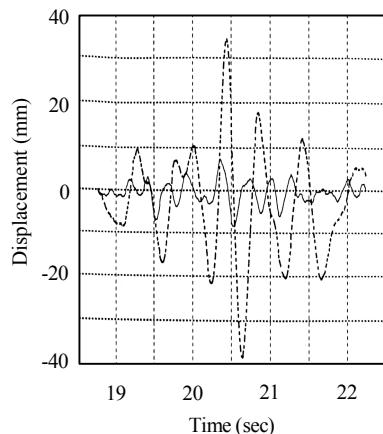
Time history responses for story displacements were obtained for the test sequence. Figure 5 shows the time history responses for displacements of the first and second floor when specimens were tested with the ground acceleration scaled to 400 Gal. Solid line plots the displacement of the first floor while dashed line plots the top displacement of the second floor.

Figure 5 Time history displacement response (IGP-66, 400 Gal)

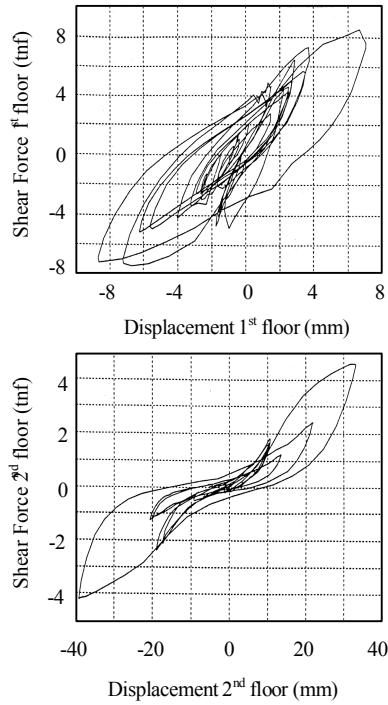
Figure 6 shows the load-displacement curves obtained for the input motion scaled to 400 Gal. It can be observed that the shape of the hysteretic loop shows large energy dissipation. These pattern were observed in all test performed with 100 Gal, 200 Gal, 400 Gal and 600 Gal respectively.

The failure of the specimen was by shear in the walls of the first floor. The adobe-quincha model resisted the 400 Gal earthquake and even the 600 Gal earthquake. However, very large displacement was observed in the second floor with considerable lost of stiffness. This excessive displacement produced during large earthquakes requires additional research to control and keep the lateral displacement of the second floor below a reasonable value.

Figure 6 Load-displacement curves (IGP-66, 400 Gal)

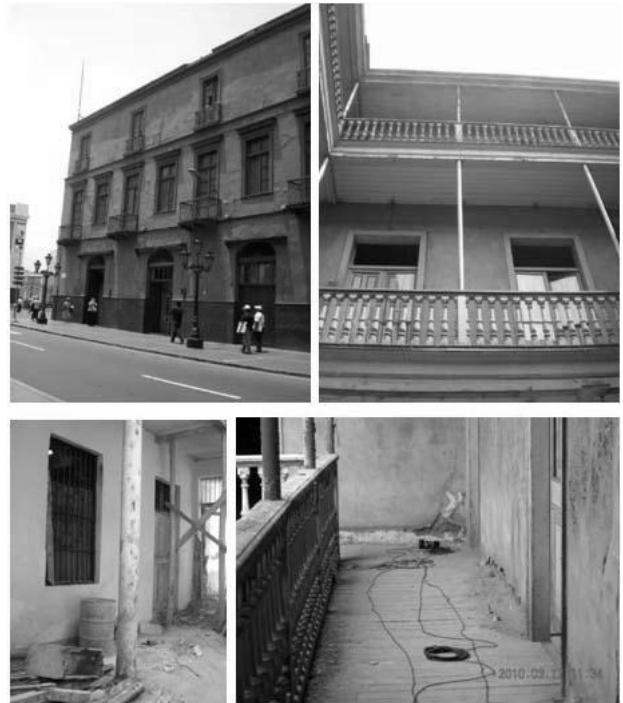
As example a building that correspond to an old hotel is presented where ambient vibration measurements were performed to estimate its period of vibration. This building can be observed in Figure 7. The walls of the upper stories (second and third floors) are made of quincha and the first story is made of adobe walls. The building presents some partial collapse of interior walls and serious deterioration of the quincha walls.

Figure 7 Adobe-quincha building at historic centre of Lima

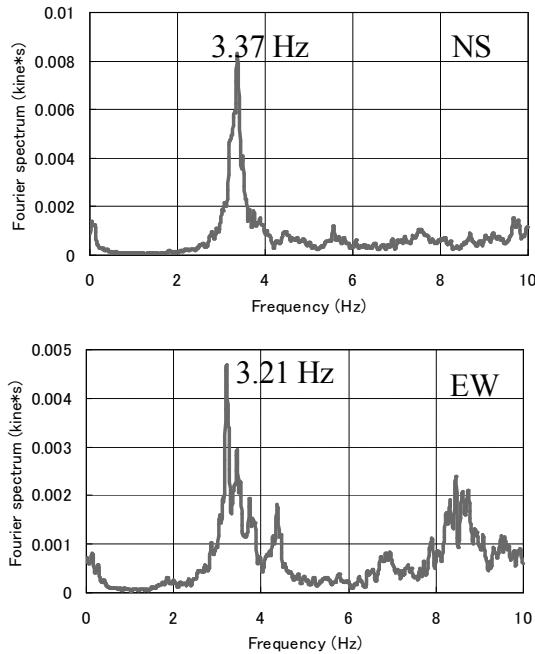
Results of ambient vibration show a predominant frequency of the order of 3.3 Hz. Figure 8 shows the predominant frequencies for NS and EW directions respectively. The NS direction was taken as the direction parallel to the façade and the predominant frequency is 3.37 Hz. In the EW direction that is perpendicular to the façade the predominant frequency is 3.21 Hz. These frequencies represent reasonable values for a building of 12 m of height however more detailed measurement are necessary to detect the local vibration of portions of the building that could indicate the condition of deterioration.

Figure 8 Predominant frequency of selected historical building of centre of Lima

Microtremor measurements at typical adobe-quincha construction have permitted to determine the predominant period of vibration of this building which falls in a reasonable value considering the building height. This value could be used to construct and calibrate analytical models for future analysis on seismic behavior of this kind of buildings.
