EVALUATION OF SEISMIC VULNERABLE AREAS IN LIMA CITY BY USING SATELLITE INFORMATION

Abstract: Within the project Enhancement of Earthquake and Tsunami Disaster Mitigation Technology in Peru, one of the objectives is to know the most vulnerable areas in the event of a big earthquake. In Lima, the capital city of the Peru, for many years has become the destination of inhabitants of the interior of the country, which has led to use unsuitable terrain areas as for example the slopes of the hills. This disorderly development has caused that the cadastral maps are not updated and therefore the extension occupied by these populations cannot be quantified. This article presents the use and integration of two sources of satellite information for the determination of vulnerable areas in the city of Lima, high resolution optical satellite images and images from PRISM sensor, which allows getting the digital elevation model. With this integration, it is possible to delineate and evaluate the likely areas of urban concentration in areas of threat. Also it is carried out the integration with social information obtained from national census in order to determine the homes of people with low econo

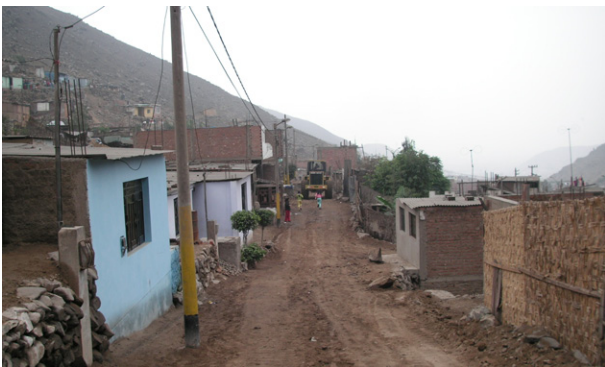
Figure 2 Photograph of the condition of the buildings on the hillsides.

Figure 2, shows the conditions of the buildings built on the hillsides. It can be appreciated the informality of buildings and poor building practices, like building their houses on land fill, to accommodate to the topography of the land. This situation generates a highly risky area in case of

the occurrence of a severe earthquake.

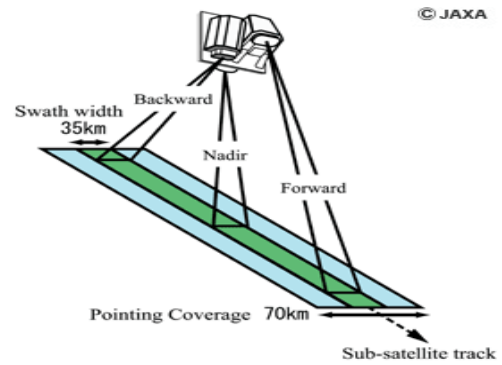
Figure 3 Schematic view of PRISM sensor, with three optical systems: nadir, forward and backward. Source: <http://en.alos-pasco.com/common/images/prism2.gif>

The original images come from the Panchromatic Remote Sensing Instrument for Stereo Mapping (PRISM) sensor that is one of the three sensors that are on board of the Advanced Land Observing Satellite (ALOS). The capability of this sensor to generate three dimensional models, comes from the simultaneous acquisition from three optical systems, as shown in Figure 3 (Pasco Corp. 2013). The general characteristics of this sensor are shown in

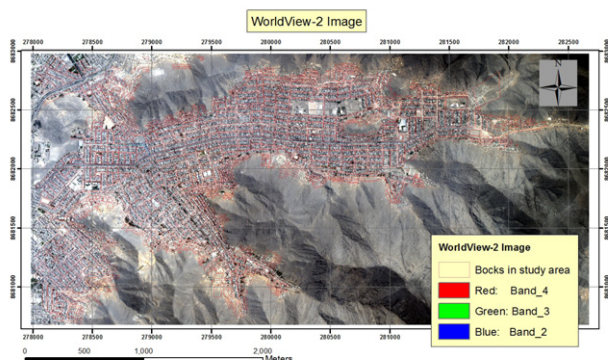
Figure 5 WorldView-2 pansharpened image integrated with blocks layer.

The raw WorldView-2 image is pansharpened by using Gram-Schmidt Spectral Sharpening (ENVI program) to take advantage of the spectral information of the bands. Then this image is georeferenced to geographically match the block layer. The WorldView-2 image is shown in Figure 5.

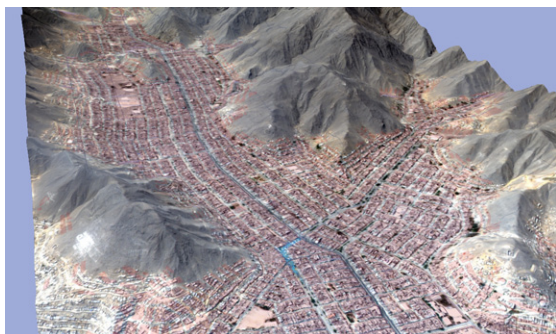
Figure 6 Integration of cadastral information, high resolution satellite image and digital surface model.

Once the images have been georeferenced with the block layer the next step is the integration of three sources of information: digital surface model, the high resolution image and the census data. Figure 6 shows the integration of these three sources:

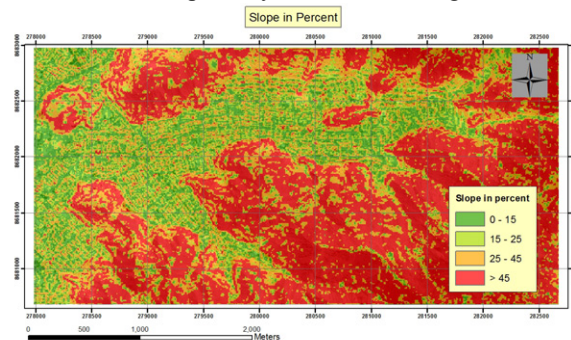
Figure 7 Slope map obtained from the DSM raster image.

Next step is to calculate the percent of slope or gradient of the terrain in the study area. This is carried out by comparing the rate change of pixel values of the DSM image in the horizontal and vertical directions (ArcGIS Slope tool).

The result of the slope analysis is shown in Figure 7.

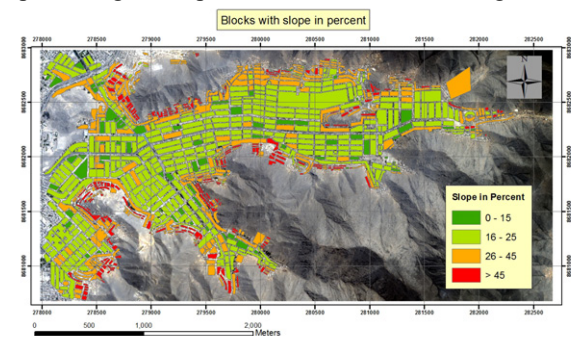
Figure 8 Percent slope integrated in the block layer.

Finally, this raster image that represents the slope is converted into point data, where the point value is the slope in percent. Then this point layer is aggregated into the block layer, given to each block an average of the slope. The map showing the slope in the block is shown in Figure 8.

As it can be seen those blocks that are on the hillside have been identify in red and orange color. Those blocks are settled in a land with an important slope that may produce slides in case of an earthquake and therefore people may be affected by this disaster.
