BUILDING MONITORING EARTHQUAKE RESPONSE NETWORK IN LIMA

Abstract: Under the Peru - Japan SATREPS Project a building monitoring network has been implemented in Lima city, under the support of JST and JICA. The network considering a set of 5 sensors installed on different levels of three building: One is framed concrete structure, the second is a masonry and concrete wall building and the third is a hospital with concrete framed structure. The buildings are located in two kinds of soil of Lima (two in medium soil, and one in rigid soil). Since the installation of the sensors, seven moderate quakes has been register. This paper presents the monitoring response of one building and the dynamic characteristics measure from the stronger event registered for the buildings. Good agreement with simulation previously performed was found, and the results give us the confidence for the developed of parameters for the stiffness degradation under small and moderate quakes for concrete framed structures.

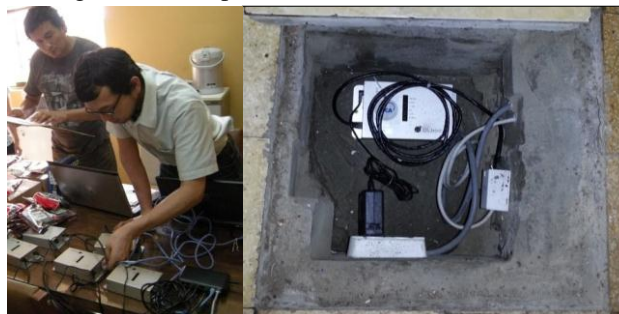
Figure 2 Network setting test and final placement of sensor at basement level in UNI Central Building

At each building, the 5 sensors set are aligned to a vertical line, and if possible near to gravity center. At the basement level, sensors has been fixed in a hole box in floor, and then at ceiling (slab) for each upper level.

After preliminar testing period in a local network (Figure 2), a set of 5 sensors has already been set in 2

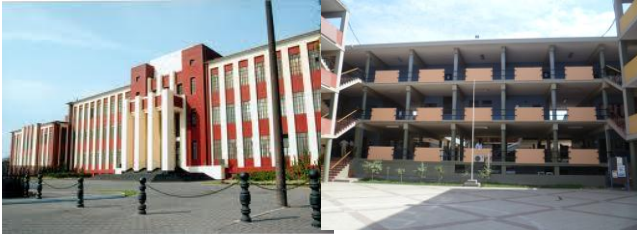
Figure 3 Central Building and G2 bldg block (North view) at Civil Engineering Faculty at UNI

- Central Building of UNI is 3F+ BF Level and 16m high, irregular configuration in plan, with masonry and

- G2 Block at Civil Faculty of UNI, is for classrooms, a 3F framed RC building with irregular configuration of stiffness due to its distribution of masonry walls (hall at 1F, corridors and classroom at upper floors).
- Block A of Edgardo Rebagliati Martins National Hospital is a 14F+BF building, more than 50 years old, RC framed building, classified as essential type for its importance of use.

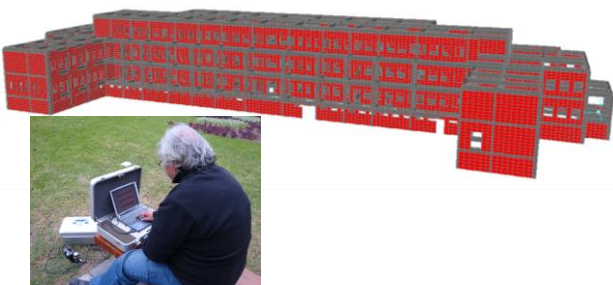
Some previous calculation and measurement has been conducted as reference for assess dynamic monitoring results. Microtremor measurements has been conducted in 3 points (soil: center zone and at 3F: NO and SE wing of building) and showed fundamental periods (from Fourier Amplitude Spectra) of $T_x=0.23\text{s}$ and $T_y=0.28\text{s}$ for the building where X is longitudinal axis, and for soil $T_s=0.41\text{s}$.

Figure 5 Preliminary measurement and analysis: microtremor and modeling

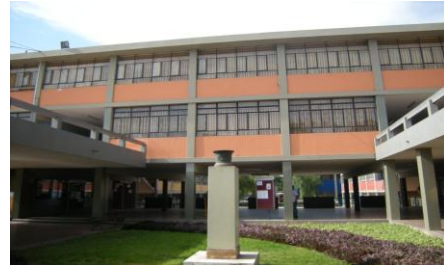
Central Block G2 Bldg of Civil Engineering Faculty (FIC) is a 58 year old, reinforced concrete framed, 3-stories (10m high) structure with one underground floor. Half of its typical plan continue down to a basement floor. First floor is the main entrance hall, and upper levels are for classroom and corridors. So, in plan shown regular configuration (28m x 12m approximately), but some masonry thick walls (250mm) not aligned, in upper levels, changes its stiffness at each story (soft floor).

Figure 6 Location of Central Block G2 in FIC and South side view of building

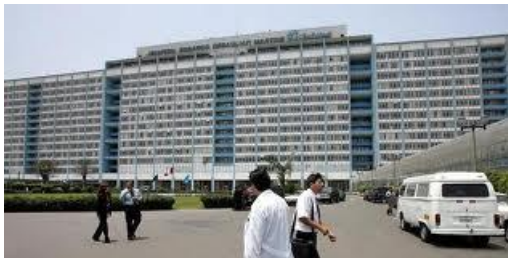
This 14F, reinforced concrete building, 55year old, beard 2 main earthquakes (1966 and 1974), but main structure have not been damaged. “A-Block” was focused for this study and is the right block show in Figure 9. Dimensions in plan are 15.9m x 73m, and 45.6m high from ground level with 14F

Figure 9 E Rebagliati Hospital and studied block

As reference also for this building exist two previous studies: evaluation 1997 and more detailed, non linear analysis conducted for a thesis research. For intermediate level earthquake, predicted damage are expected in beams in both directions of analysis, endangering immediatly occupancy or interrupting normal performing of functions as hospital

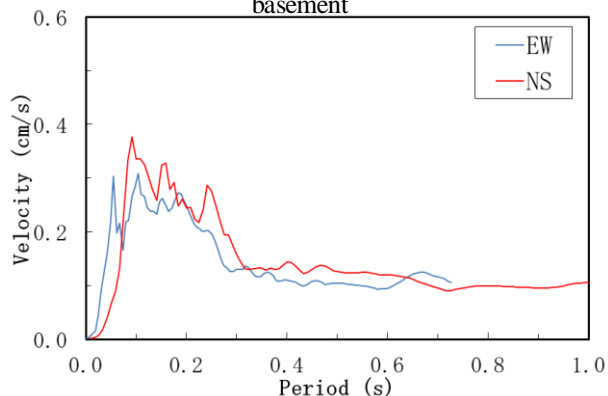
Figure 15 Velocity spectra (h=0.05). signal from basement

Both figures presents peaks values at the predominant periods and components of acceleration reach a maximum spectral component for a range between 22 to 27 gals for each direction of the building. Also the velocity indicates a peak value between 0.3 s. to 0.38 s. for this building.

Figures 14 and 15 shows spectra (acceleration and velocity) for basement level measurements
