Diagnosis for Seismic Vulnerability Evaluation of Historical Buildings in Lima, Peru

Carlos Cuadra*, Taiki Saito**, and Carlos Zavala***

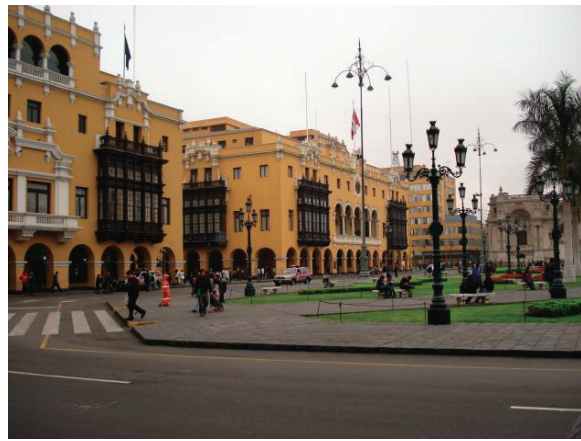
Fig. 3. Lima city hall.

mainly made of reinforced concrete or confined masonry, while old buildings use traditional construction materials. These traditional materials are unreinforced masonry, adobe (sun-dried bricks) and quincha (earthen construction with a wooden frame). **Fig. 3** shows the city hall of Lima, which is a reinforced concrete building combined with confined masonry.

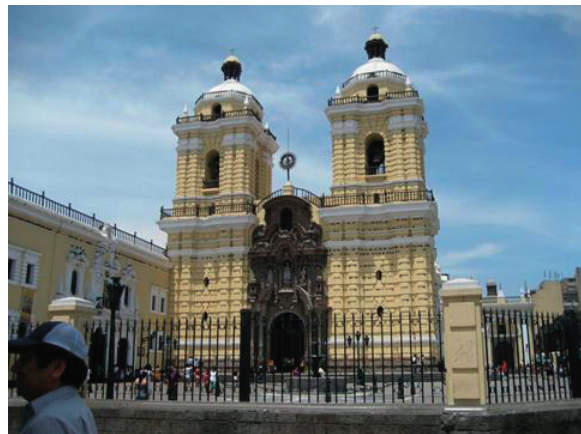
Fig. 4. San Francisco church.

Figure 4 shows a view of the San Francisco church (unconfined masonry and adobe) and **Fig. 5** shows a typical quincha construction.

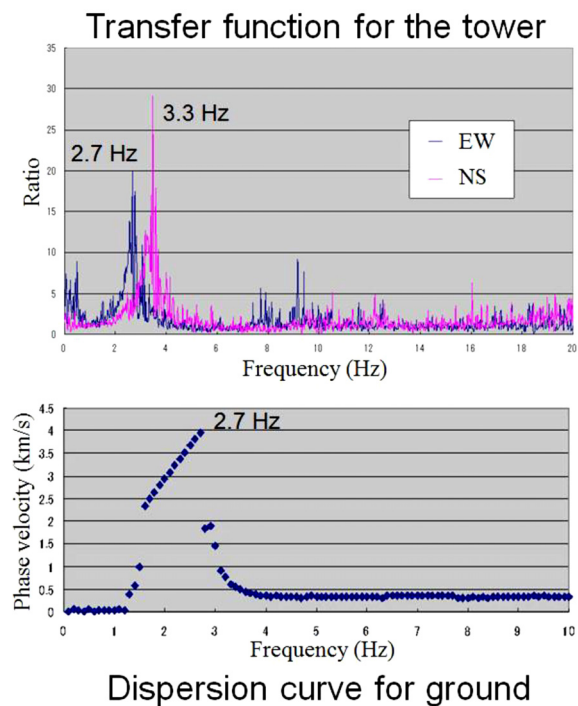
Fig. 7. Ambient vibration results for Santo Domingo church tower and ground.

Here, ambient vibration of ground was also performed and, as is indicated in Fig. 7, vibration characteristics of the church tower are similar of those of ground and therefore great amplification of the tower response is expected to occur in the case of an earthquake. This fact could explain failures of towers during past earthquakes.

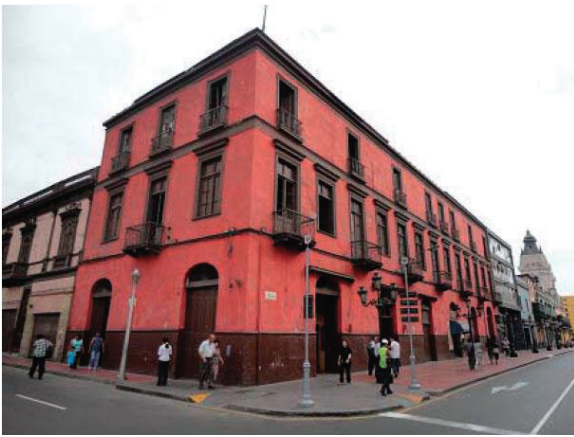
Fig. 8. Typical quincha construction for measurements.

A building that was an old hotel in Lima city is presented as an example in which ambient vibration measurements were performed to estimate its period of vibration. This building is shown in Fig. 8. Walls of the upper stories (second and third floors) are made of quincha and first story walls are made of adobe. The building presents some partial collapse of interior walls and serious deterioration of quincha walls due to ageing and humidity.

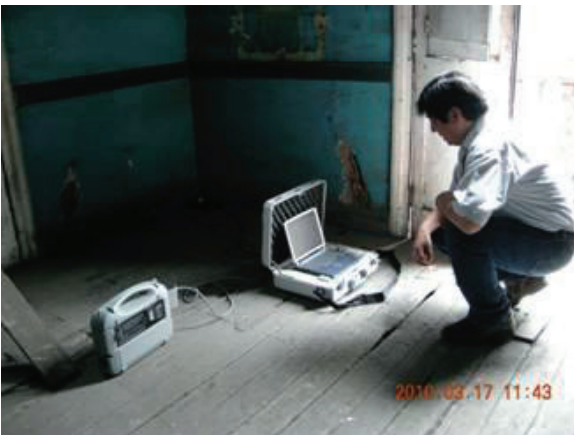
Fig. 9. Microtremor measurement of adobe-quincha building.

Figure 9 shows the setup of ambient vibration sensors. These micro velocity sensors were located on the third floor and at the corners of the building.

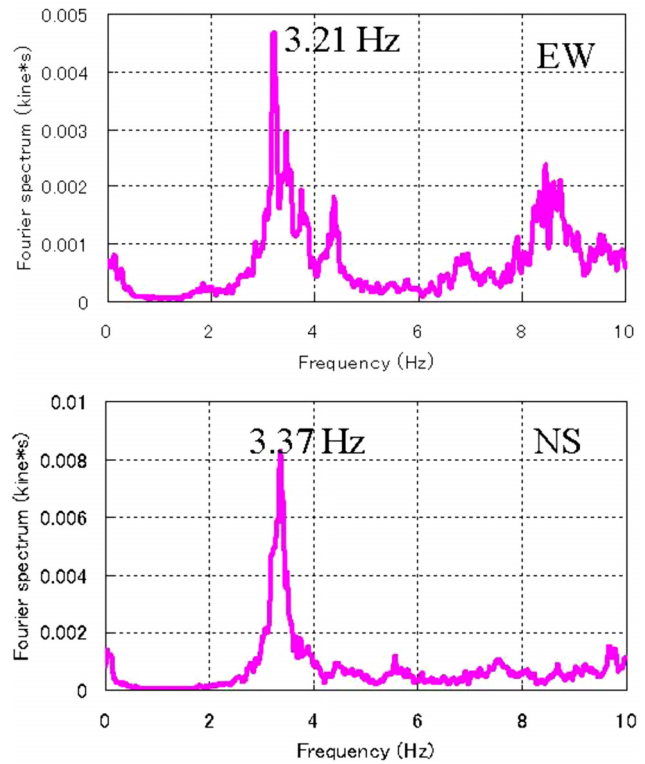
Fig. 10. Predominant frequency of selected historical building.

Results of ambient vibration show a predominant frequency on the order of 3.3 Hz. Fig. 10 shows predominant frequencies for NS and EW directions respectively. The NS direction was taken as the direction parallel to the façade and the predominant frequency is 3.37 Hz. In the EW direction, which is perpendicular to the façade, the predominant frequency is 3.21 Hz. These frequencies represent reasonable values for a building 12 m in height.
