# Urban Recovery Process in Pisco After the 2007 Peru Earthquake

**Keywords:** 2007 Peru Earthquake, Pisco, urban recovery process, building examination, satellite image

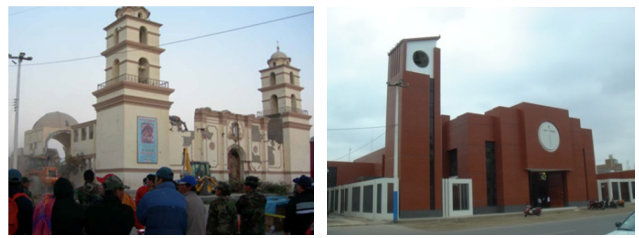
Some important facilities are concentrated in the central area of Pisco. Most of them had been reoccupied by the time of the field survey. Fig. 2 shows the recovery status of the Central San Clemente Cathedral of Pisco, which had been seriously damaged by the earthquake. Fig. 3 shows two other public buildings, City Hall and the Police Station.

Fig. 2. Central San Clemente Cathedral of Pisco.

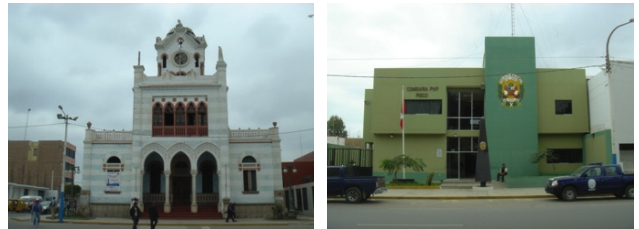
Fig. 3. Recovery of public facilities.

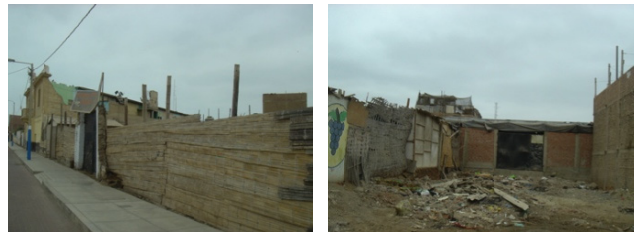
Walking around in central Pisco, we found many unrebuilt lots, as shown in Fig. 4.

Fig. 4. Empty lots.

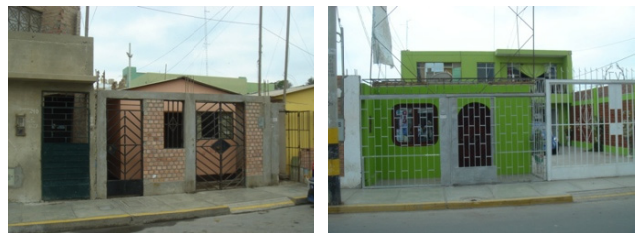
Fig. 5. New front gate instead of solid new house.

some of those receiving subsidies used the money for installing new front gates as symbols of their houses (Fig. 5).

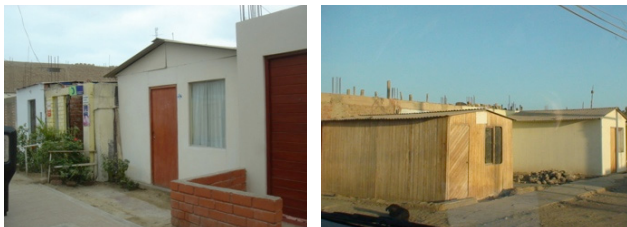
In order to coordinate reconstruction efforts, the Fund for the Reconstruction of the South (FORSUR) was established just after the earthquake. Fig. 6 illustrates the reconstruction stage indicated by FORSUR [5]. Temporary housing were supposed to be in a stage of transition according to FORSUR recovery strategy. There remained many temporary housing around the district, however, when the authors investigated. There were also blocks that were occupied by temporary housing as new settlements into which affected people moved after the event (Fig. 7).

Fig. 7. Remaining temporary housing.

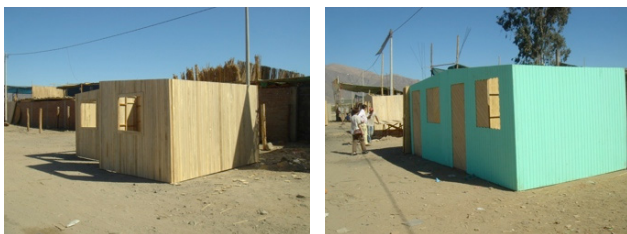
Fig. 8. Temporary house construction.

The authors then visited a few building-materials stores to get some information on temporary housing construction (Fig. 8). Salesclerks gave us information useful for understanding the temporary house construction situation as follows:

- (1) Although house units for sale are not for temporary housing but for huts, affected people often buy them themselves, and they are not provided by the government for temporary use.
- (2) If the user daubs house parts with waterproof paint once a year and changes the roof often, the house can be used for about ten years. It does not last long without maintenance.
- (3) The total price of the material, not including handling, and time necessary for construction is

[3 × 3 m] S/.1,350 (\$519), one day  
 [3 × 4 m] S/.1,600 (\$615), two days  
 [3 × 6 m] S/.2,400 (\$922), two days.

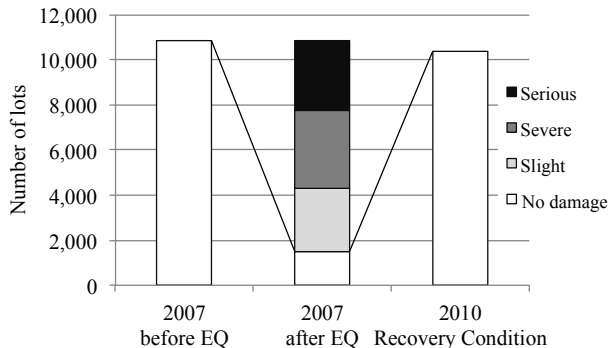
**Fig. 12.** Damage and recovery condition.

data, but the figure after the elimination is used to evaluate recovery conditions here. Polygons categorized into “no data” and “others” are counted, too. **Fig. 12** shows damage and recovery conditions as results of analysis.

Based on analysis, 87.6% of seriously damaged buildings and 98.3% of severely damaged buildings had been reoccupied by the time of the survey.

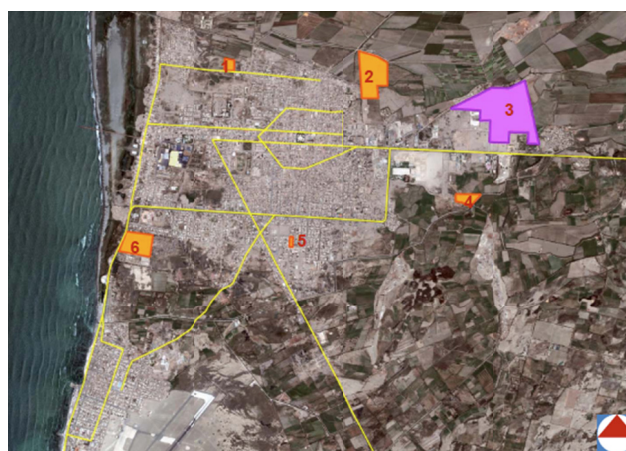
**Fig. 13.** Housing project for Pisco (Ministro de Vivienda, Construcción y Saneamiento [7]).

While residents had reoccupied or repaired their damaged houses individually since the earthquake, the governments devised future plans for Pisco. The housing project shown in **Fig. 13** is one of the plans provided by the Government [7].

Some of the areas planned by the Government are shown in **Fig. 13**: Areas B, D, E, G, J, and N in **Fig. 14** according to Areas 1 to 6 in **Fig. 13**, respectively. **Table 2** shows the number of buildings inside and outside of the central area of Pisco, which is covered by the analysis in
