Paper:

Experimental Study on Dynamic Behavior of Unreinforced Masonry Walls

Keywords: masonry wall, shaking table test, out-of-plane failure

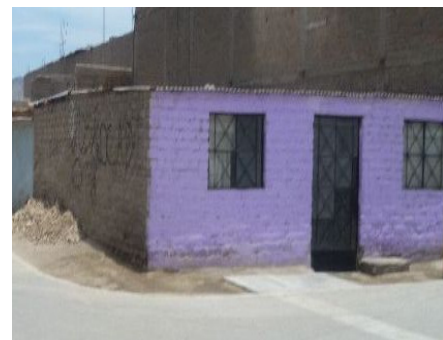
Fig. 1. URM house.

A fundamental purpose of this study is to mitigate the seismic hazard of URM walls. This concern is relevant to Peru because residential buildings located in areas with low economic resources are mostly non-engineering houses. **Fig. 1** illustrates a non-engineering house built with URM walls and without a floor diaphragm. **Fig. 2** illustrates typical URM exterior walls of a masonry building, which could injure people around it when they collapse during an earthquake.

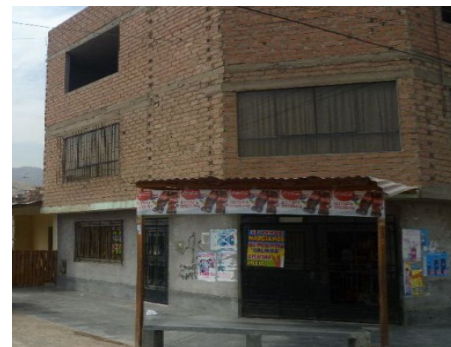
Fig. 2. Building with URM wall.

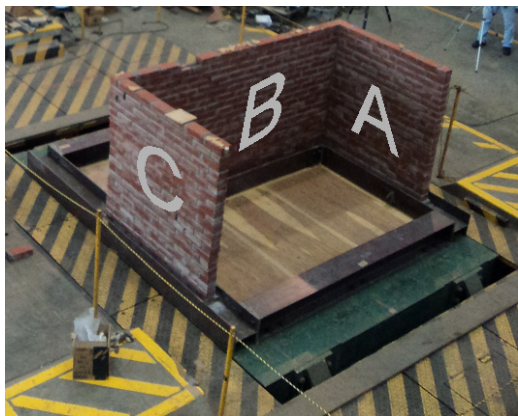
(a) Scheme of the test set up

(b) Specimen of the shaking table

Fig. 3. The first specimen (specimen without floor).

In January 2012, two specimens were constructed on the shaking table of the Structural Engineering Laboratory at the Building Research Institute. **Figs. 3** and **4** illustrate the idealized models, which represent a URM wall of a single-story building and an upper level of a multistory building, respectively. Each specimen consists of three masonry walls: A, B, and C.

The wall B was 1440 mm high × 2850 mm wide × 100 mm thick. The orthogonal walls (A and C) were

1440 mm high \times 1450 mm wide \times 100 mm thick. The above dimensions give a slenderness ratio of 14.4.

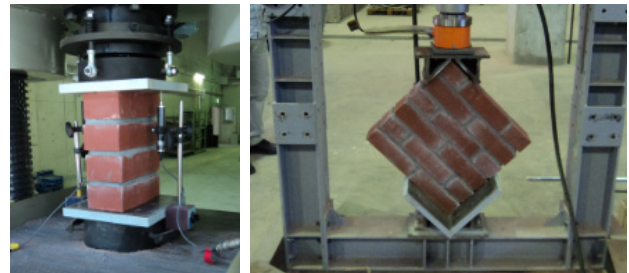
(a) Compression

(b) Shear

Fig. 5. Test of masonry prism.

Solid bricks and type O mortar (cement : sand ratio of 1 : 6) were used in the specimen. The average compression strength of the masonry prism with four bricks was found to be 6.09 MPa from the test, as shown in **Fig. 5(a)**. Diagonal compression tests according to the ASTM E519 were carried out on 430 mm \times 410 mm specimens, as shown in **Fig. 5(b)**. The average shear strength of the masonry was found to be 1.28 MPa.

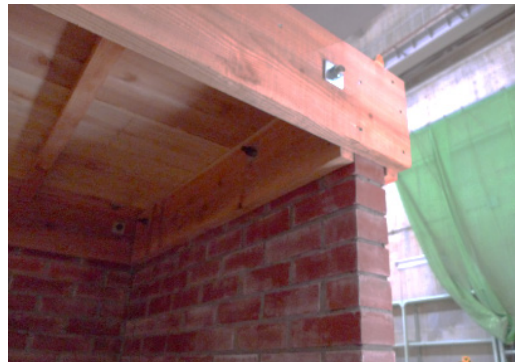
Fig. 6. Connection between wall and diaphragm.

The specimen was constructed on a steel frame support and hoisted up to set on the shaking table. The first specimen has no floor at the top. On the other hand, the second specimen has a wooden diaphragm floor and steel weights at the top. The diaphragm was connected to the masonry wall by sandwiching it between two plates as shown in **Fig. 6**.

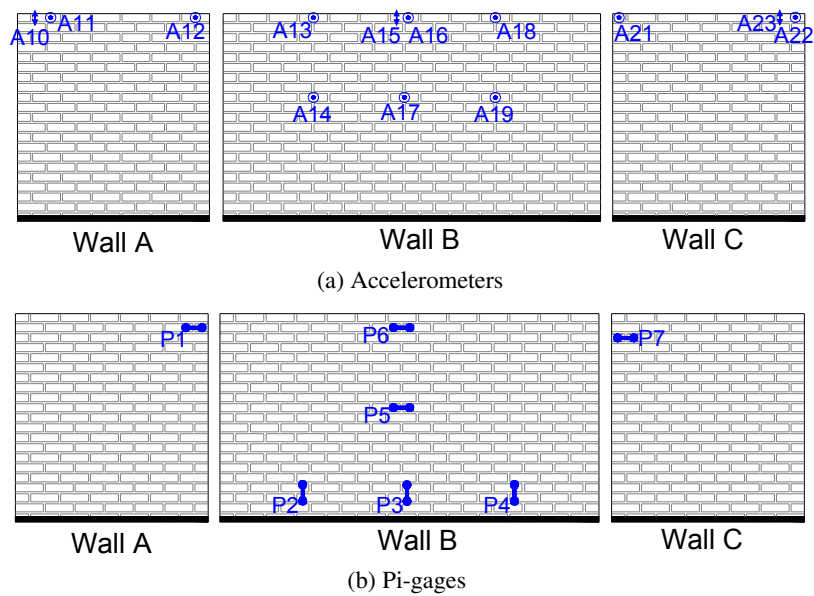
Fig. 7. Instrumentation for the wall test.

Figure 7(a) shows the positions of the accelerometers. The A10, A15, and A23 accelerometers recorded vibrations in the up-down direction, and all the others recorded vibrations in the direction perpendicular to the wall where they were located. Assuming that the wall “B” would fail due to out-of-plane behavior, it was decided that the pi-gauges would be arranged as illustrated in Fig. 7(b).

Most of the accelerometers were placed on wall B because previous researchers showed the out-of-plane mode of failure to be the weakest. Three additional accelerometers were placed over the floor diaphragm for the second specimen. One accelerometer located at the middle of the diaphragm recorded acceleration in the same direction as the shaking table, and the other two accelerometers, which were located at the ends, recorded up and down acceleration.

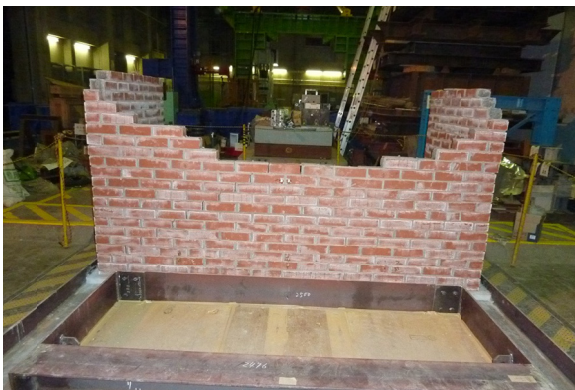
Fig. 10. Shape of failure of the 1st specimen.

Besides, the cracks located at the upper corners became larger, and they reached the half-height of the wall. Finally, when the connections between in-plane and out-of-plane walls were partially lost, a horizontal crack formed at the middle of the wall; this wall corresponds to the collapse of the specimen (see Fig. 10).

The shape of failure of the first specimen, which simulated a single-story building, was found to be out-of-plane. However, at the beginning, the crack patterns were different than those in the previous research due to the influence of the in-plane walls.

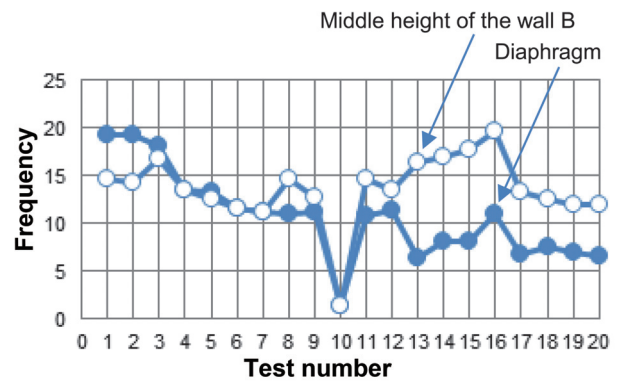
Fig. 11. The first natural frequency of the 2nd specimen.

The change in the natural frequency can be used as a trace of the damage caused in the specimen. **Fig. 11** illustrates how the natural frequency of the accelerations recorded over the diaphragm decreased. However, the natural frequency recorded at the mid-height of Wall B did not decrease significantly.

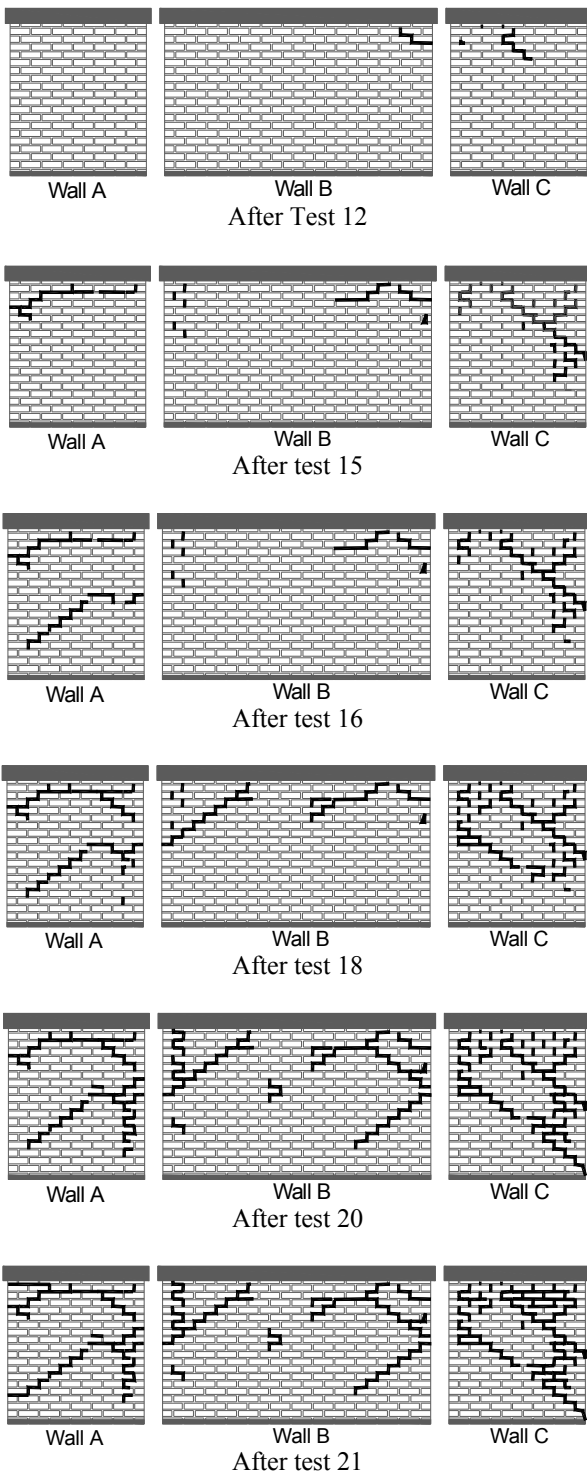
Fig. 12. Crack patterns developed in the 2nd specimen.

Furthermore, the floor diaphragm and the roof provided a type of confinement. As shown in **Fig. 12**, at the beginning, the crack patterns that developed over the in-plane wall components were totally different. After the 15th

test, a bed-joint sliding on a horizontal plane located at the top developed in Wall A. Meanwhile, a sliding on a stair-stepped diagonal crack developed in Wall C. Due to the difference in behavior between the in-plane wall components, torsional movements developed in the specimen. After the 18th test, diagonal cracks, which began in the in-plane walls and ended up on wall B, developed because of the torsional behavior. Finally, the shape of failure can be seen in Fig. 13.

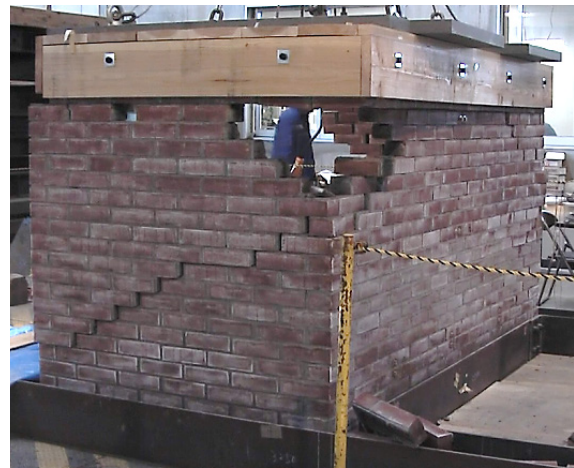
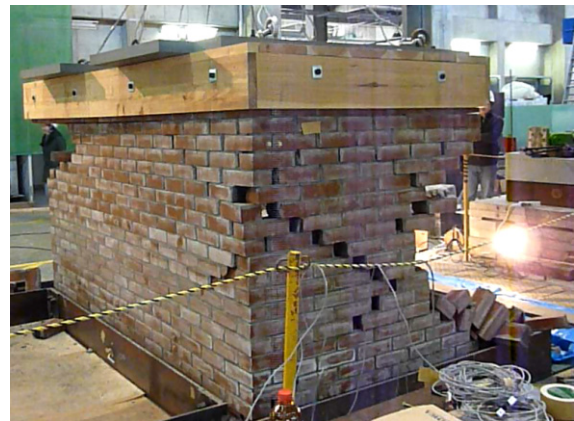
Fig. 13. Shape of failure of the 2nd specimen.

On the other hand, the damage in the second specimen was observed on the in-plane walls. It is presumed that the floor diaphragm and the axial load produced by the weight suspended at the top enhanced the stability of the out-of-plane wall component.

As happened in the second specimen, the possibility of different modes of behavior in the in-plane wall components of a building produced torsional movements. Besides, the URM walls have several shear behavior modes, such as wall-pier rocking, bed-joint sliding, spandrel-joint sliding, and rocking/toe crushing, among others.
