Paper:

# Basic Study on Reinforced Concrete Shear Walls Without Boundary Columns Retrofitted by Carbon Fiber Sheets

Tomoya Matsui, Taiki Saito, and Roy Reyna

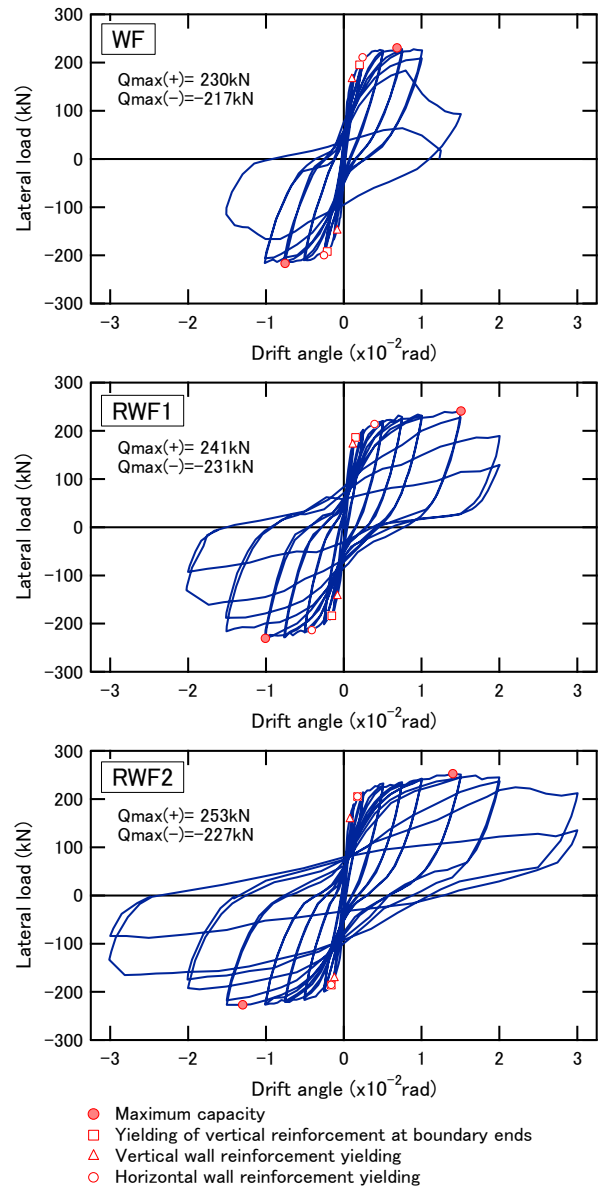
Fig. 5. Lateral load and drift angle relationship.

The relationship between lateral load and drift angle for each specimen is given in Fig. 5. Also, Fig. 6 shows the

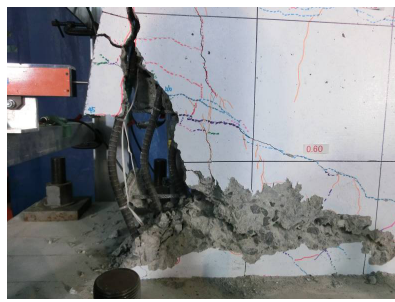
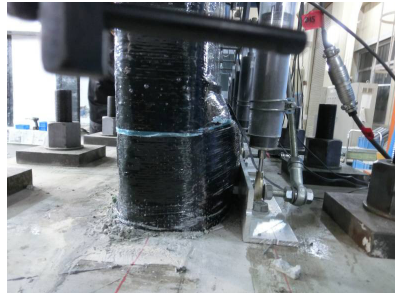
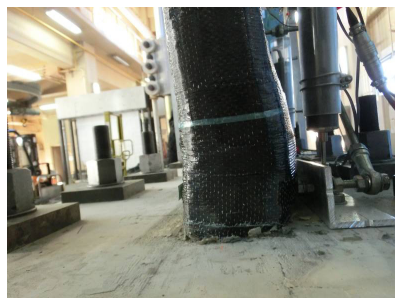
(a) Specimen WF ( $R = 1/67$  rad)

(b) Specimen RWF1 ( $R = 1/50$  rad)

(c) Specimen RWF2 ( $R = 1/50$  rad)

Fig. 6. Wall base condition at failure for each specimen.

For specimen WF, shear cracks appeared at the same time that the vertical wall reinforcement yielded under the  $R = 1/800$  rad cycle, while the horizontal wall reinforcement and the vertical reinforcement at boundary ends yielded under the  $R = 1/400$  rad cycle. Afterwards, maximum capacity was reached at the  $R = 1/133$  rad cycle; large concrete spalling at the lower part of the wall occurred under the  $R = 1/67$  rad cycle, at which point the axial load could not be sustained and loading was terminated (Fig. 6(a)).

cle, concrete swelling at the wall base grew (Fig. 6(b)) until swelling occurred at the center of the lower part of the wall as well.

For specimen RWF2, the vertical wall reinforcement yielded under the  $R = 1/800$  rad cycle while the horizontal wall reinforcement and the vertical reinforcement at boundary ends yielded under the  $R = 1/400$  rad cycle, similar to specimen WF. Afterwards, maximum capacity was reached at the  $R = 1/67$  rad cycle; large concrete spalling at the base occurred during the  $R = 1/33$  rad cycle. And then, right after commencing with the  $R = 1/25$  rad cycle, the axial load could not be sustained and loading was terminated. Looking at the condition at the base during  $R = 1/50$  rad, it was found that the swelling was not as much as that of specimen RWF1 (Fig. 6(c)).

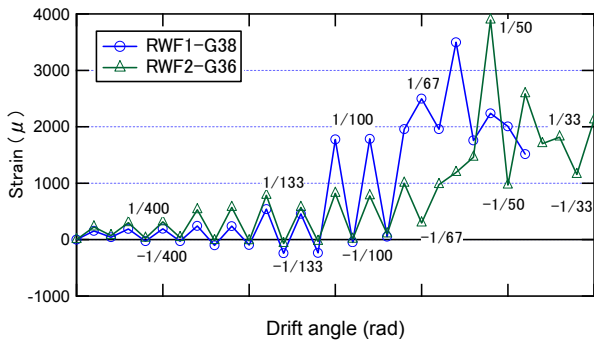
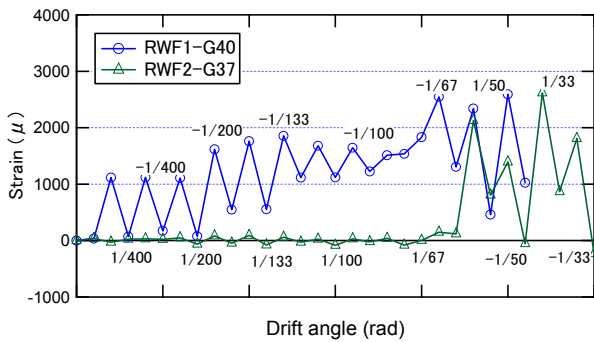
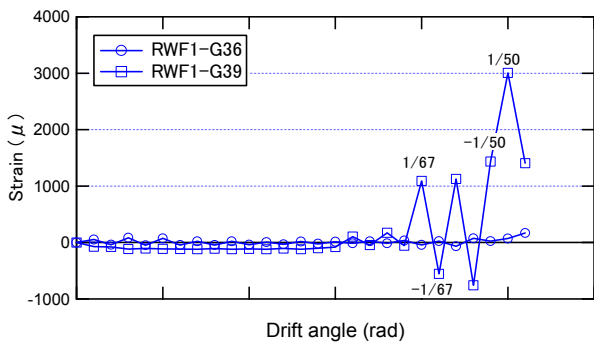
(a) Boundary ends of the wall base

(b) Boundary ends of the wall base

(c) Middle area of wall

Fig. 13. CFS strain.

Figure 13 indicates the CFS strain for specimens RWF1 and RWF2. The locations of the strain gauges are illustrated in Fig. 14.

According to reference [4], experiments of retrofitted walls have shown that the peak strain of the CFS during maximum strength is about  $2000 \mu$ . Specimens picked up in the reference were I-shaped walls which had boundary columns, and failure mode of these specimens were shear failure or slip failure of wall panel. Although the test specimens in the present experiment are not comparable since they were designed for flexural failure, strains between  $2000 \mu$  to  $3000 \mu$  during maximum capacity have been measured at the wall base even in this experiment, confirming the confining effect of the CFS. Furthermore, strain at the wall center was confirmed to increase starting

from the  $R = 1/67$  rad cycle, when concrete crushing has advanced as shown in Fig. 13(c).
